Conservation Management Plan

Maryborough Municipal Olympic

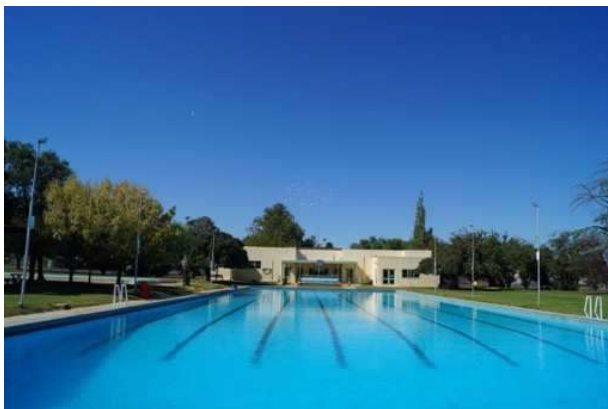
1.0 EXECUTIVE SUMMARY

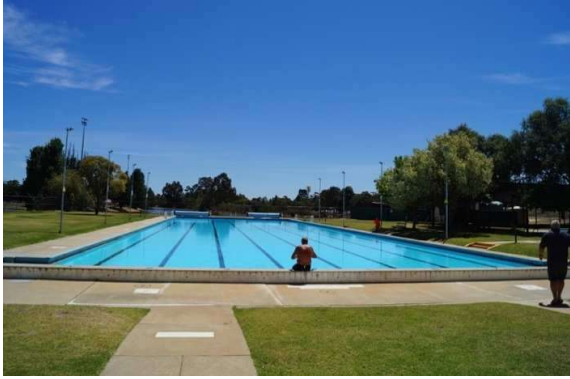
- Enhancement of the heritage values of the place can be improved by removal of the shelter shed near the Octagonal Pool, concrete concourse repairs and renewal of original signs that were painted on the concrete concourse.

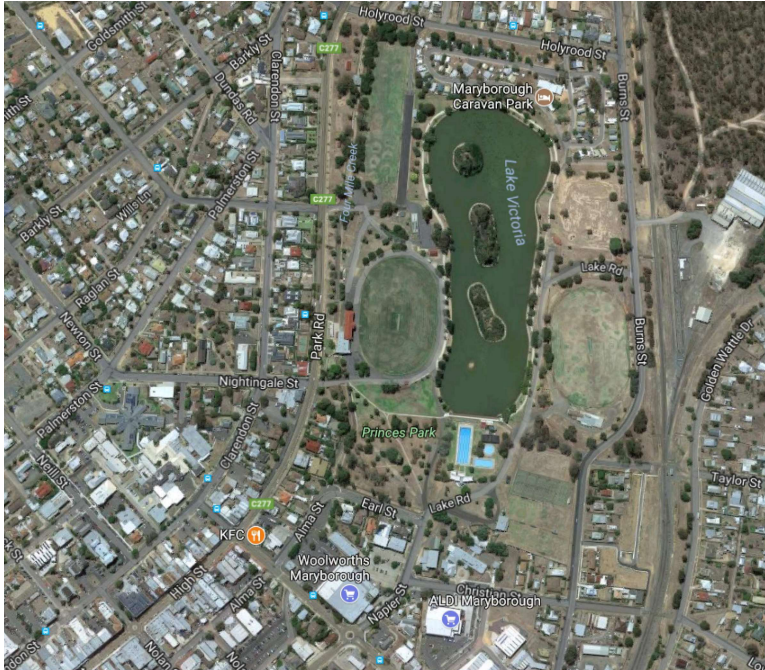
¹ FMG are a consulting engineering firm that includes expertise in civil, structural, environmental, geotechnical, building assessment and forensic, soil and material testing and have extensive experience in commercial/public swimming pools design and refurbishment.

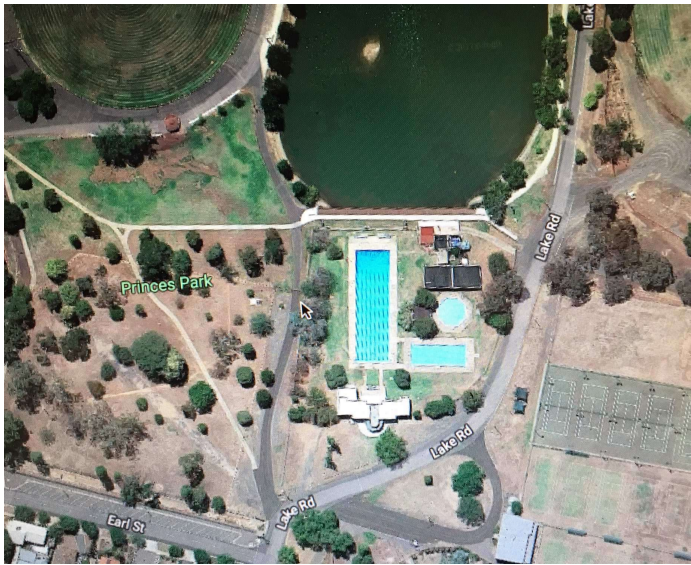
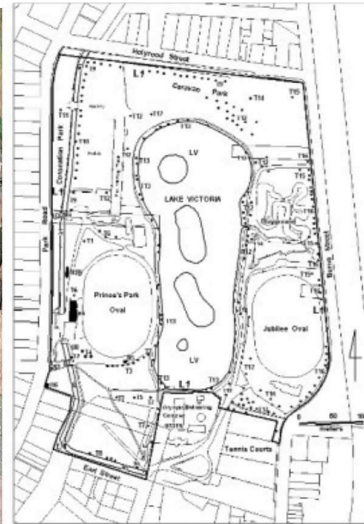
The Conservation Management Plan relates to the fenced area of the Olympic Pool, including all the buildings and structures as defined by the it's legal boundaries and extent of Victorian Heritage registration. The front forecourt is an important setting for the Entrance Pavilion to the swimming pool complex. It includes both formal and informal car parking and is framed by large mature trees. However, it is not included in the state heritage listing.

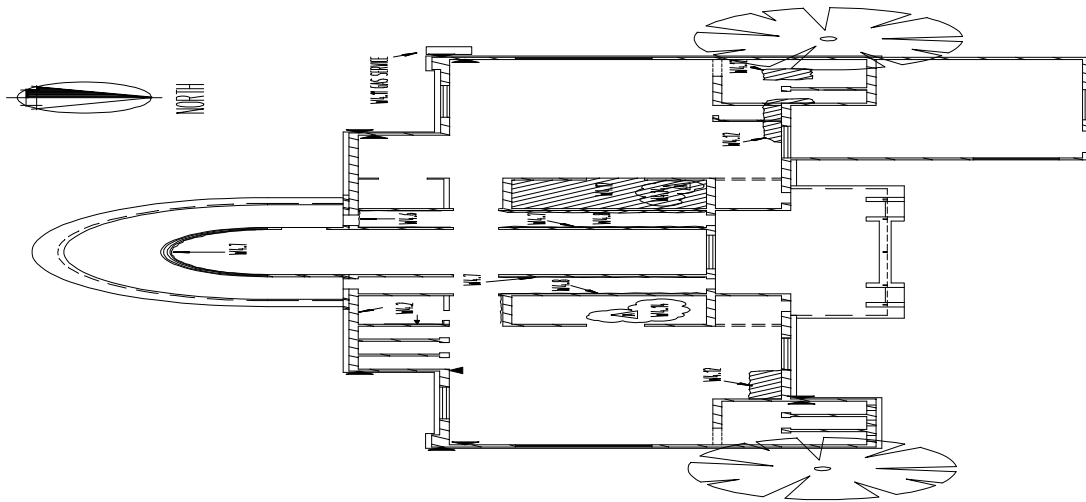
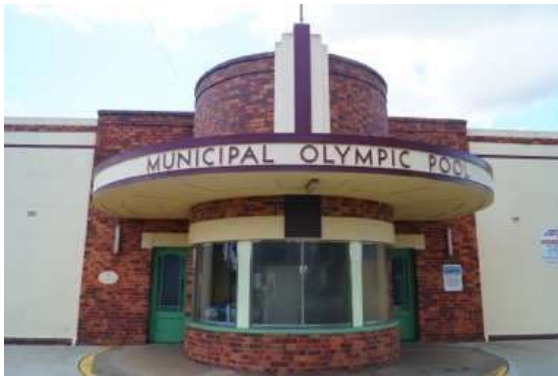
3.2 The Entrance Pavilion

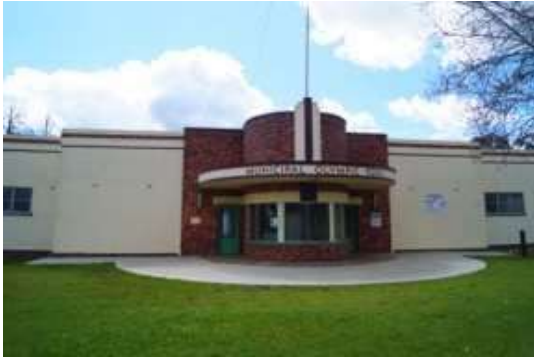
At the time of construction there was some discussion about dedicating the Municipal Olympic Swimming Pool complex as a memorial to the soldiers who fought in the Second World War. The idea was abandoned although the building is still heroic in design.

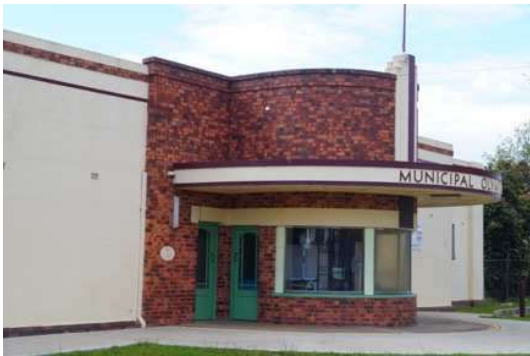
Due to war time shortages of funding and materials no reinforced concrete foundations were included. The walls were built directly off the clay ground. Sometime later, underpinning in the form of reinforced concrete pads were located at each corner wall junction, indentation and projection.

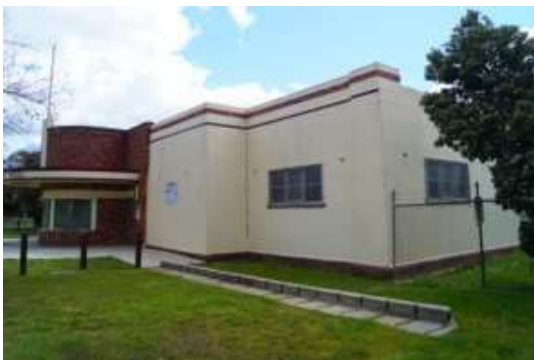
The building is designed around a grid of five roughly equal rectangular blocks. The front façade is a mixture of engineering ingenuity and bold architectural design.

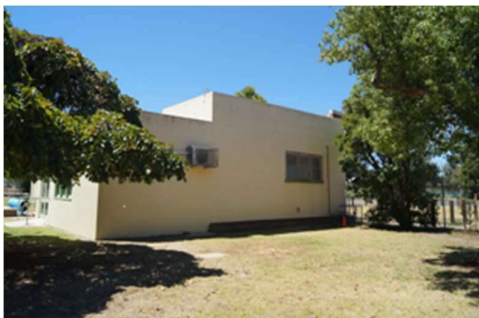
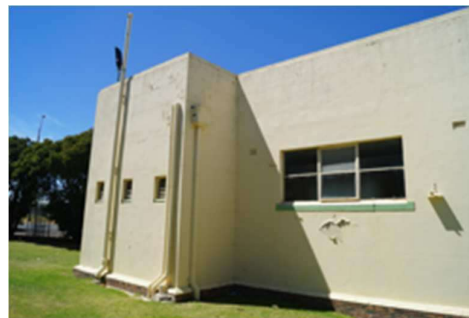
The minimal use of reinforced concrete footings meant that over time the build developed substantial cracks in the walls.

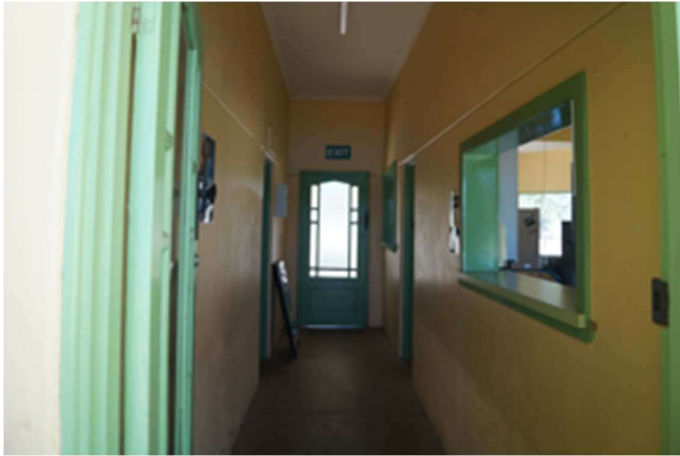
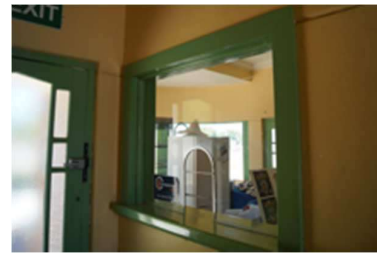
The front entrance door is 1930s in style with glazed bubble glass central panel and lower solid panel. The hardware is original and does not comply with Disability Act requirements.

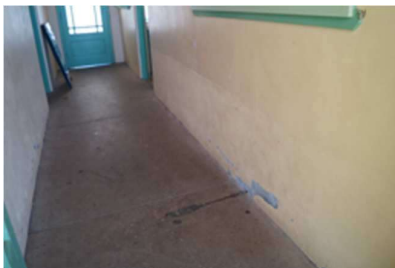
The internal wall clearly shows the line of new render repairs and also the height at which the salts rise in the wall before coming out of the brickwork. The First Aid Room is on the left of the public passage.

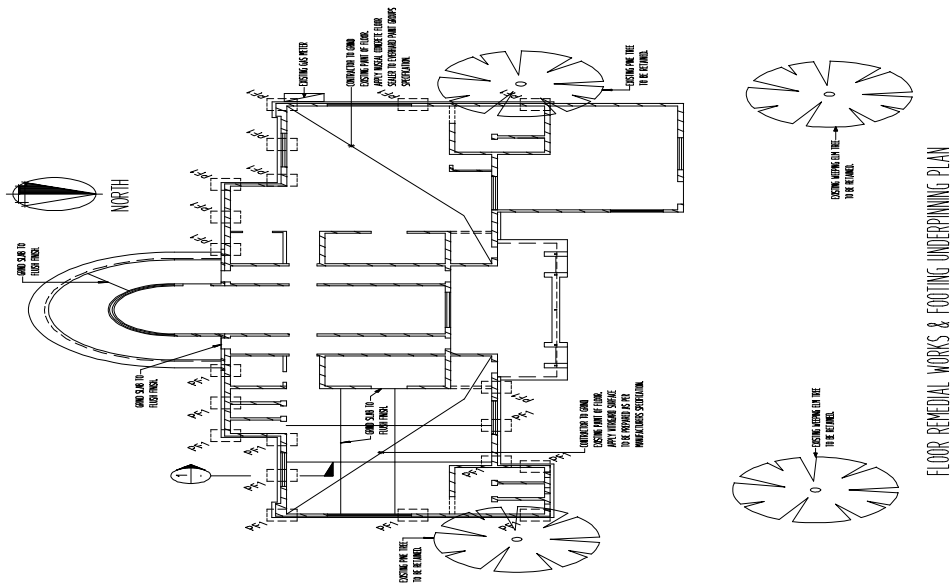
3.8 Previous Changes and Remedial Work

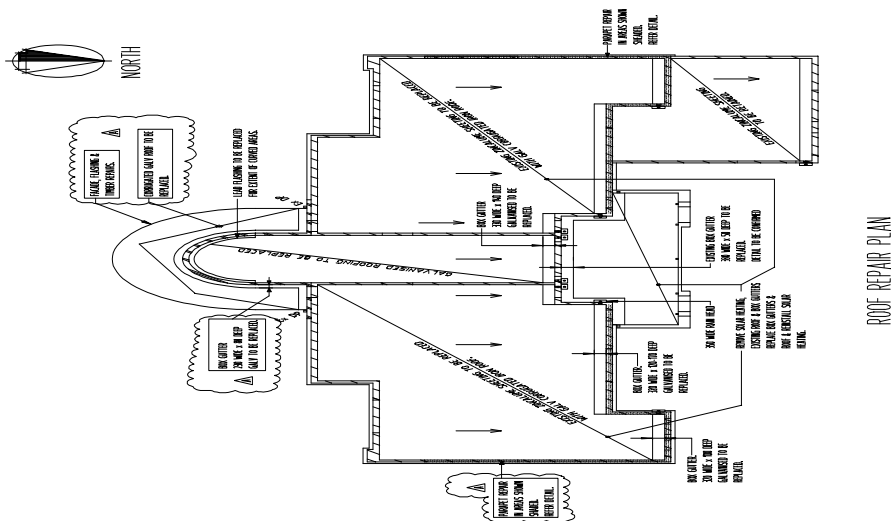
Drawings and structural remedial design by Hogg Beauchamp and Spano Pty Ltd.

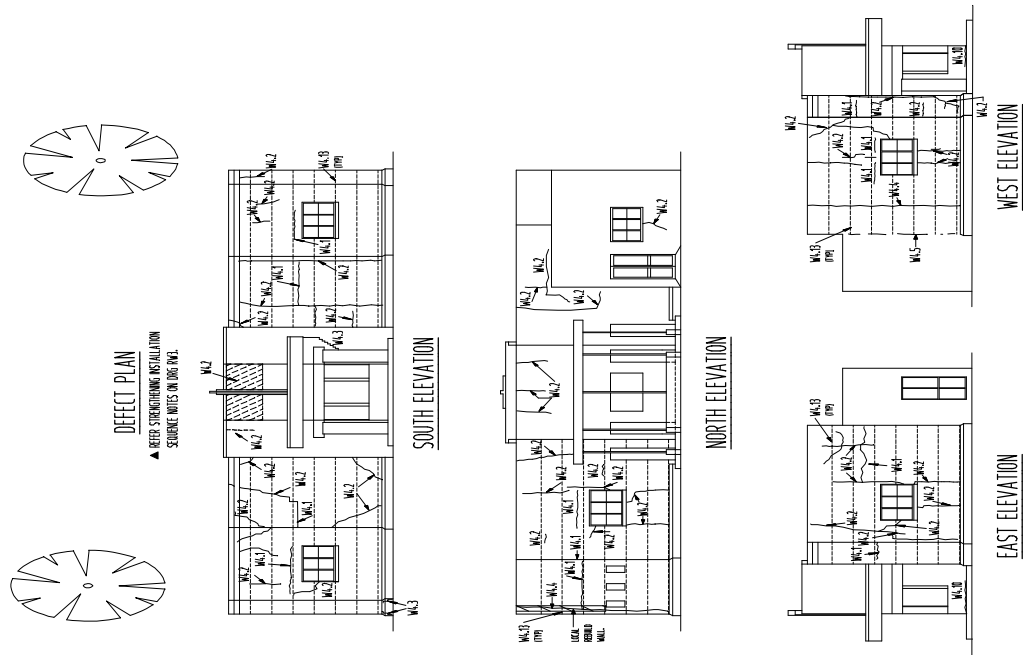
3.8.1 Interior Remedial Work 2002

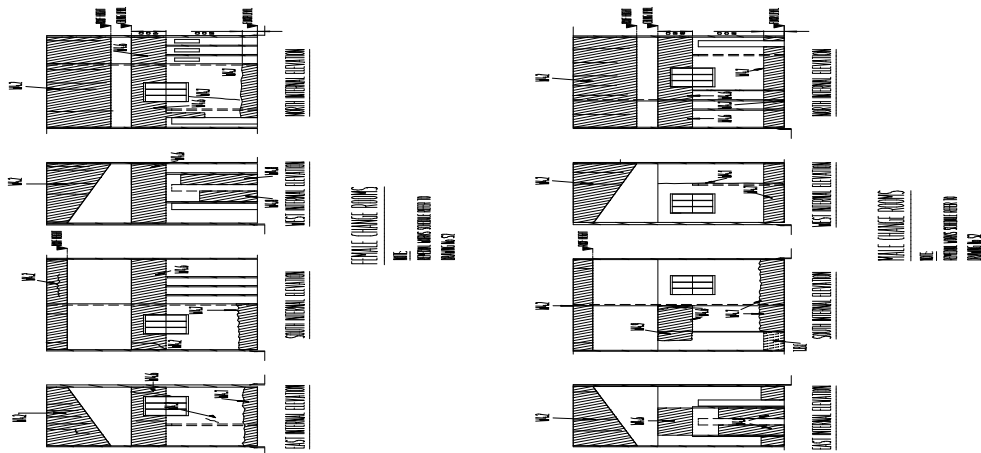
Drawings and structural remedial design by Hogg Beauchamp and Spano Pty Ltd.

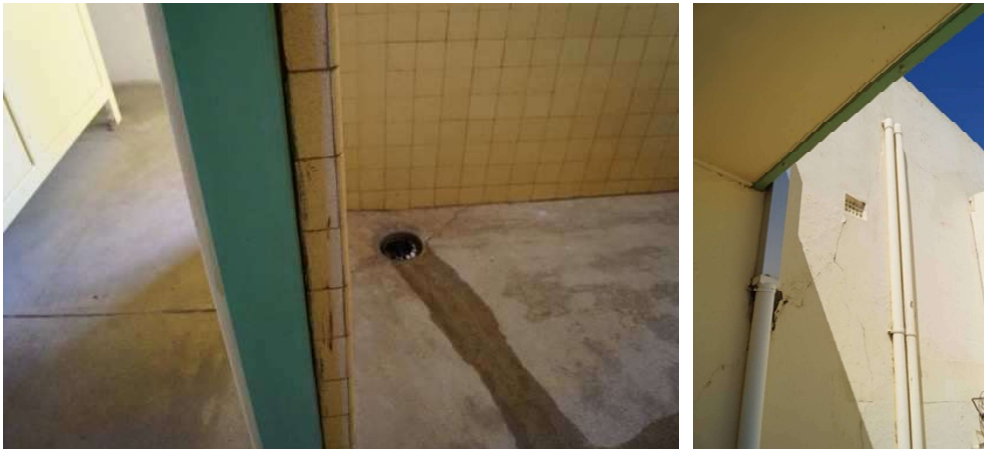
View of the continual water leak in the shower recess in the Men's Changing Room and damage caused to the floor waste. Evidence of both internal and external cracking at the entrance to the Men's Changing Rooms.

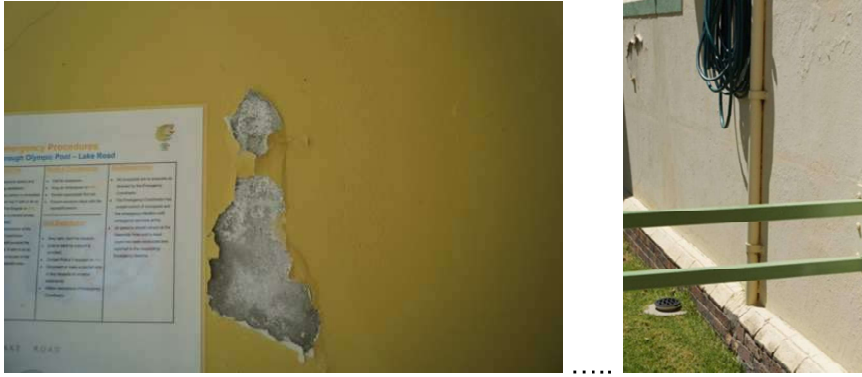
The damp wall showing efflorescence salts is directly behind the external downpipe and water hose.

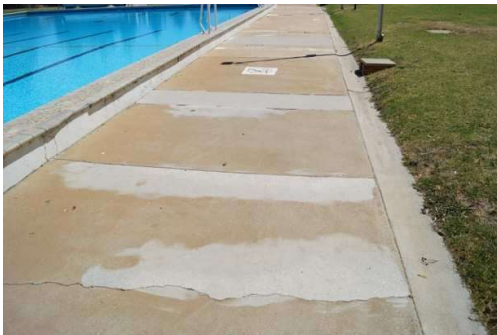
View of the concrete concourse.

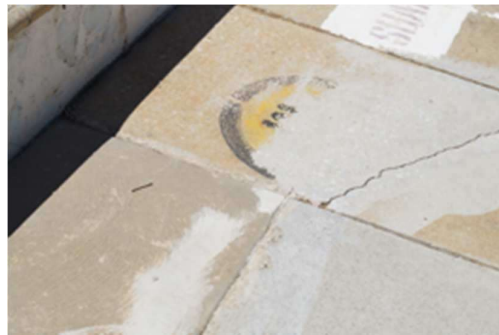
Detail showing successive repairs to the paving.

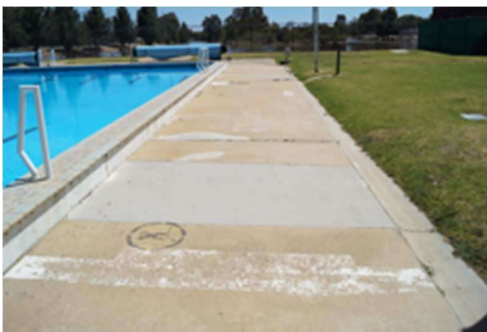
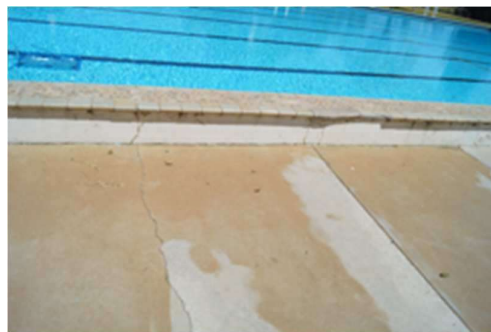
Safety signs and depth markers consist of painted signs on the concourse which are faded. There are also depth markers located above the line of the scum gutter. The signs are no longer legible due to continual maintenance and repairs to the concourse.

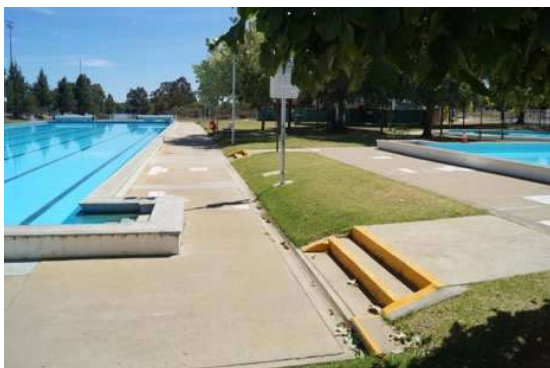
Photograph taken in January 2018
When the pool is open to the public.

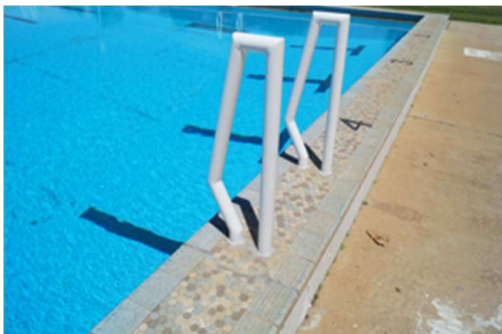
View showing the cracking along the junction of the upstand at the base and also beneath the tiles. Cracks are across the tiles and vertical.

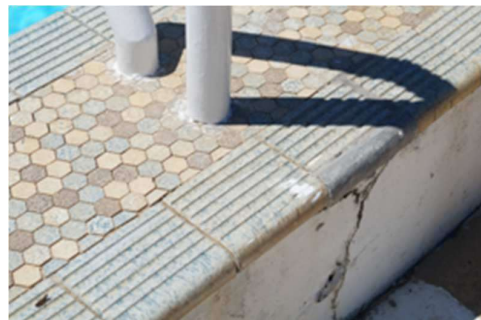
The cracking to the upstand. Cracks runs horizontal along the top and vertical to meet cracking long the concourse paving.

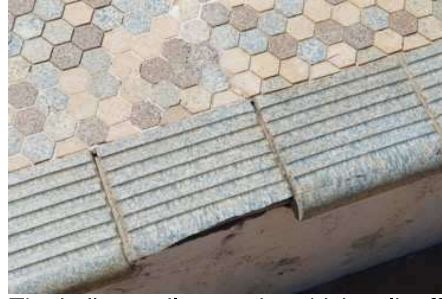
The bullnose tiles cracks which split off.

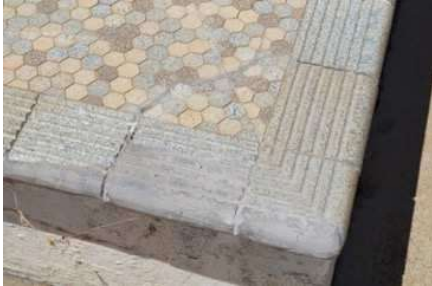
Example of regular repairs to the bullnose tiles using concrete to form the original shape.

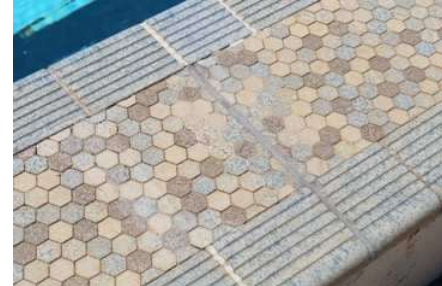
Continuous crack repairs where the tiles have substantially moved apart.

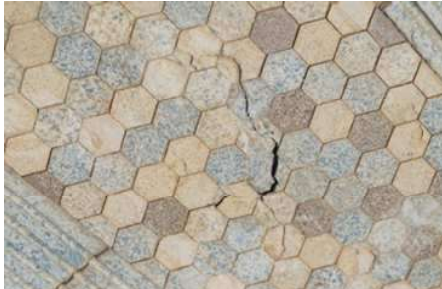
The hexagonal tiles are made of two different thicknesses, where there has been collapse of the substrata due to erosion by water there is irregular cracking through the hexagonal tiles as the thinner tiles settle unevenly.

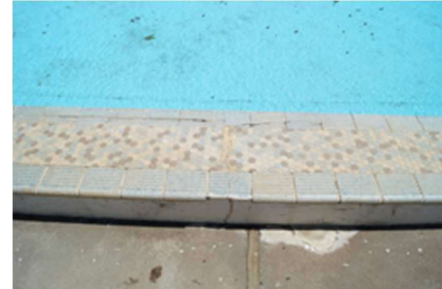
There is evidence of both horizontal cracking and vertical cracking to over 75% of the tiling. This corresponds to widespread horizontal and vertical cracking to the upstand kerb around the pool where the reinforced bars have deteriorated, causing damage.

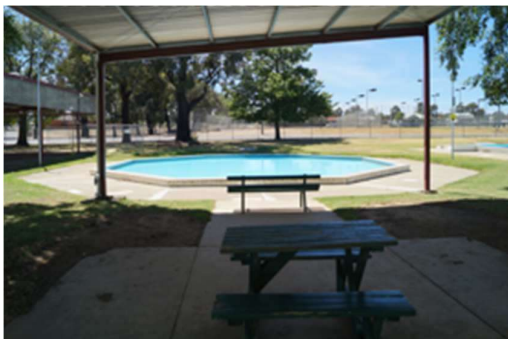
The Octagonal Pool also known as the Toddler pool was strongly advocated for by local councillor Sam Poole

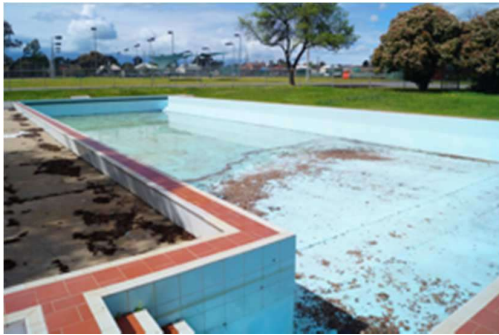
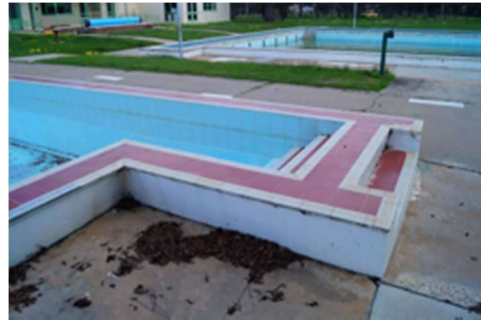
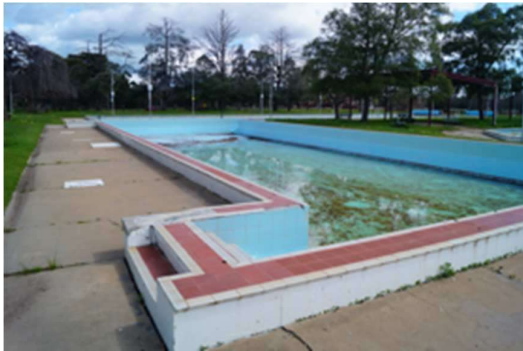
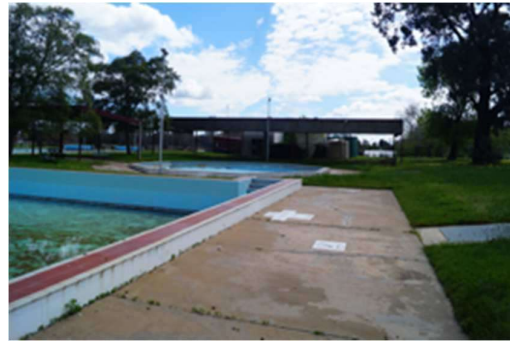
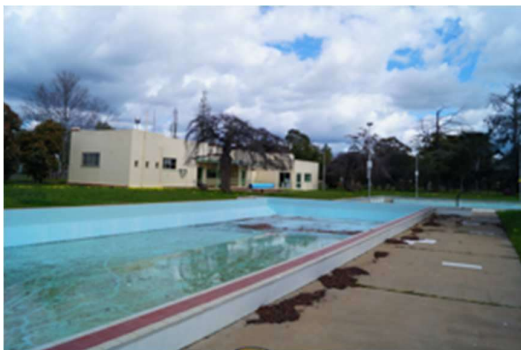
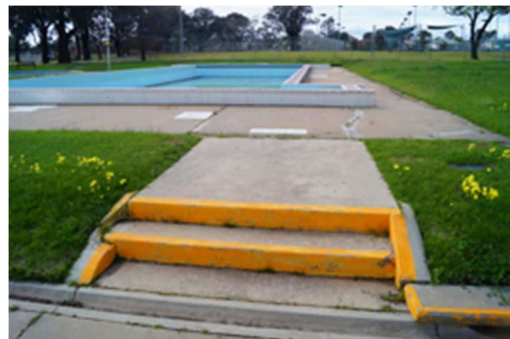
Existing Condition 2018

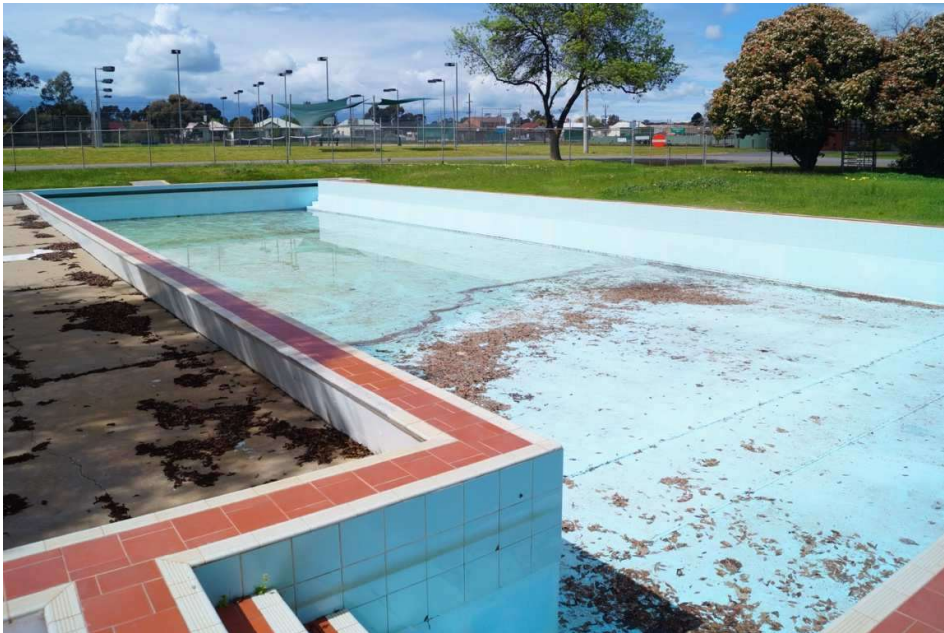
3.24 The Filter Room and Balance Tanks

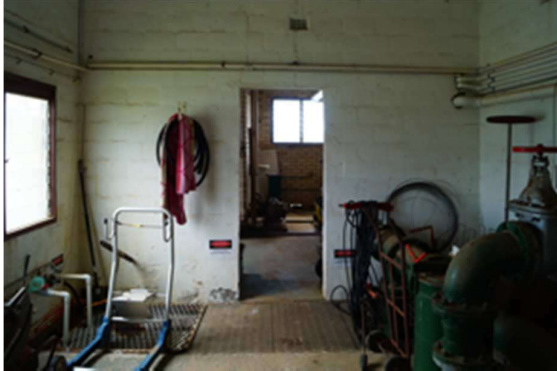
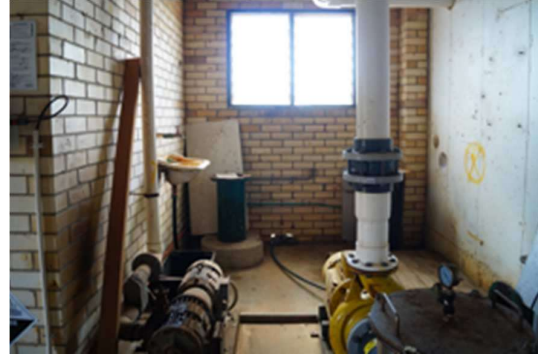
Liquid acid (hydrochloric acid) is also stored in this room. The liquid acid is not stored in a bunded area and there are trip hazards between the acid storage and where it is in use [121, 122]. There is also an electrical switch board and sink located in the pump and testing room.

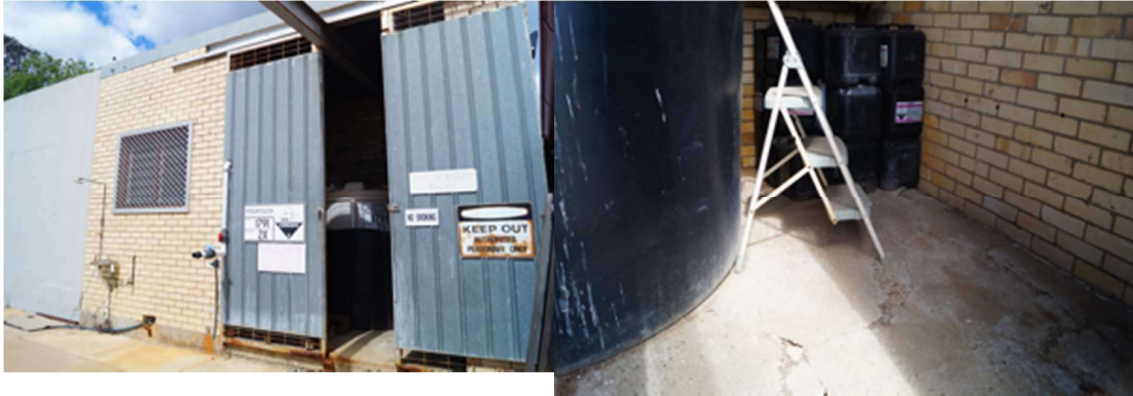
There is also a redundant chlorine storage room with a badly spalled concrete floor. The chlorine storage room consists of a small veranda style enclosure with 'shade cloth' walls.

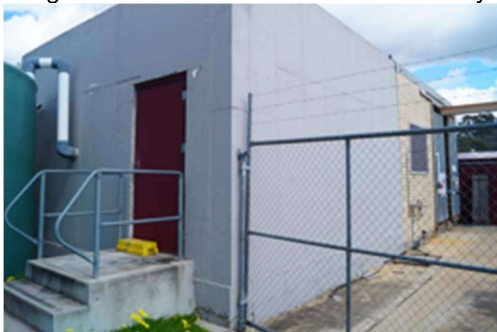
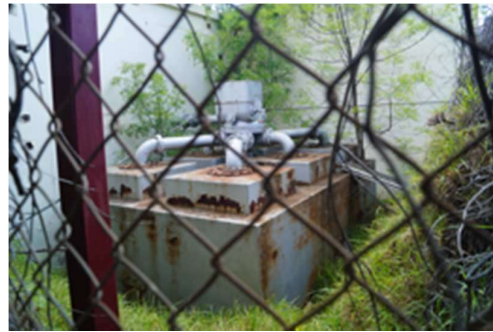
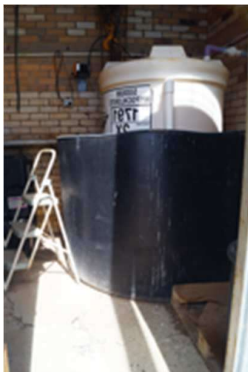
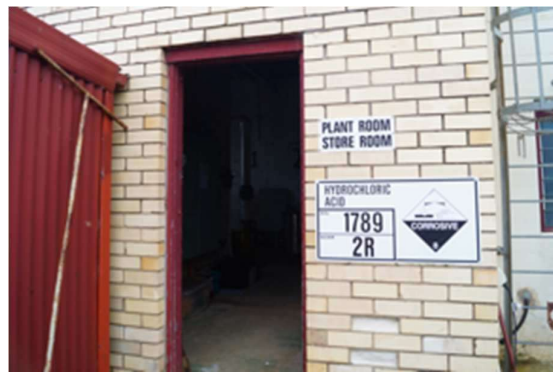
The fixed chlorine delivery point is not located in a bunded area. There is also no allowance for a bunded zone for the delivery truck. There is an eyewash and shower located nearby.

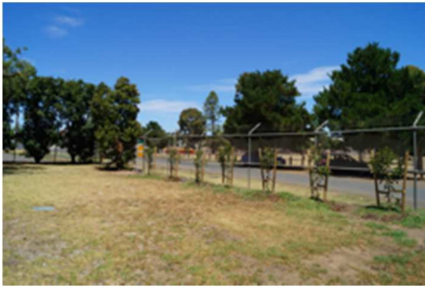
The early cedars and cypress trees have been replaced recently with similar trees.

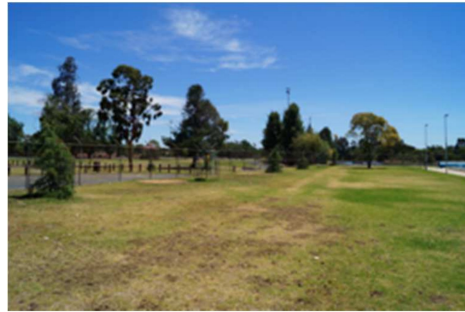
View of new plantings

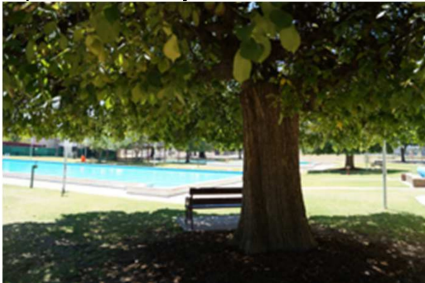
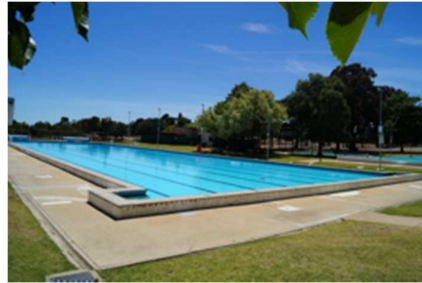
Tree List & Condition

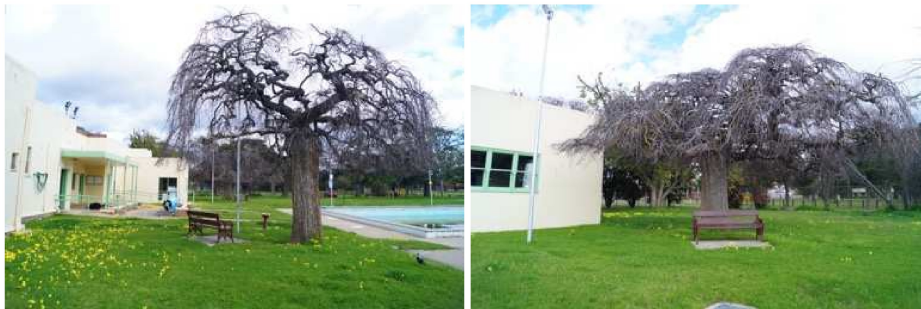
View of the two mature weeping elms, (*Ulmus glabra* 'Camperdownii') in winter.

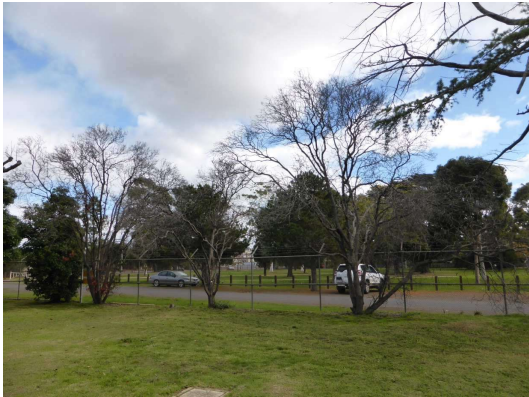
A Photinia serratifolia hedge x4, 3 dead plants and 2 stumps
Coppice living plant to 0.5m and replant 6 new Photinia. Mulch all plants

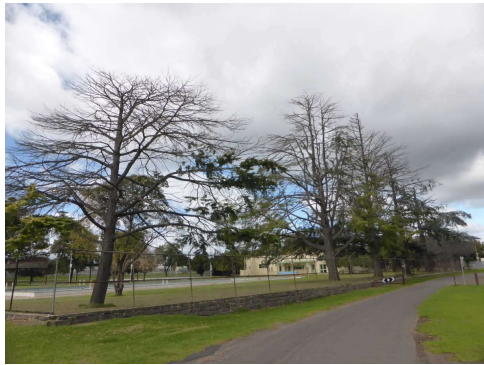
Recommendations & Tree Photographs - 27 April 2017

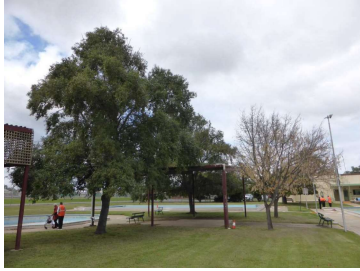
T14 Acer negundo rhs, behind
 T15 Acer negundo rhs, front
 T16 Alnus acuminata subsp. glabrata lhs, behind
 T17 Alnus acuminata subsp. glabrata lhs, front
 Remove 1-2m grass strip around trunk and mulch

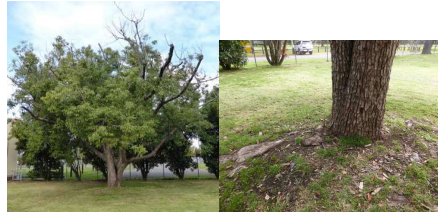
C Cinnamomum camphora has extensive deadwood and root damage
 Prune deadwood and shape crown, formative prune to improve branch structure
 Top dress exposed roots
 Mulch raised root zone for a distance of 3-4m radius,

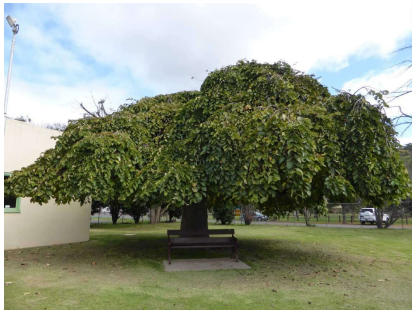
T6 Ulmus glabra 'Camperdownii'
 Remove 1-2m grass strip around trunk and mulch

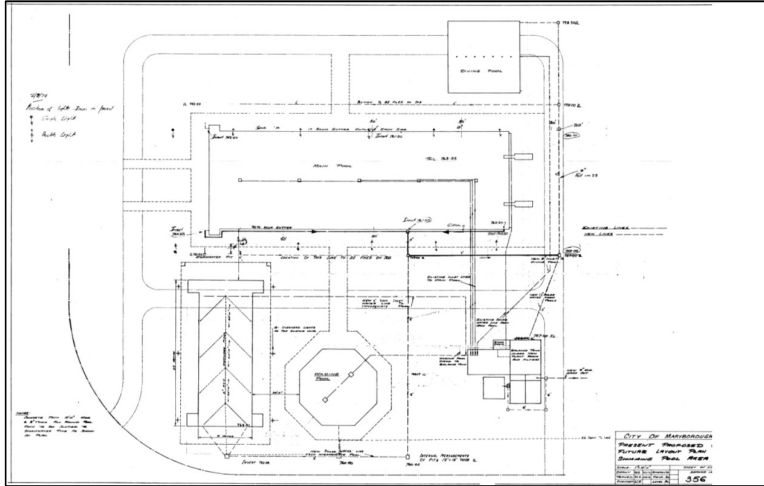
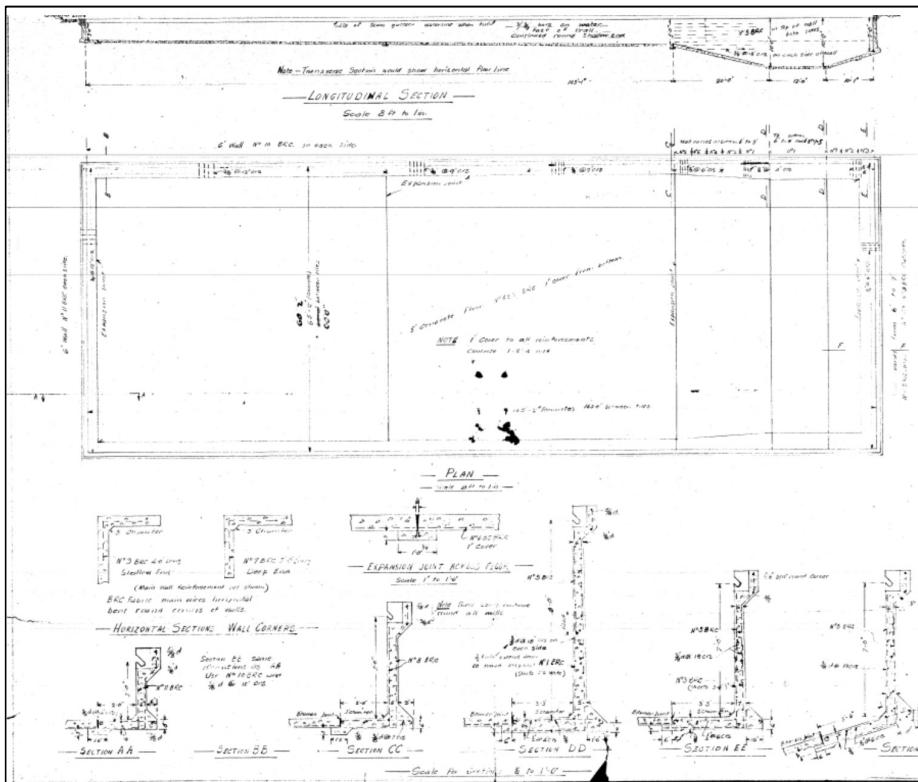
Future Layout Plan of the Maryborough Swimming Pool Complex showing the proposed new Intermediate Pool 1972 drawn by the City of Maryborough Engineering Department. The lower diagram is a plan of the Olympic Pool as existing in 1972.

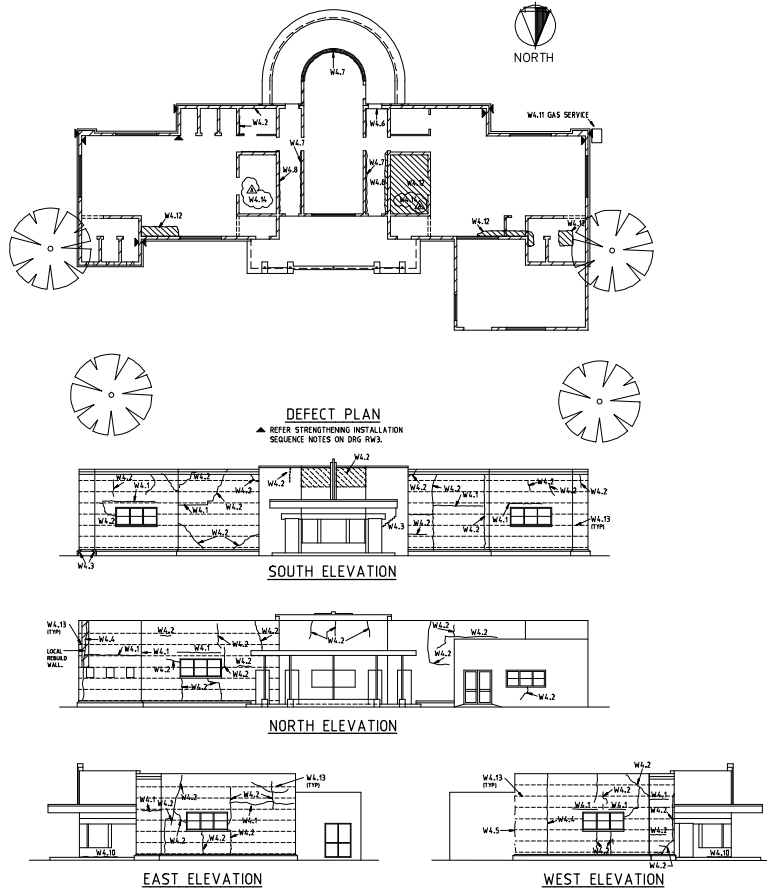
Plan of the Entrance Pavilion prepared by Beauchamp Hogg & Spano Pty Ltd., 2002 (Detailed plans held by the Central Goldfields Shire)

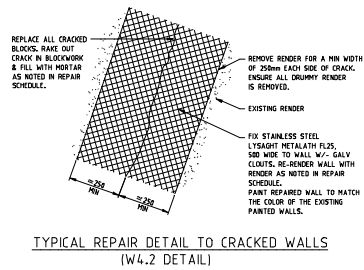
TYPICAL REPAIR DETAIL TO CRACKED WALLS
(W4.2 DETAIL)

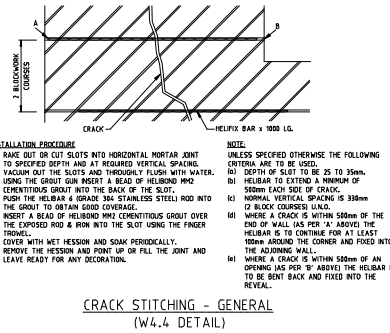
CRACK STITCHING - GENERAL
(W4.4 DETAIL)

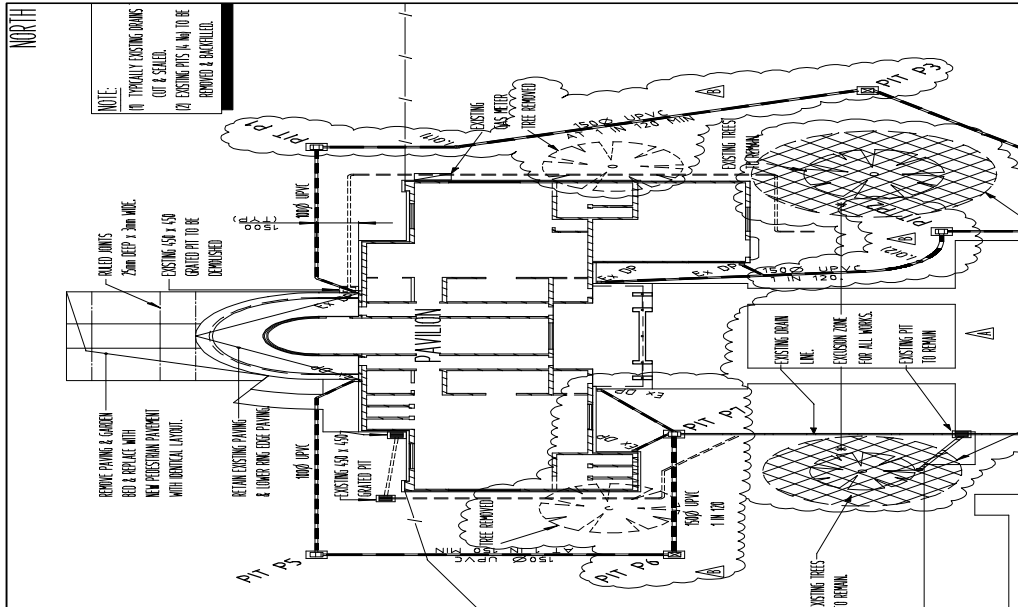
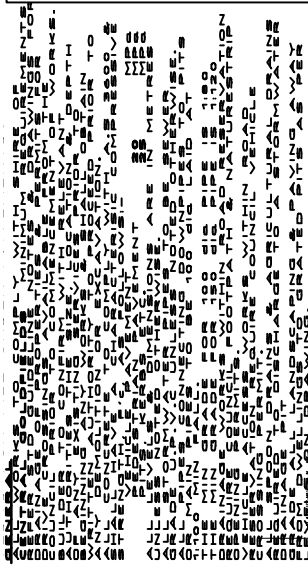
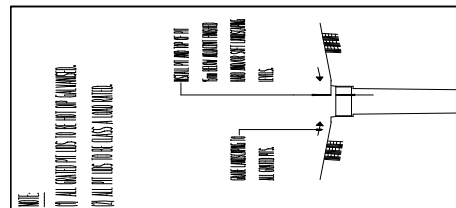
Repair of the Concourse to specifications and schedules previously prepared by Beauchamp Hogg & Spano Pty Ltd., 2002.

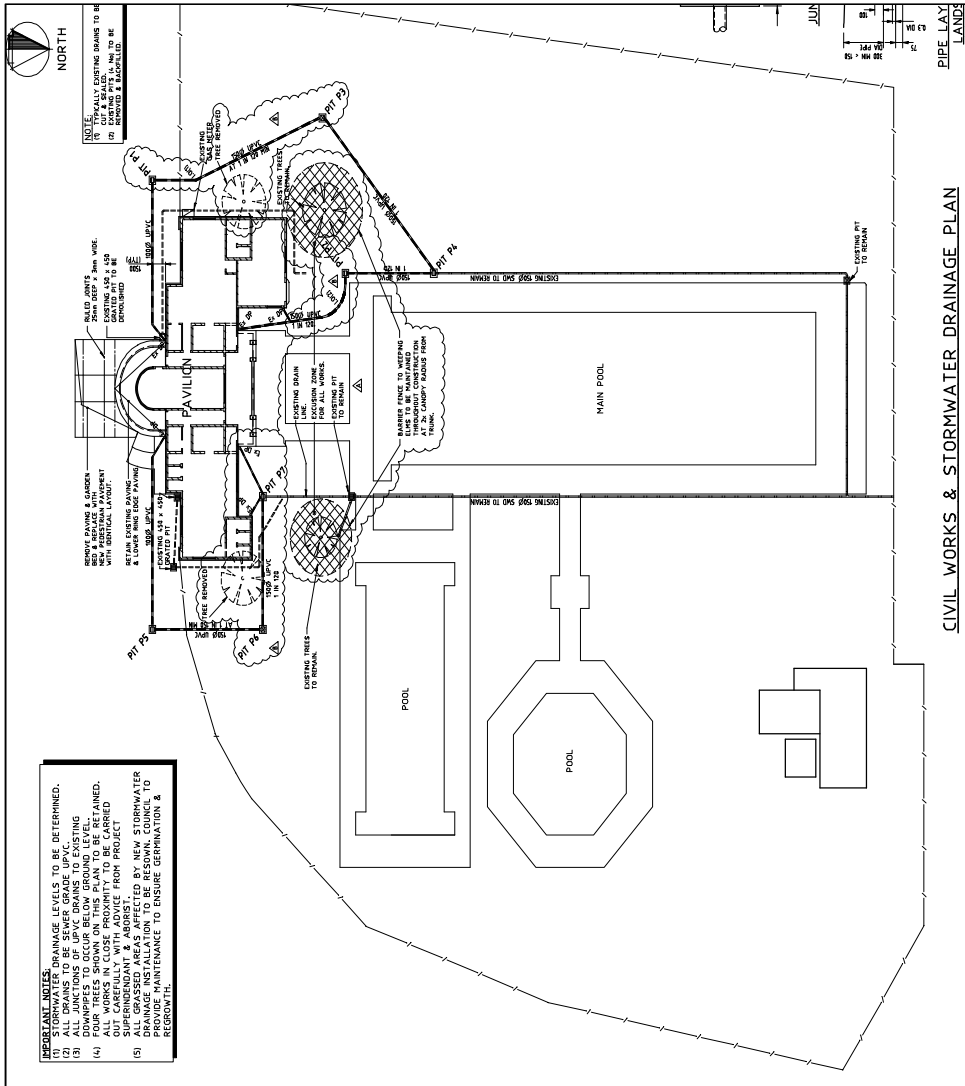
All to specifications and schedules previously prepared by Beauchamp Hogg & Spano Pty Ltd., 2002. The above works were carried out in 2000 for the repair of the stormwater and concrete concourse around the Pool area.
