Carisbrook Levee Review Report

Review of Floodplain Management since 2013

Report Number: P-FY20242892-PWO-DAM-RP-001 August 2024

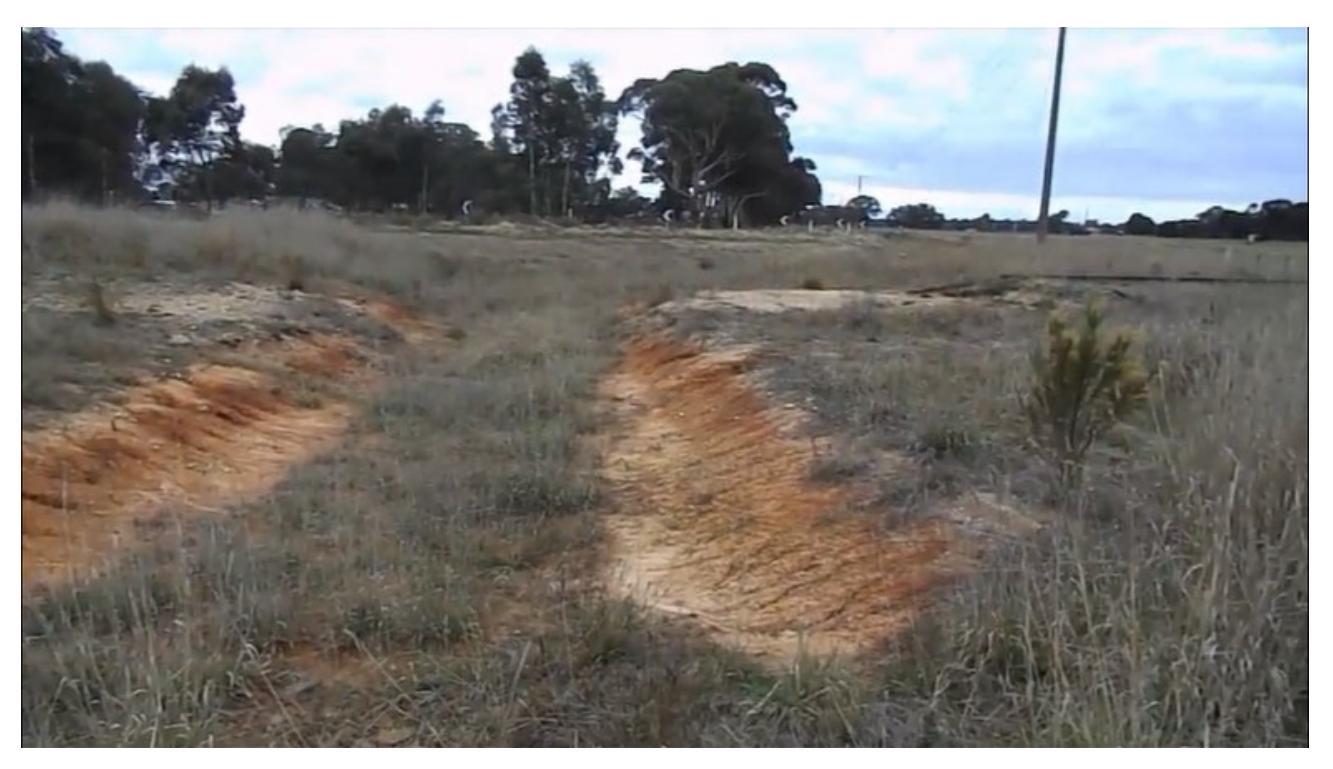
Figure 4-21 Channel through cutting in railway line near Pleasant and High Street

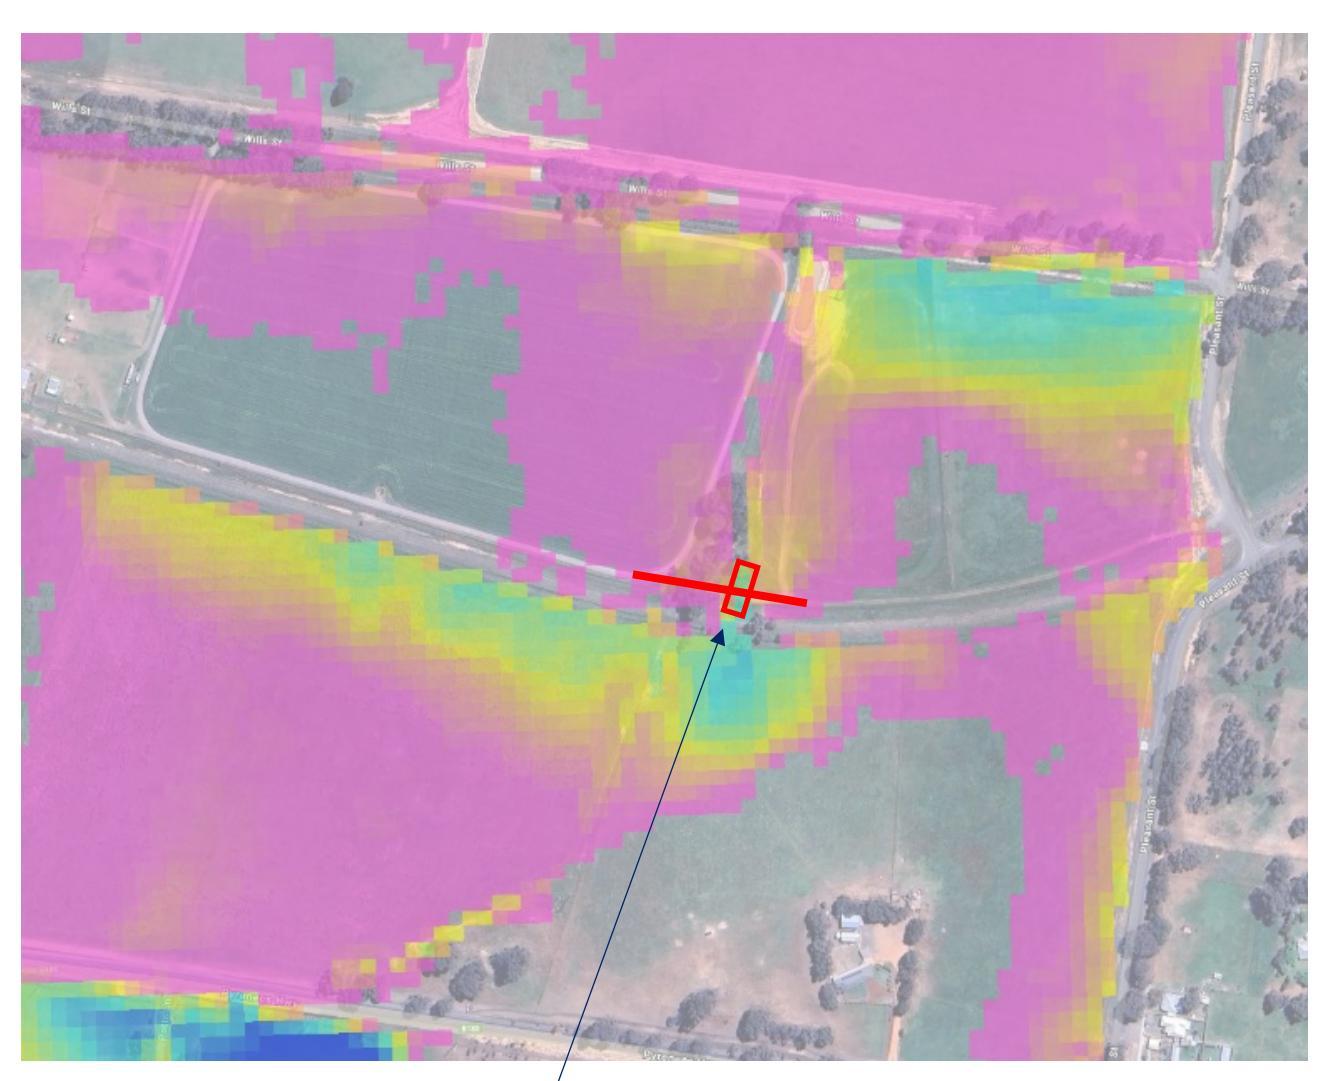
6. The existing culverts under the railway line further west are a VITAL component of the Flood Protection System. That is, they allow a major portion of the floodwater to pass northwards without going through the cutting near Pleasant Street / High Street. It is vitally important that there is nothing to impede those flows. It is for this reason that (minimum) yearly (if not seasonal) inspections be undertaken, and repair work be undertaken IMMEDIATELY when defects (of any severity) are found. That is, there must be a HIGH level of inspection and diligence (and budget) to ensure the Levee Bank is "Operationally Ready" at all times.

Figure 4-22 Flooding through / under railway line west of Pleasant and High Street

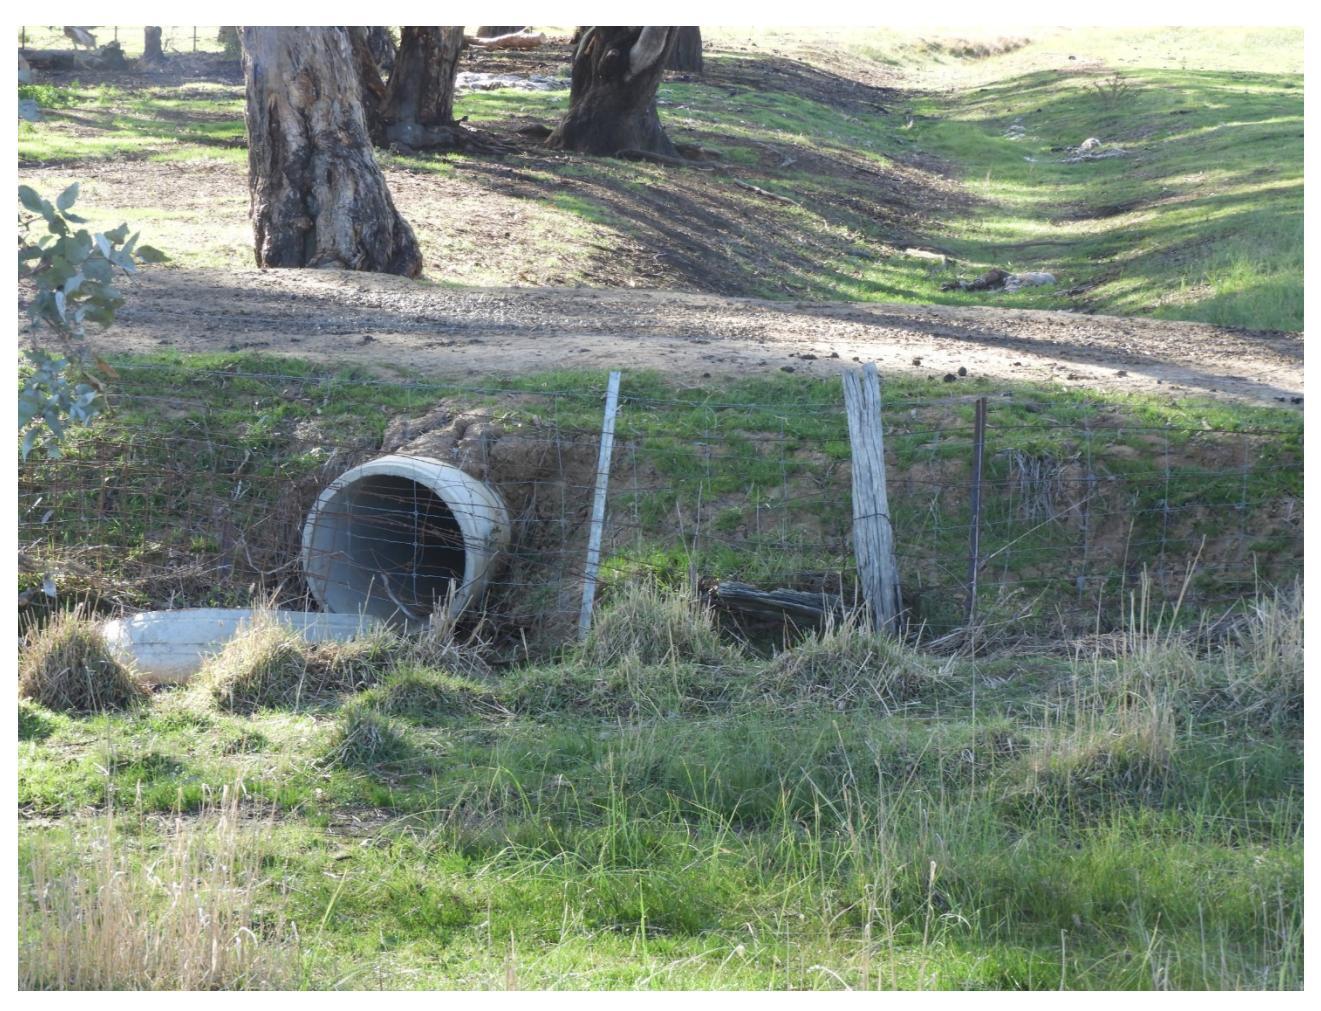
There is already an embankment (with a 700mm diameter pipe through it) <u>blocking</u> the northern side of the 16m wide railway culverts. The <u>modelled</u> depth of water where the block bank and pipe are located is only 750mm. That is, the flow of water through the railway culverts appears to be entirely cut off.

Figure 4-23 Block bank and pipe north of railway line west of Pleasant and High Street

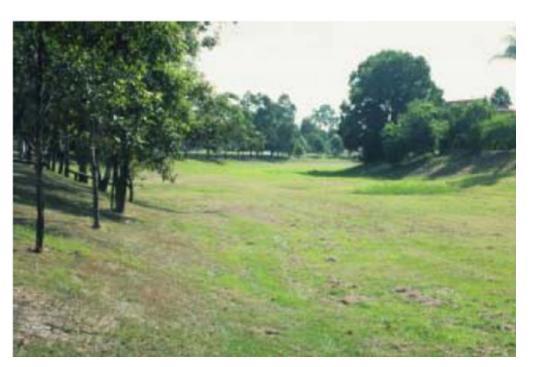
Figure 4-25 Photo of channel with manning's roughness GREATER than 0.022

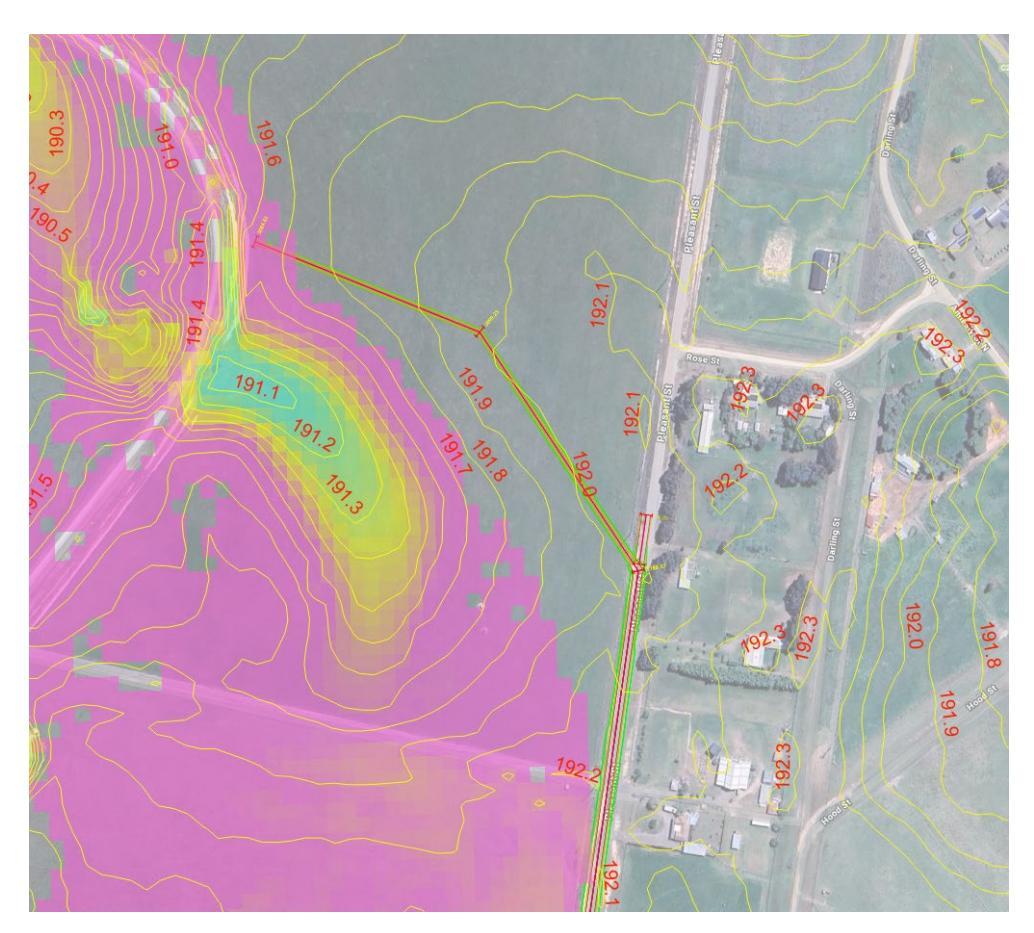
Figure 4-28 End of Levee Pleasant Street / Racecourse

Extend the levee bank across the racecourse as designed (unless ground levels surveyed using RTK method) shows otherwise.

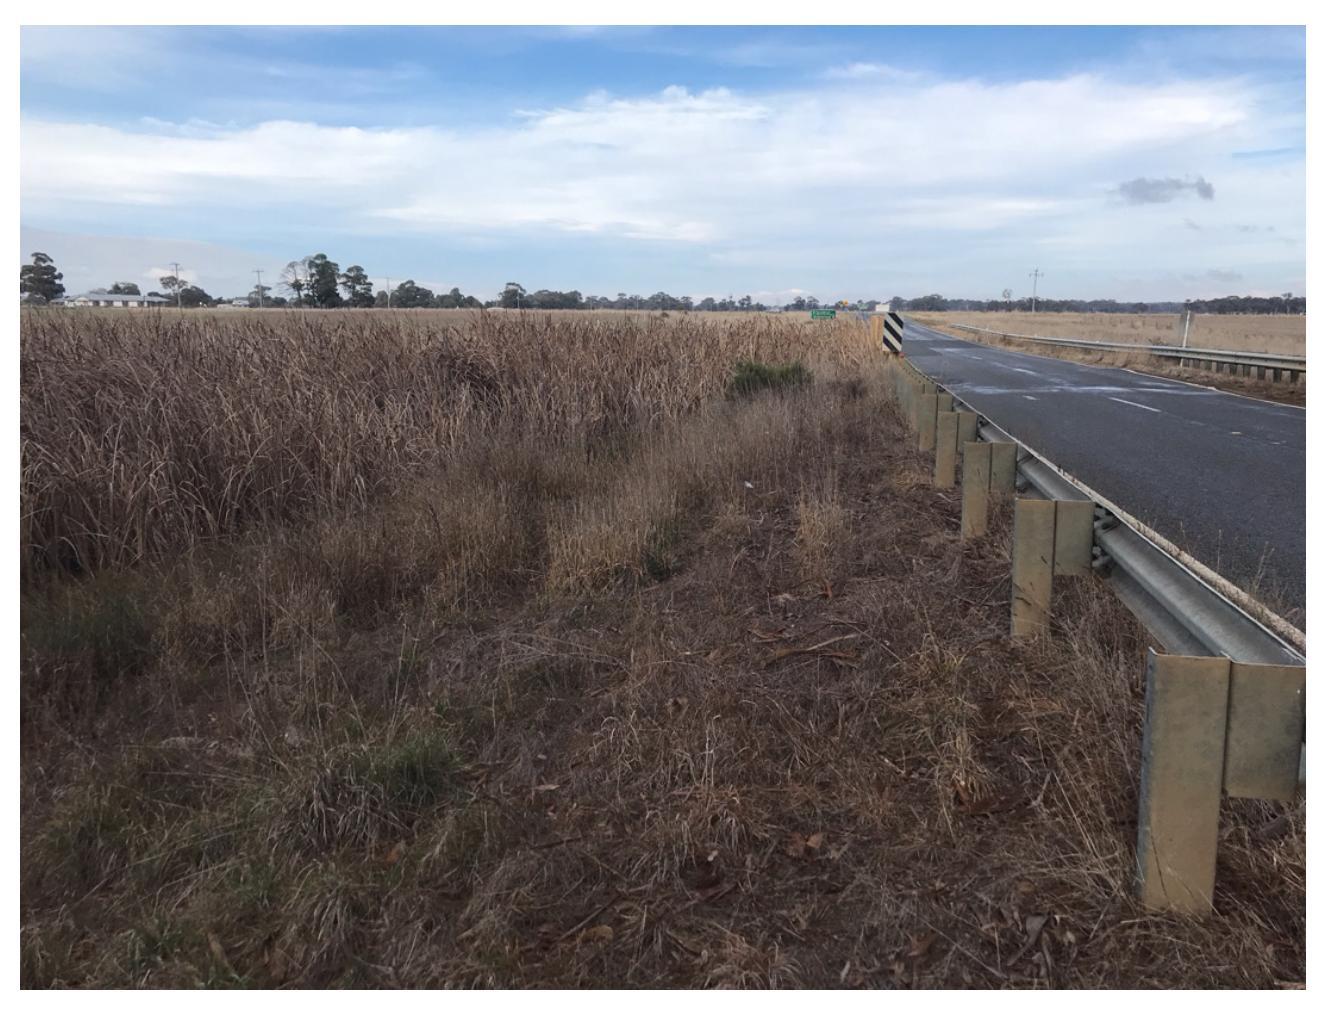
The modelling shows that the water depth at the Eddington Road culverts is supposed to be some 2m+ deep. However, an inspection of the culverts showed that it was overgrown with reeds some 3m tall which are impassable. Further east are dams that has been constructed also obstructing the flow of water through the culverts.

Figure 4-29 Eddington Road Culverts overgrown with Reeds

Remove (and keep clean) all the reeds around the culverts. The dams on the downstream side (in private property) are to also be removed to ensure the culvert can function as designed.

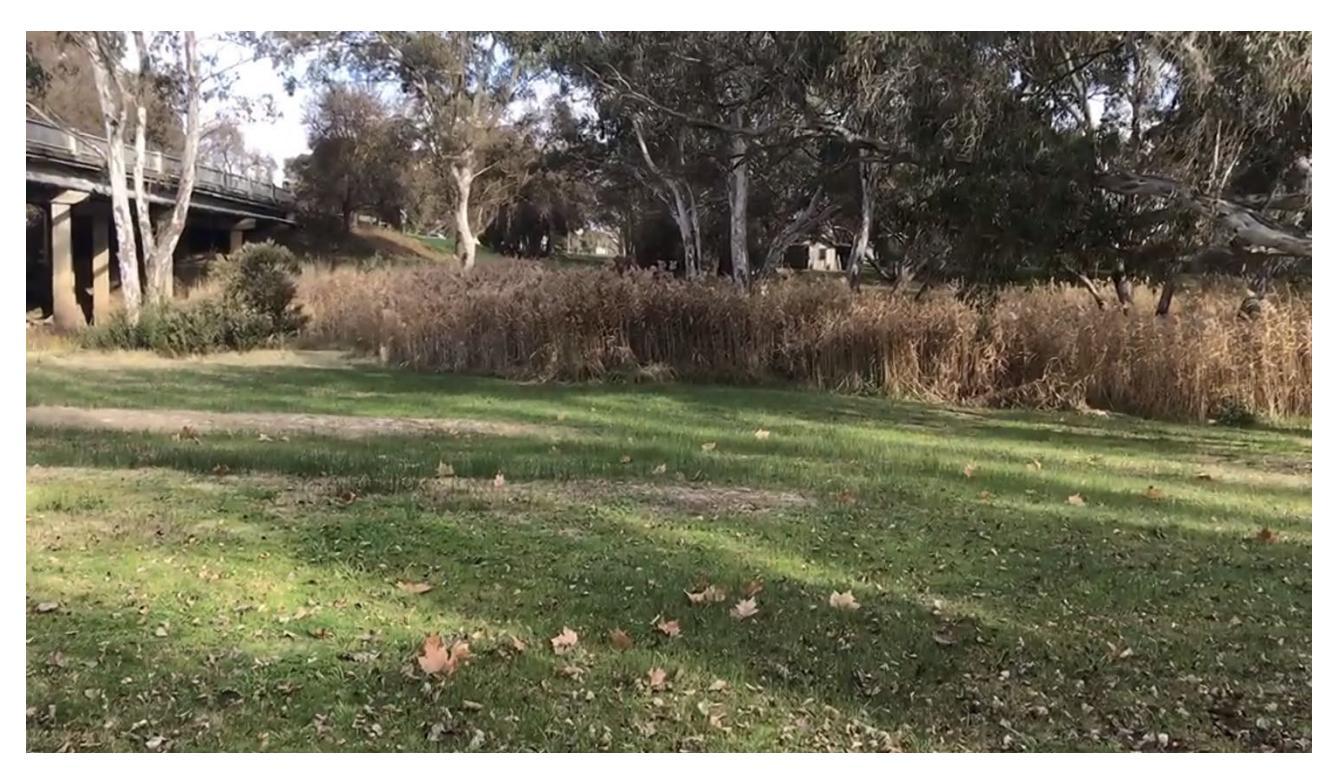
Observations of the creek shows that there is a lot of sand deposition occurring (especially upstream of the bridges) as well as regrowth of reeds, grasses and saplings in those and other locations. These are signs that water flows there are "slower" than other locations just upstream. And, as water is slowed, the faster water behind "catches up" resulting in increased flood heights (locally).

Figure 4-33 Example of Reed growth in Creek downstream of road bridge.

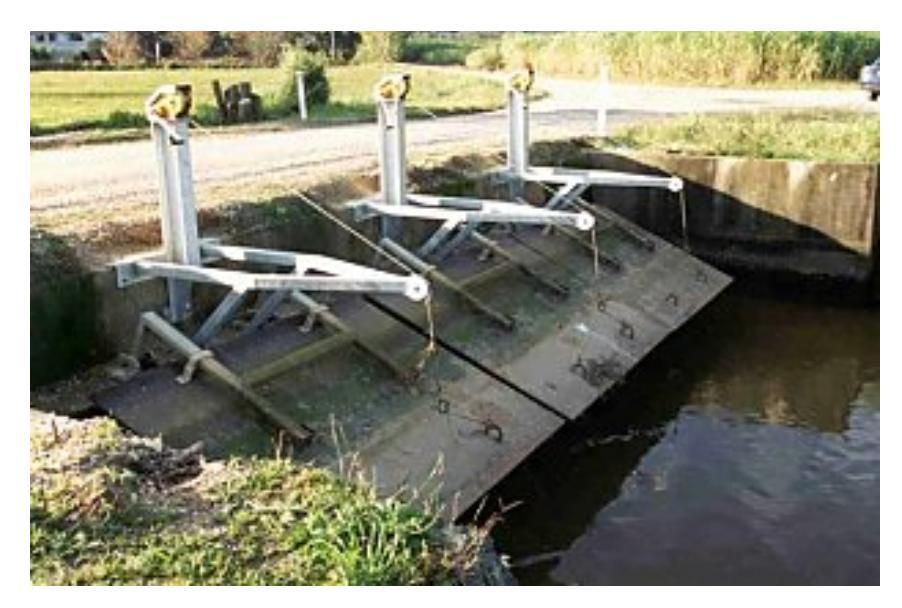
Figure 4-35 Lifting Arm on Flap Valves

Fit lifting lockable Lifting Device to Flap Valves or replace with Sluice Gate Valves and include its' operation into the Levee Management Plan.

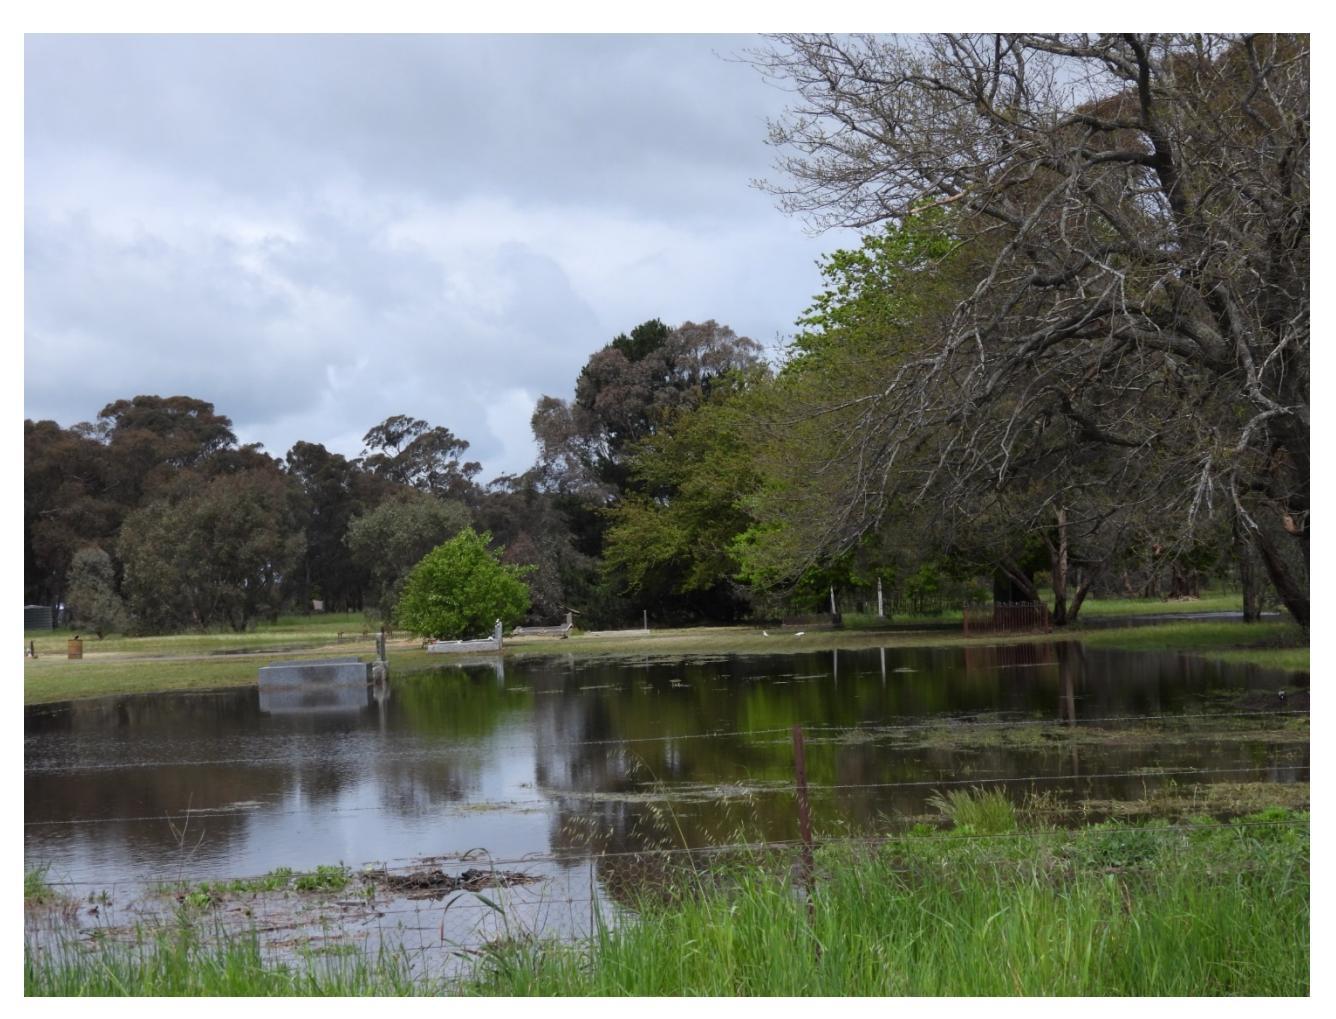
Figure 4-38 Water sitting in and around Cemetery

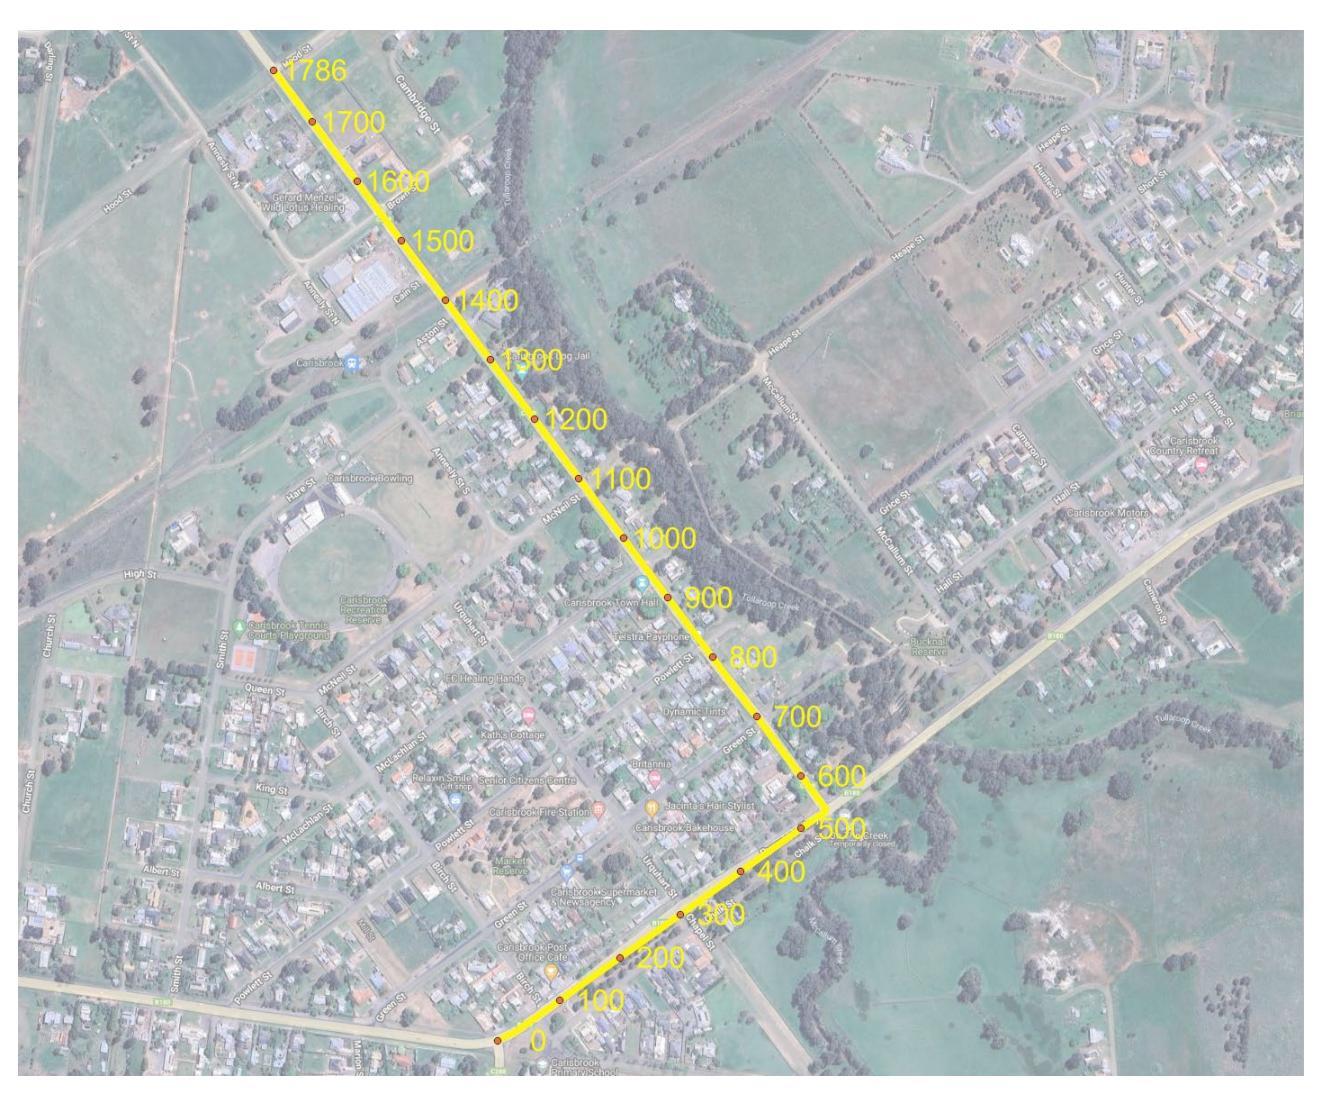
Figure 5-2 De-facto "Eastern" Levee Bank

Start thinking of the Pryenees Highway (between the Bridge and Chapel Street) and Bucknall Street as a (de-facto) levee bank. Basically, "If it walks like a duck and quacks like a duck...it's a duck!".
