NOVEMBER 2021

Waterway Management Plan for Carisbrook

Final

Central Goldfields Shire

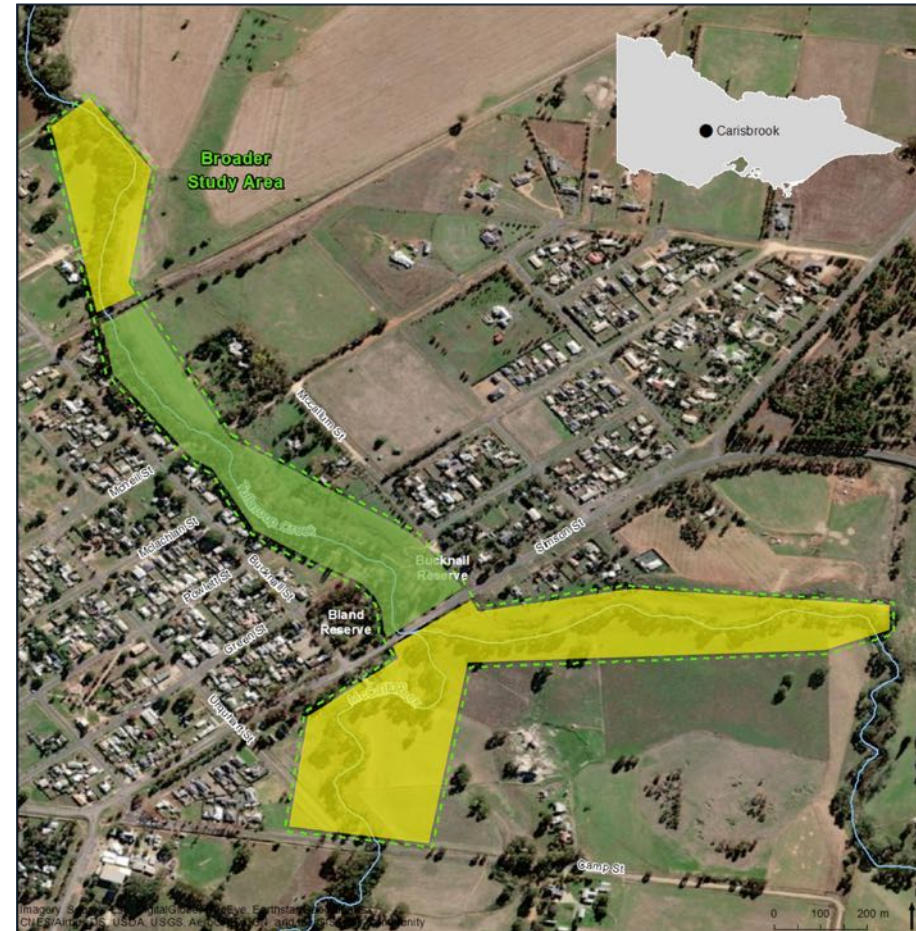
The core project site extends from a point approximately 50m south of the Pyrenees Highway (Simpson Street), and the railway bridge approximately 850m north-west of the Highway (*shaded green*). The area includes two public reserve areas being Bucknall and Bland Reserve. The broader project area for mitigating flood impacts extends upstream to Camp Street and downstream of the railway line (*shaded yellow*) (Figure 1-3 below).

Figure 1-3: Overview of project site

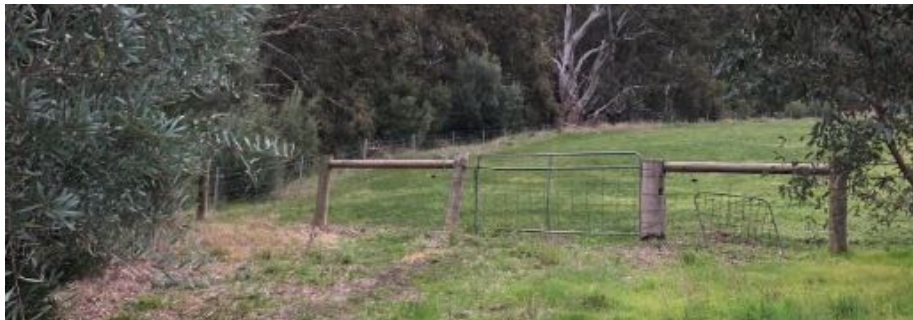
Figure 2-4: Fenced area at the north eastern end of the reserve

Whilst there are well maintained unsealed walking/ cycling tracks along much of the creek reserve and a pedestrian bridge linking the Bucknall and Bland Reserves, the track becomes informal towards the northern end of the western bank and is unpassable on the eastern side due an existing Water Frontage Licence, just south of the railway bridge. Accordingly, there is no easily means to walk the entire length of the track, nor is it suitable for disability access, which is important providing access to all, including elderly members of Carisbrook.

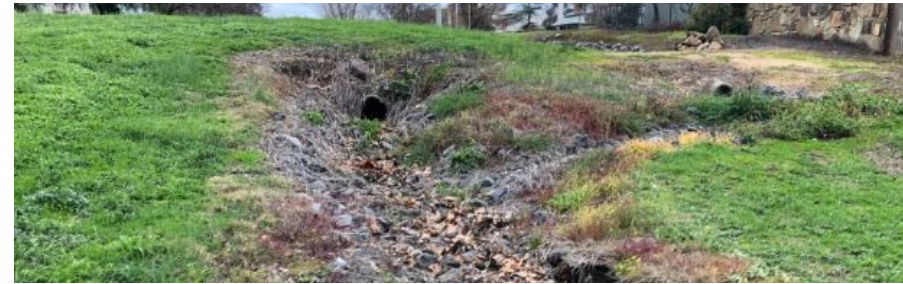
Stormwater outfalls from Carisbrook (see Figure 2-5) flow overland directly to the creek through a series of stormwater outlet pipes that are causing erosion at their discharge points.

Figure 2-5: Stormwater outfall off McNeil Street

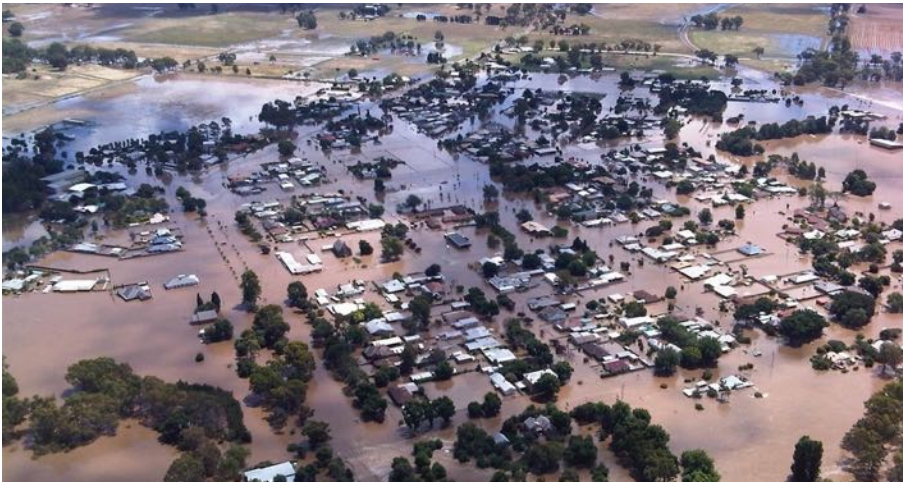
Figure 2-6: Carisbrook in flood in 2011¹⁶

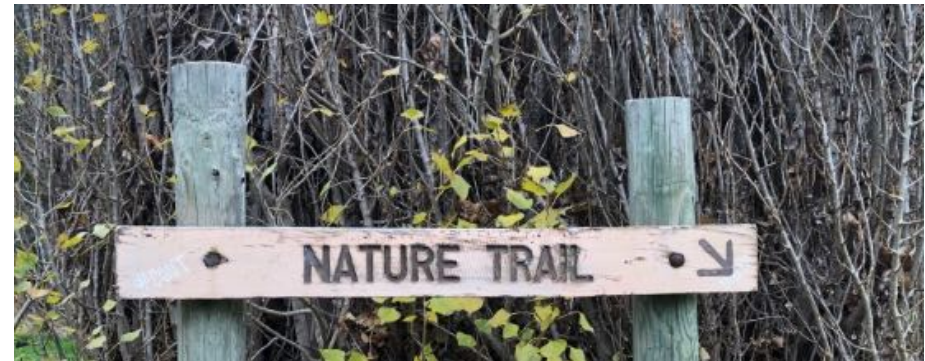
Figure 2-7: Trail signage along Tullaroop Creek.

The reserve also has extensive interpretive signage, established by the Friends of the Tullaroop Creek, that promotes its natural values and features and the local history of the Carisbrook. Although still intact, the signage could be renewed and expanded (refer Figure 2-7).

GOAL	NO.	RECOMMENDED ACTION	TIMEFRAME
OBJECTIVE 3 - Build a connection with the place			
Provide environmental education	3.1.1	Install new interpretive signage (that builds on existing signage) along the circular Creek track to provide information on healthy waterways, local ecosystems, flora and fauna and flood management.	Short
Reflect on the Creek's history in the development of Carisbrook	3.2.1	Install interpretive signage to the reserves focusing on historic images of the Creek and verified first person recollections.	Short
Acknowledge the importance and ongoing connection of the Creek to its Traditional Owners, Dja Dja Wurrung and Aboriginal Victorians	3.3.1	Install interpretive Dja Dja Wurrung signage focusing on Traditional Owner connection and cultural values. Signage should include an acknowledgment of the Traditional Owners of the land and interpretive signage informing visitors of the cultural heritage of the site, food and fibre in the area and the traditional uses of these plants.	Medium

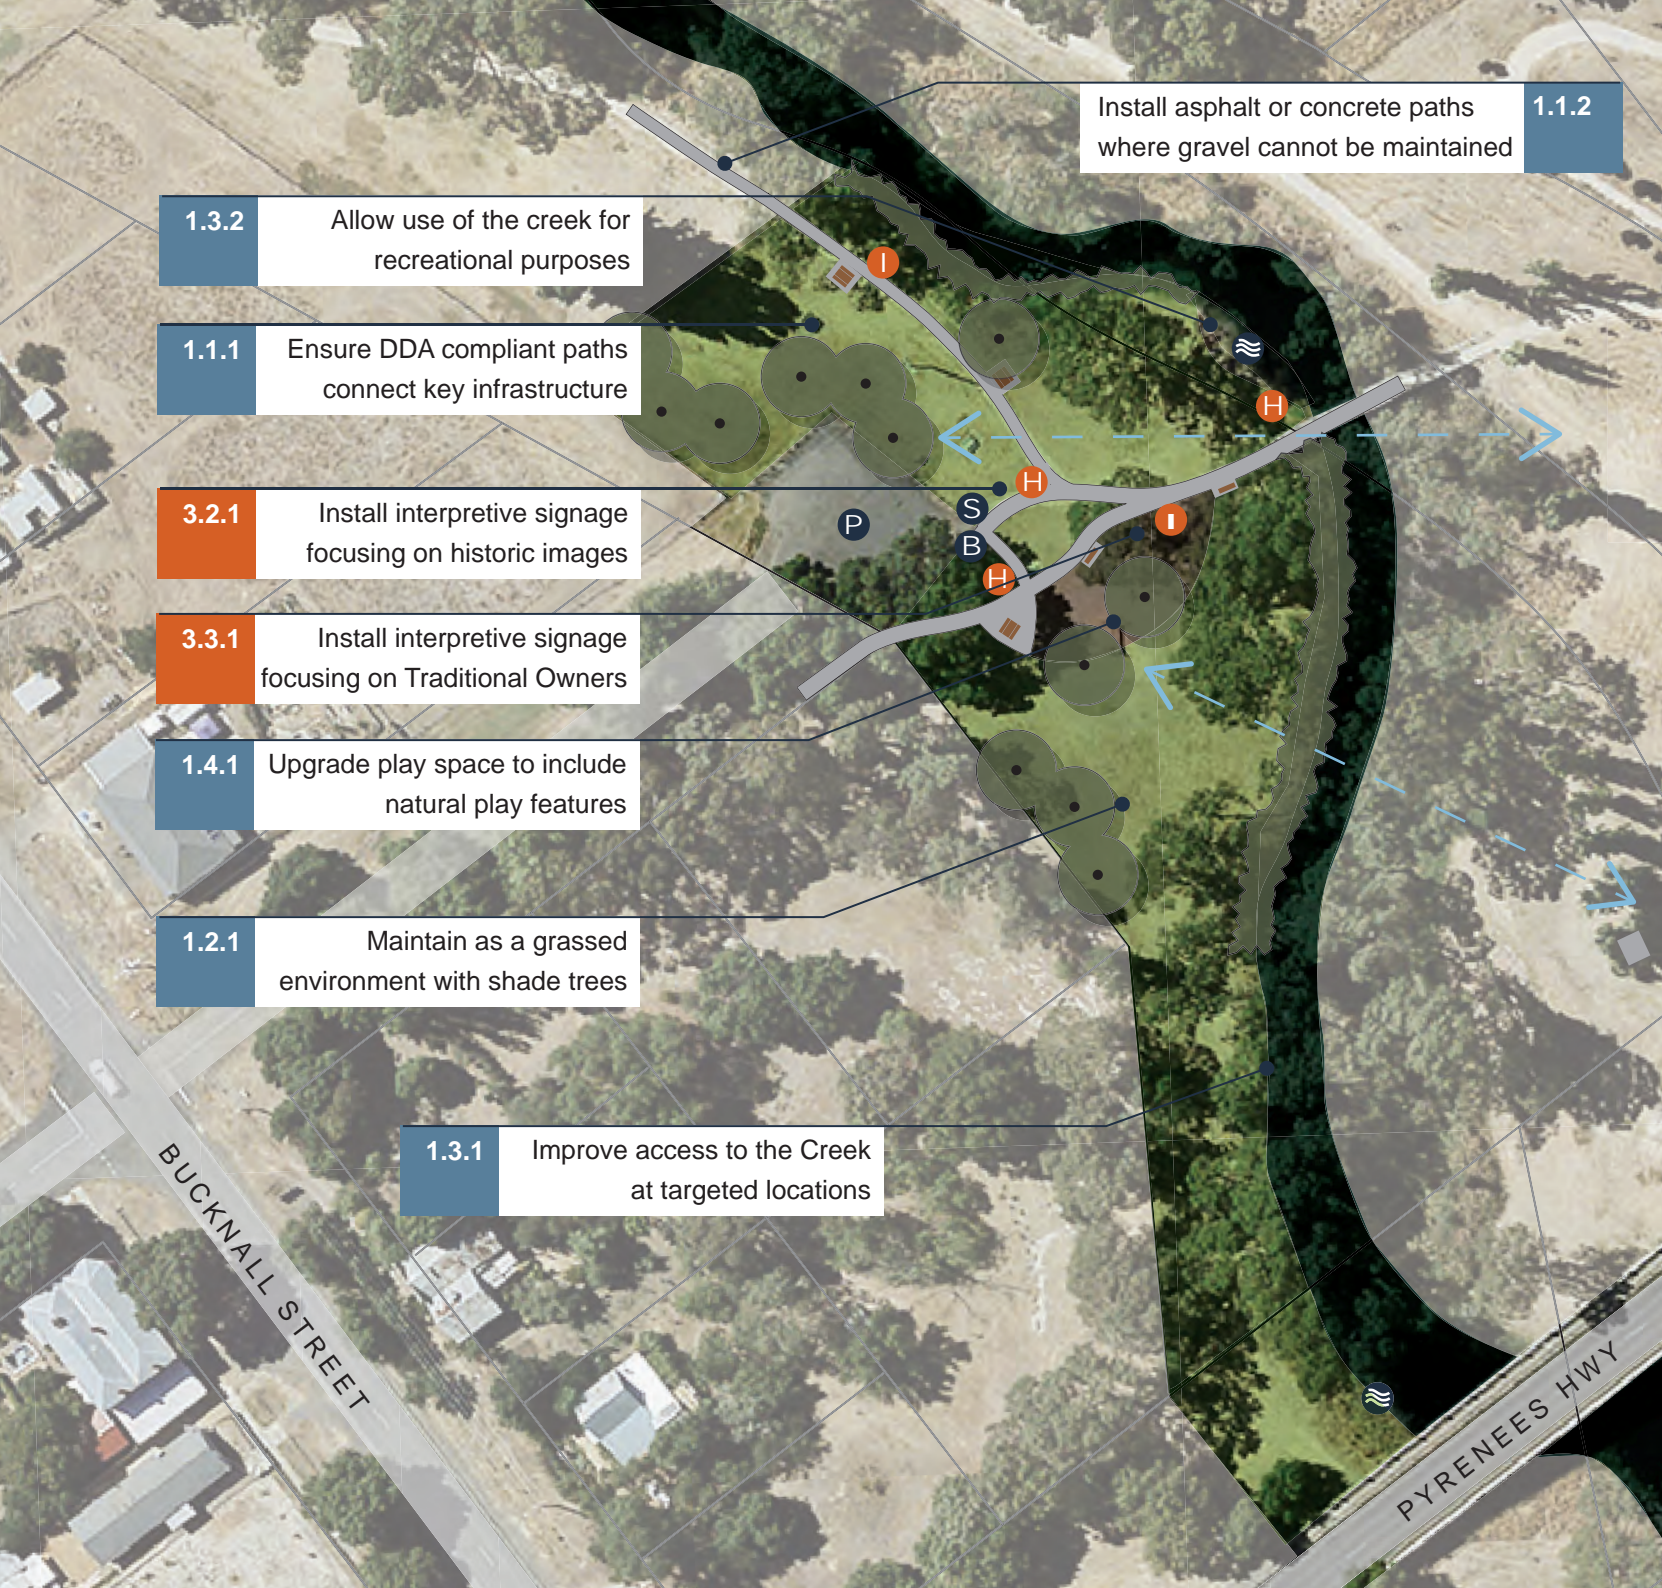
Bland Reserve
Proposed Recommendations

Install asphalt or concrete paths where gravel cannot be maintained **1.1.2**

1.3.2 Allow use of the creek for recreational purposes

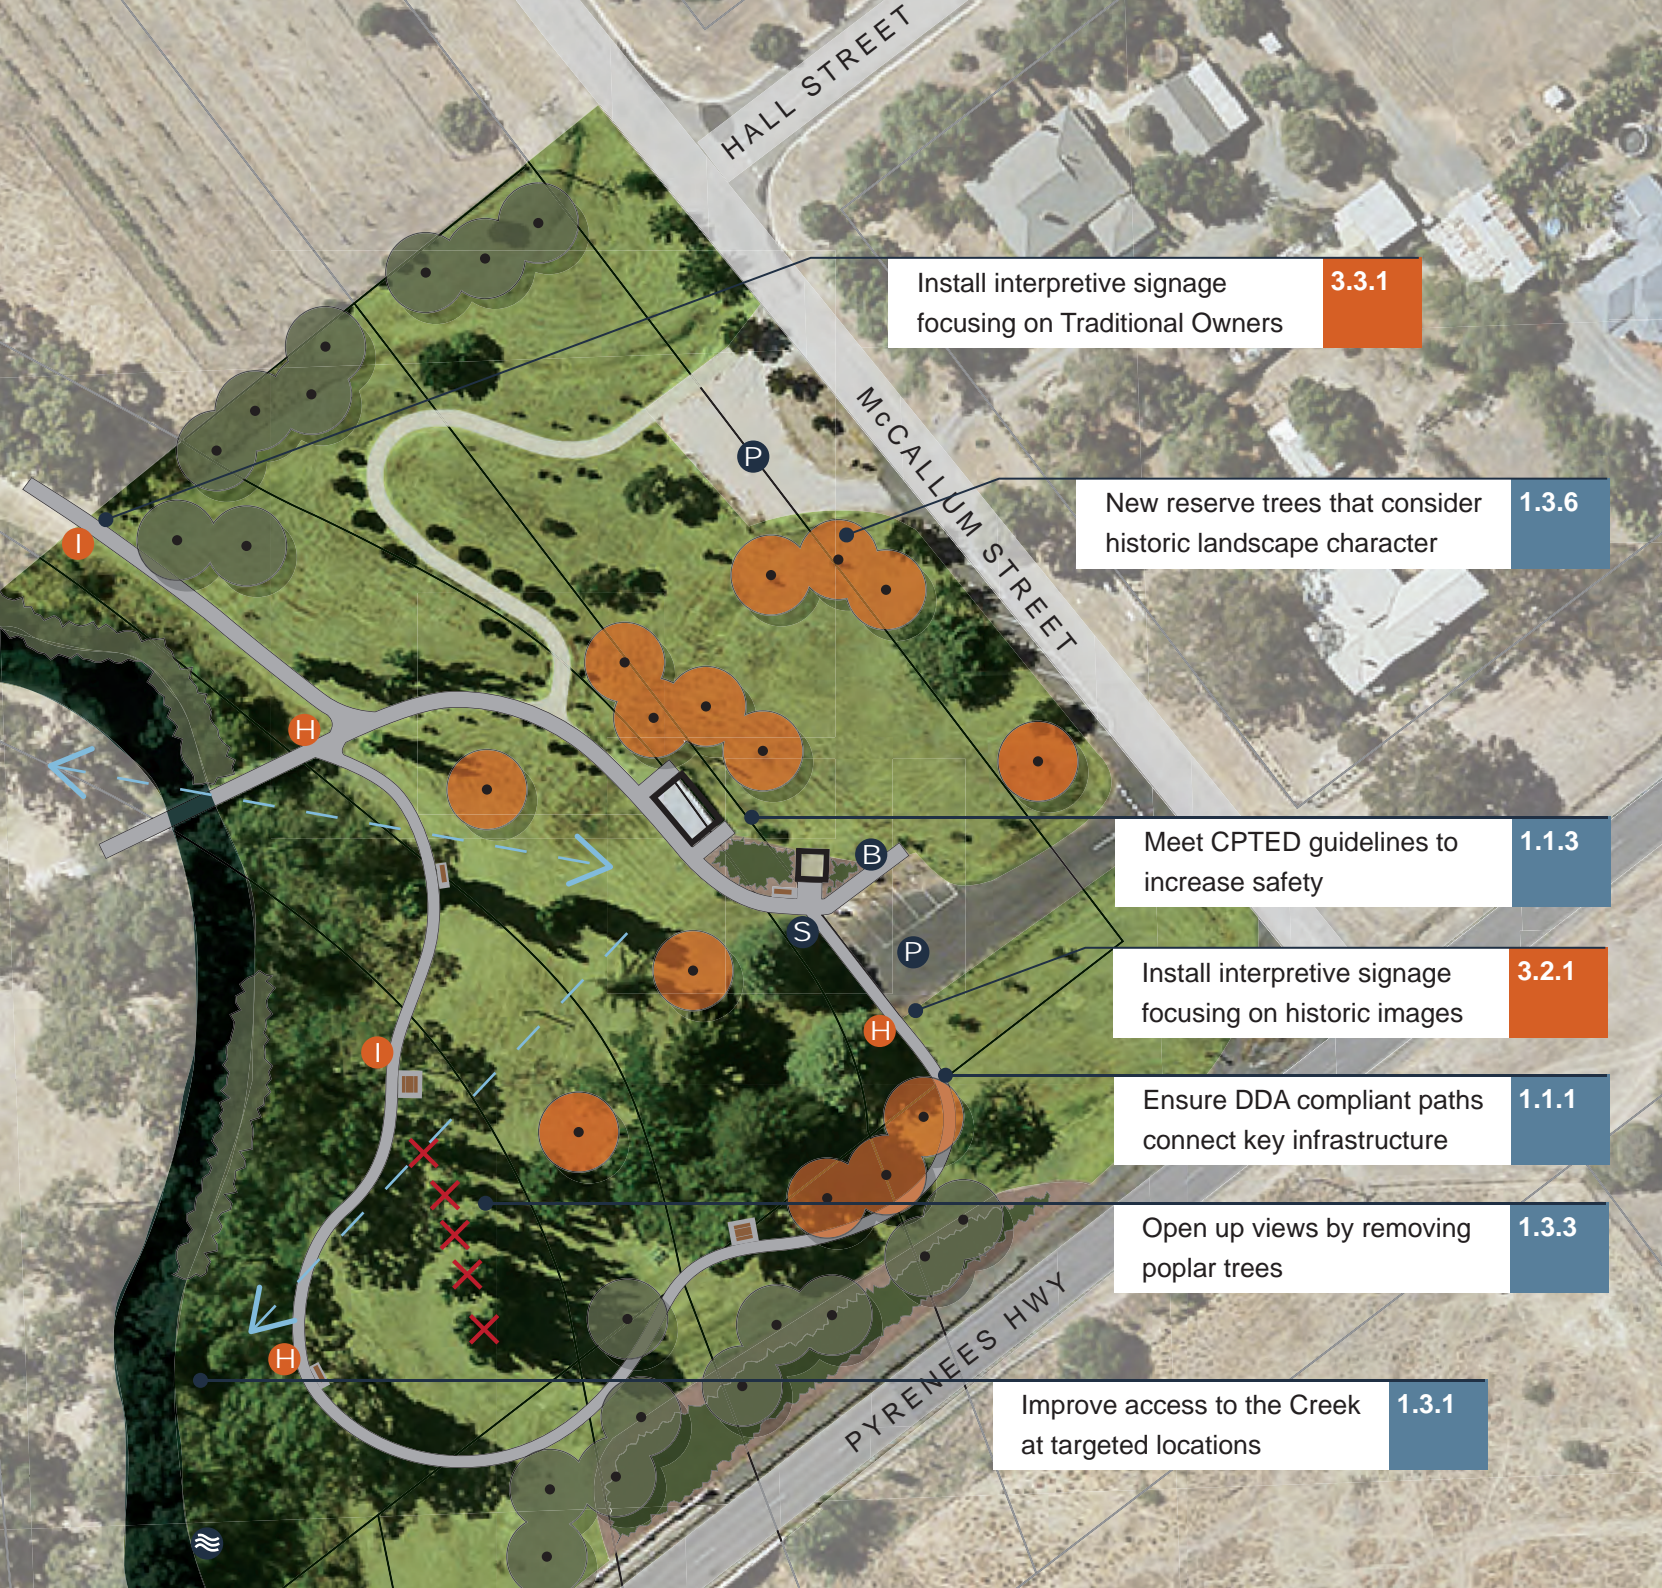
Bucknall Reserve
Proposed Recommendations

Install interpretive signage focusing on Traditional Owners **3.3.1**

New reserve trees that consider historic landscape character **1.3.6**

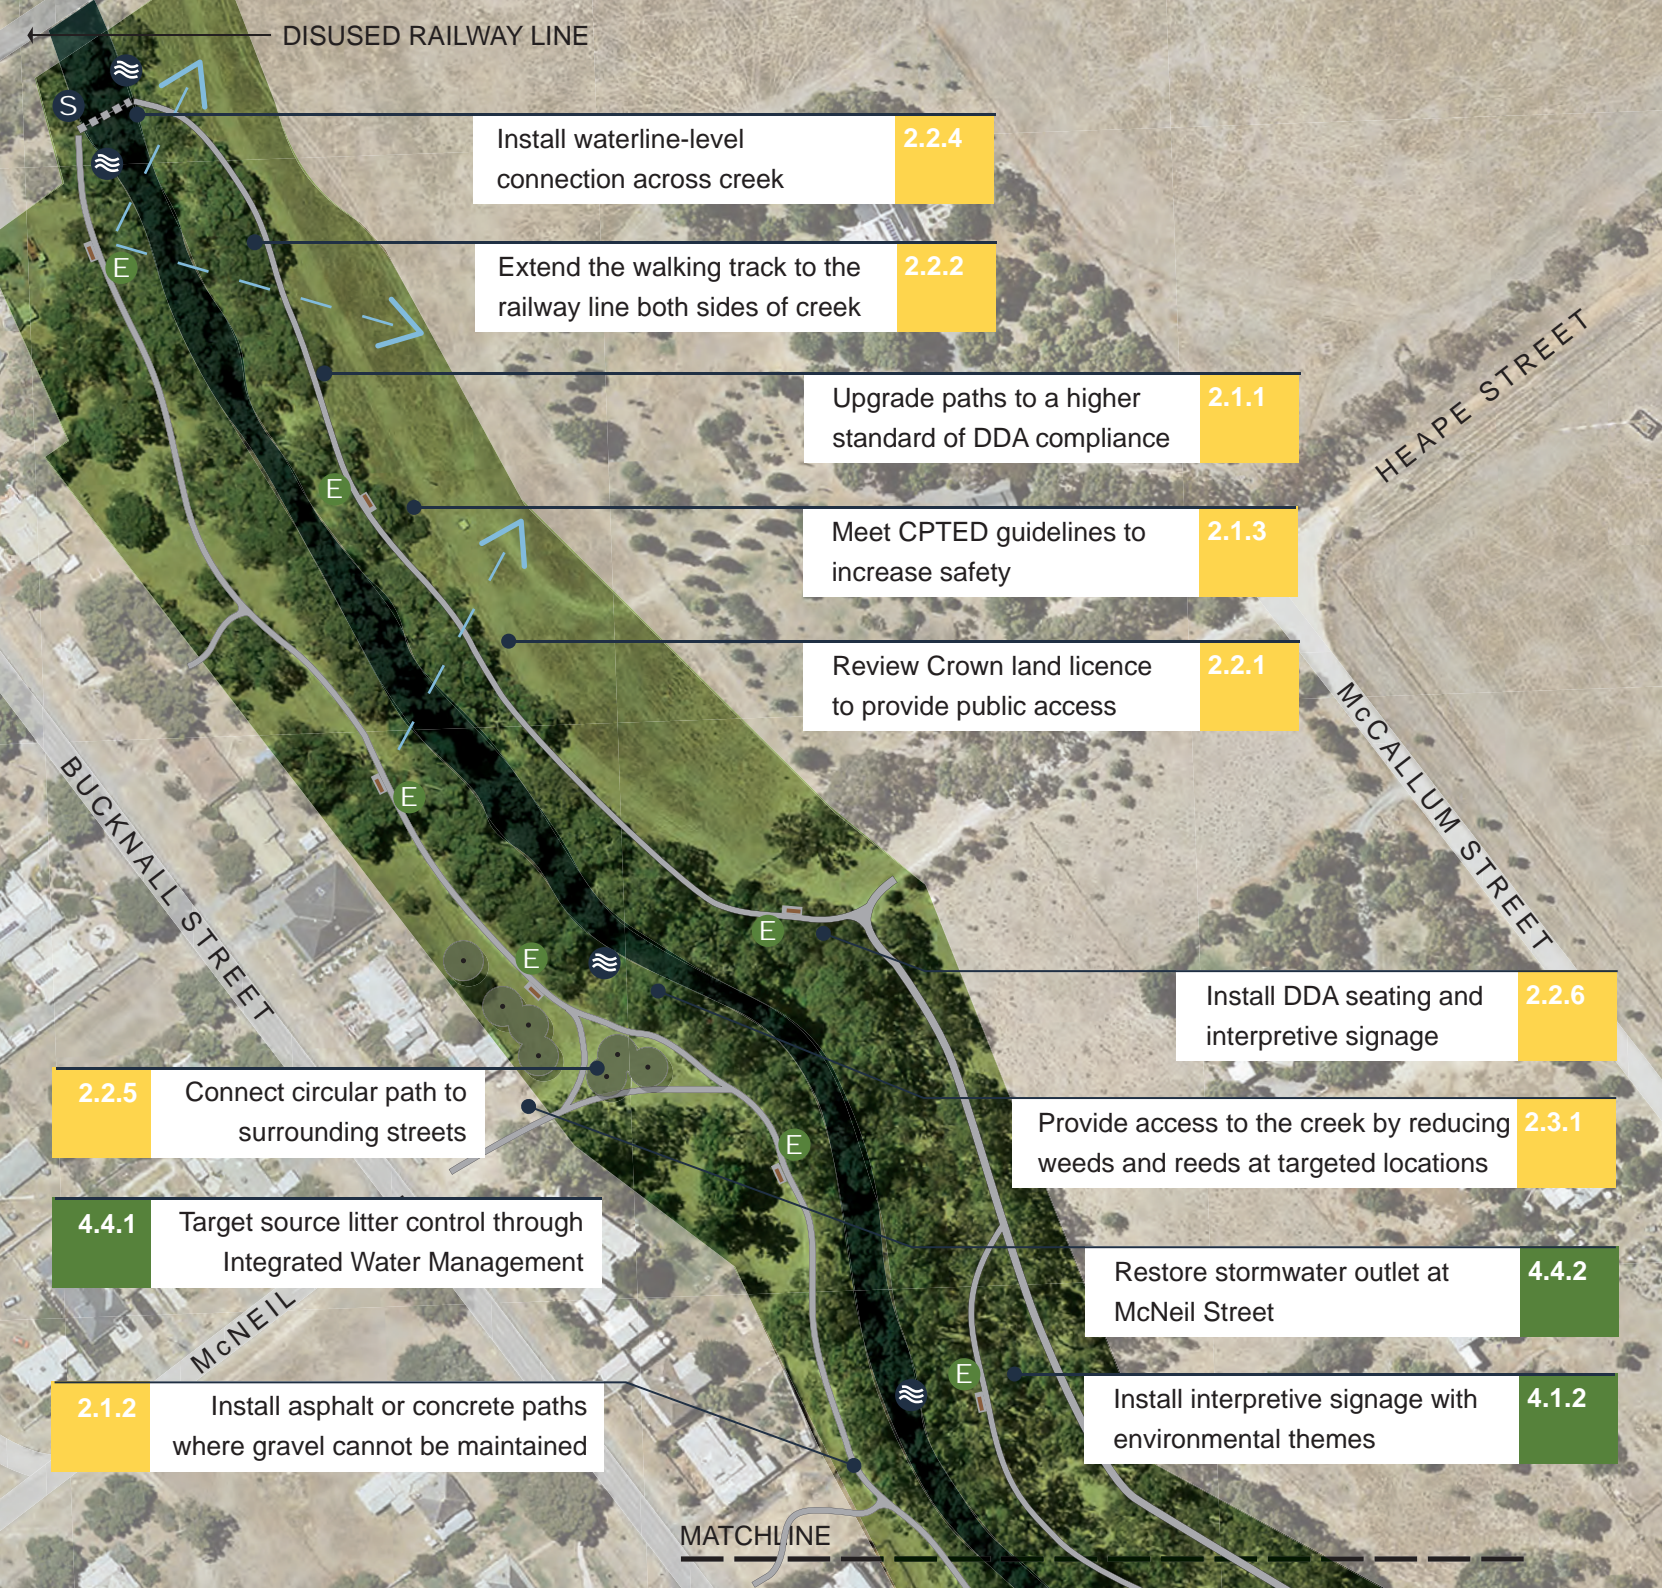
Tullaroop Creek Nth
Proposed Recommendations

2.1.2 Install asphalt or concrete paths where gravel cannot be maintained

Install interpretive signage with environmental themes **4.1.2**

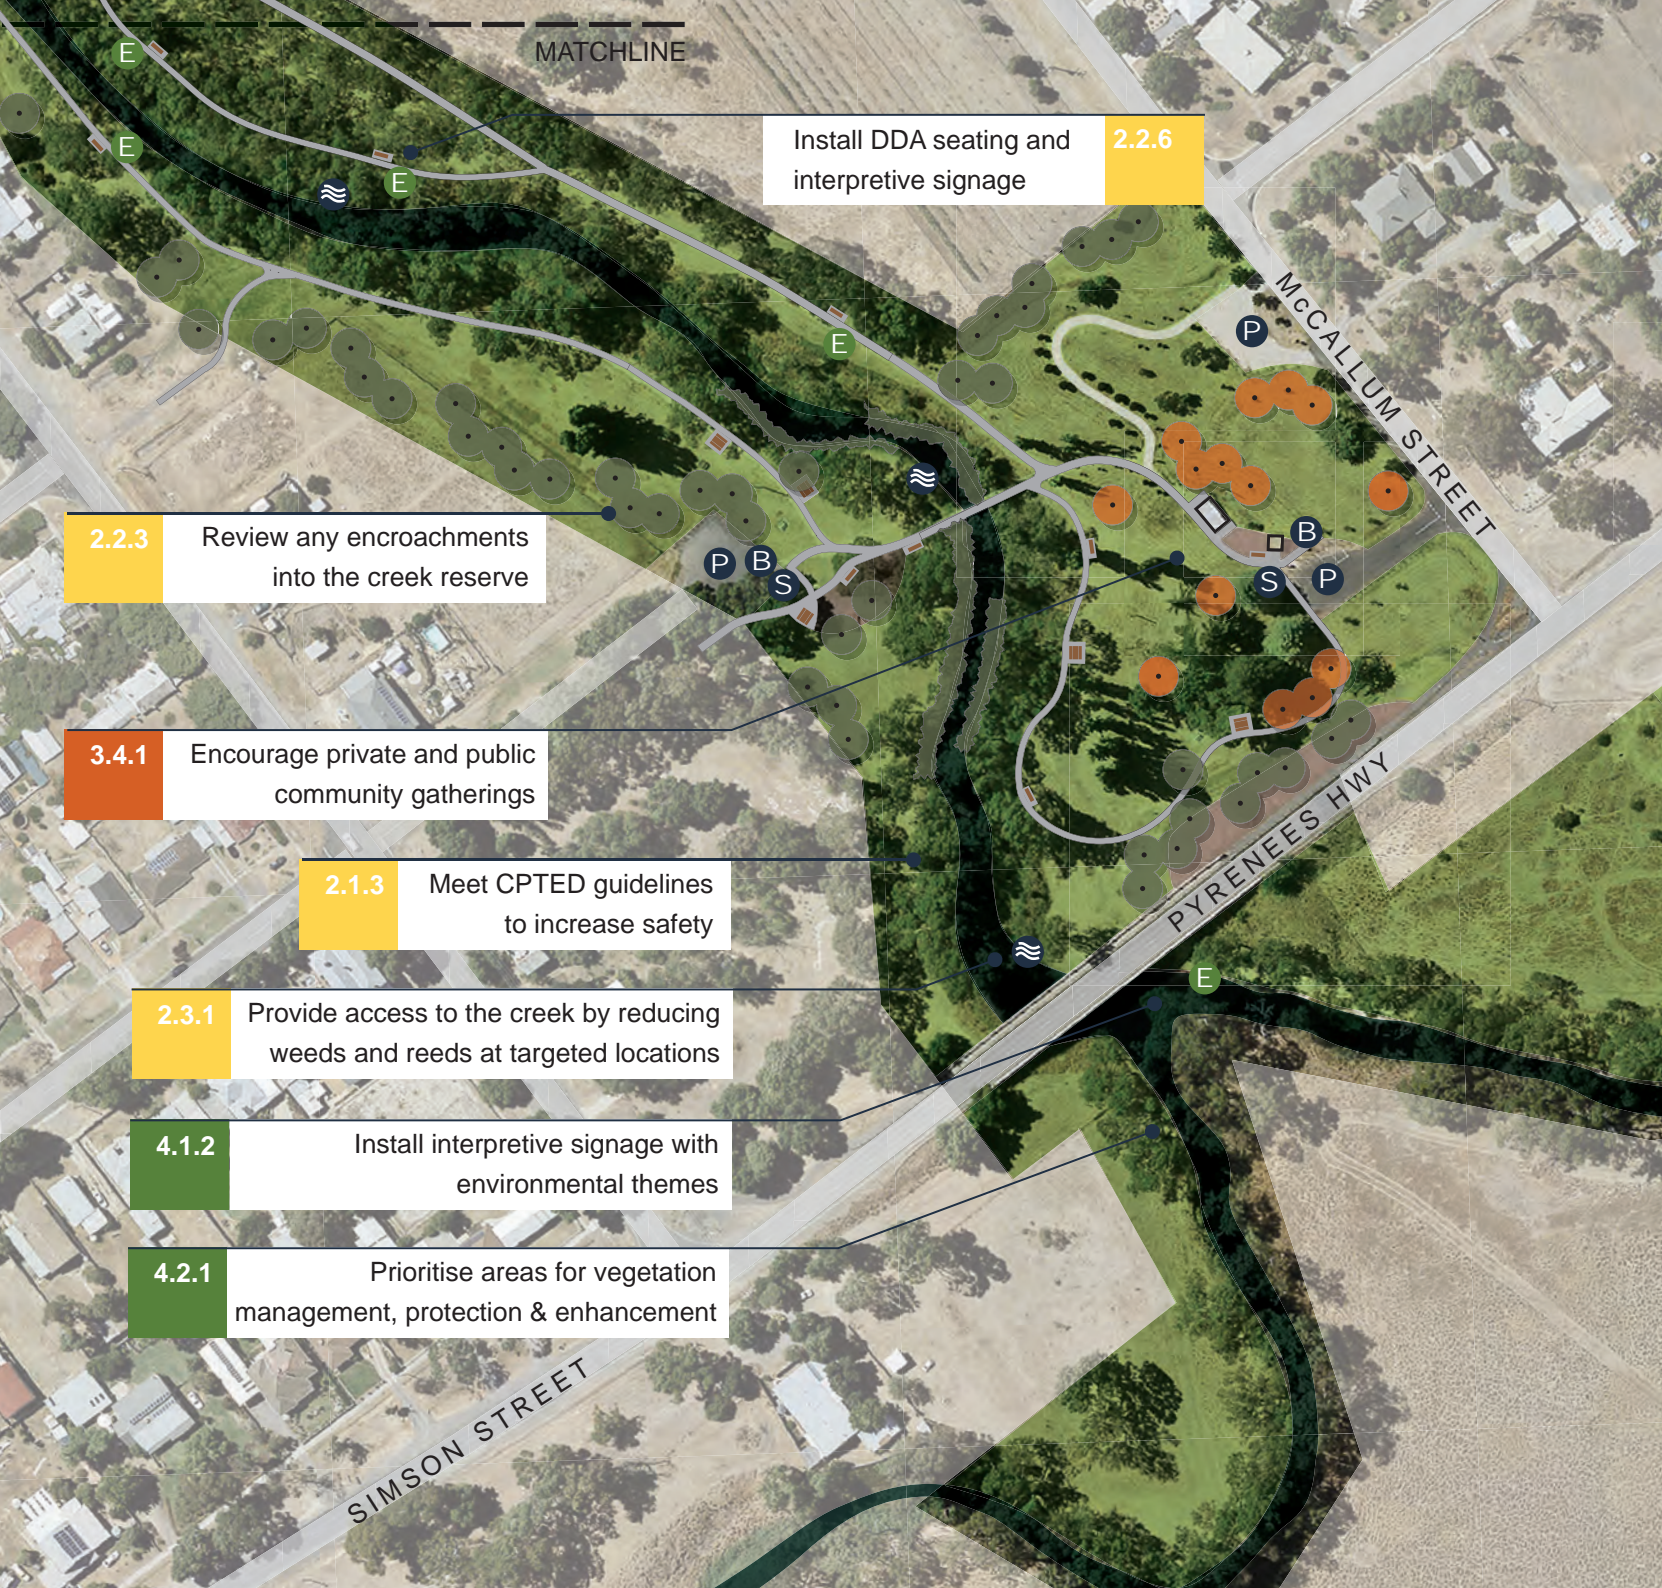
Tullaroop Creek Sth
Proposed Recommendations

Install DDA seating and interpretive signage **2.2.6**

2.2.3 Review any encroachments into the creek reserve
