Carisbrook Levee Review Report

Review of Floodplain Management since 2013

Report Number: P-FY20242892-PWO-DAM-RP-001 August 2024

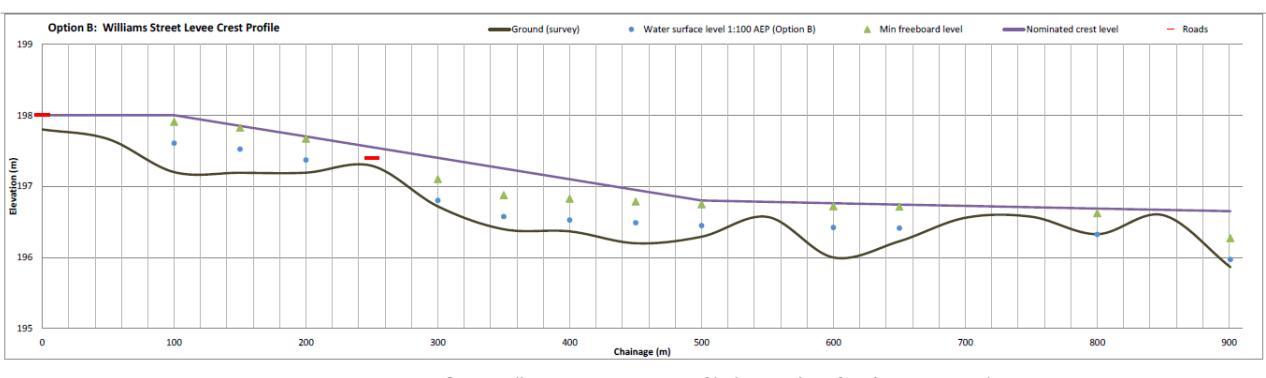
Figure 4-8 Williams Road design longsection

It is noted that in the Entura Preliminary Design Report (2015), there is a long section of the (then) proposed Williams Road Levee Bank) as below. However, it is noted that levels are only taken at every 50m, not every metre. It is easy to miss critical locations when only looking at 50m intervals in (very) flat floodplains.

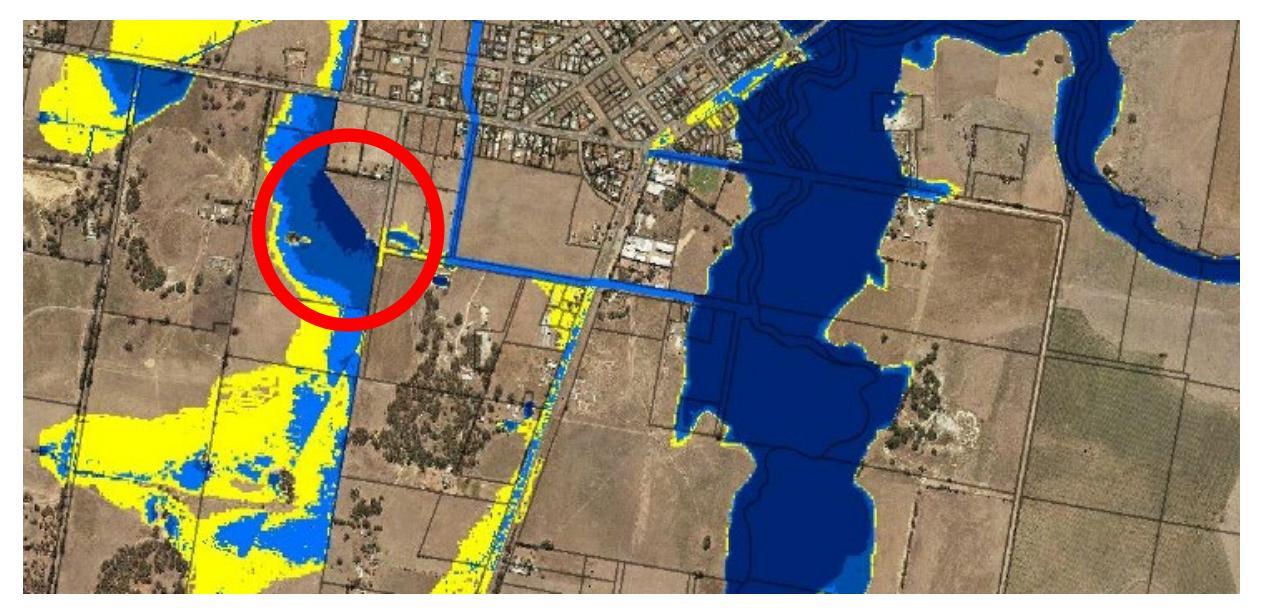
Figure 4-12 Location of "Low Point" in flood model

This location was identified as a low point in the general topography in the 2013 Flood Study where water would sit behind the levee and not be able to drain away (as shown below).

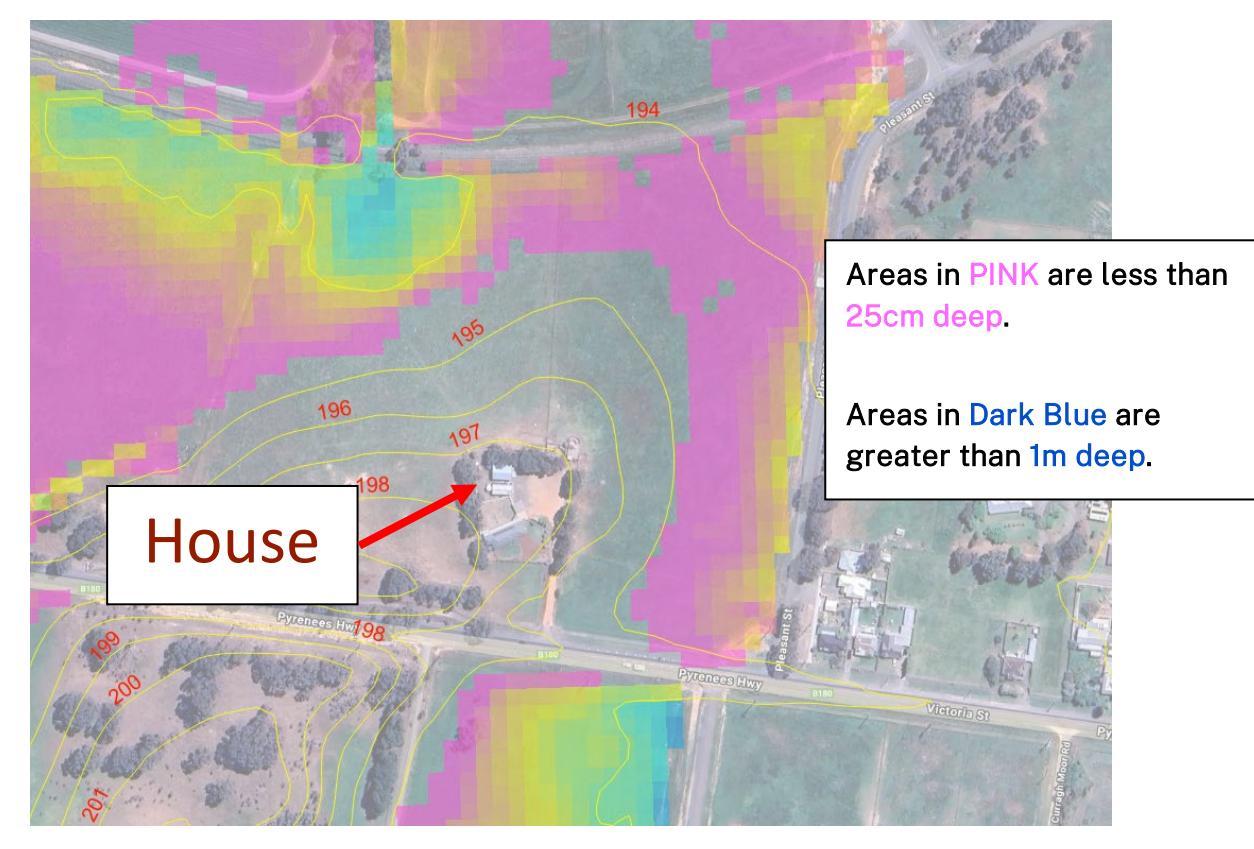
Figure 4-16 House on norther side of Pyrenees Highway culverts

It should be noted, there is a house on the northern side of the culverts, however it is some 2m higher than the design flood levels and (very) unlikely to be impacted.

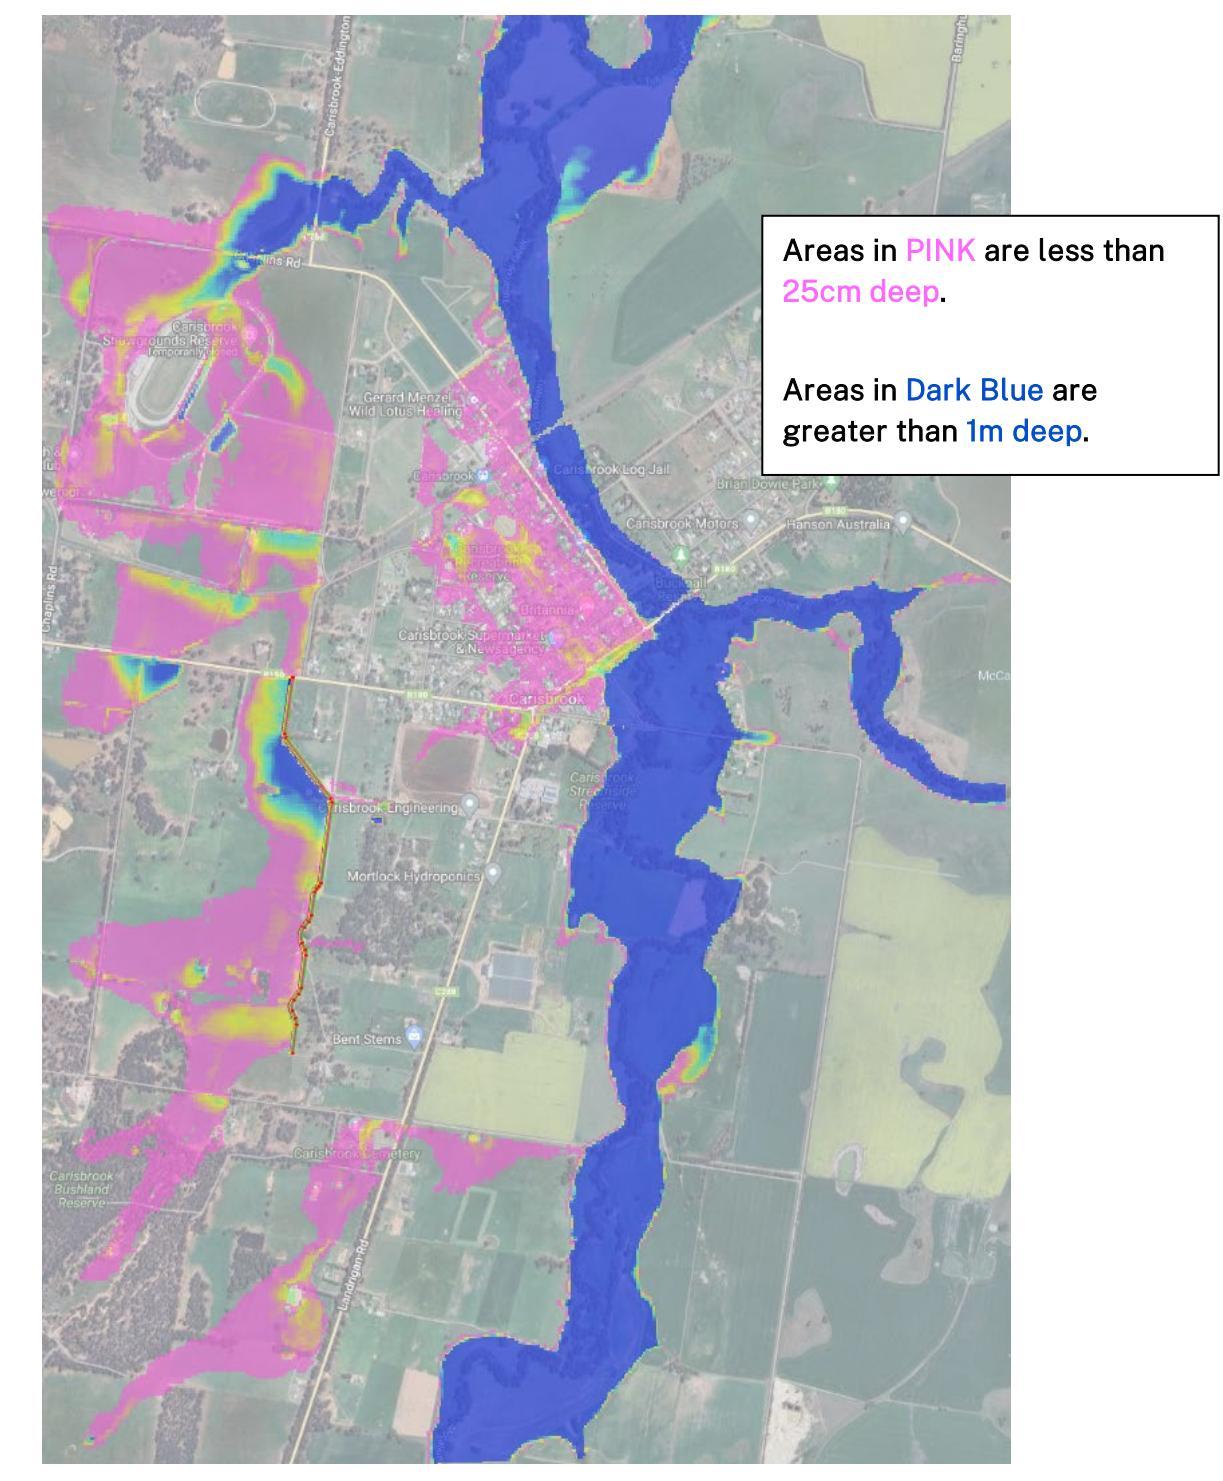
Figure 4-20 Design Flood Depths

It should also be noted that a lot of the flood water is LESS THAN 25cm deep (as per the pink areas below). These small depths are very susceptible to variation both in the inaccuracy of the LIDAR survey, the modelling and any later activities that may (inadvertently) be done.

This would change how water behaves on the floodplain.

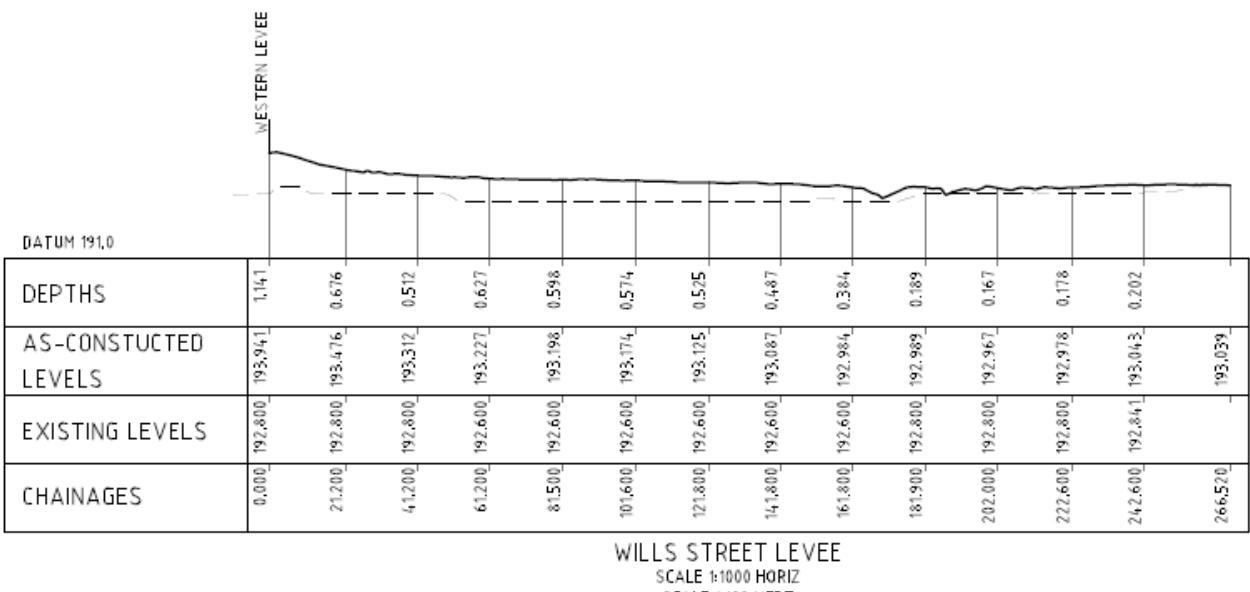
Figure 4-27 Longsection of the supposed Wills Street Levee (Engeny 2024)

The 2019 Flood Study makes no mention of there being a Levee Bank running down Wills Street, nor was it modelled as such. However, the (draft) Flood Levee Management Plan (Engeny May 2024) has labelled 270m of Wills Street as a levee and even produced a long section stating such. Apart from a small ramp off pleasant Street, there is no levee bank on Wills Street.

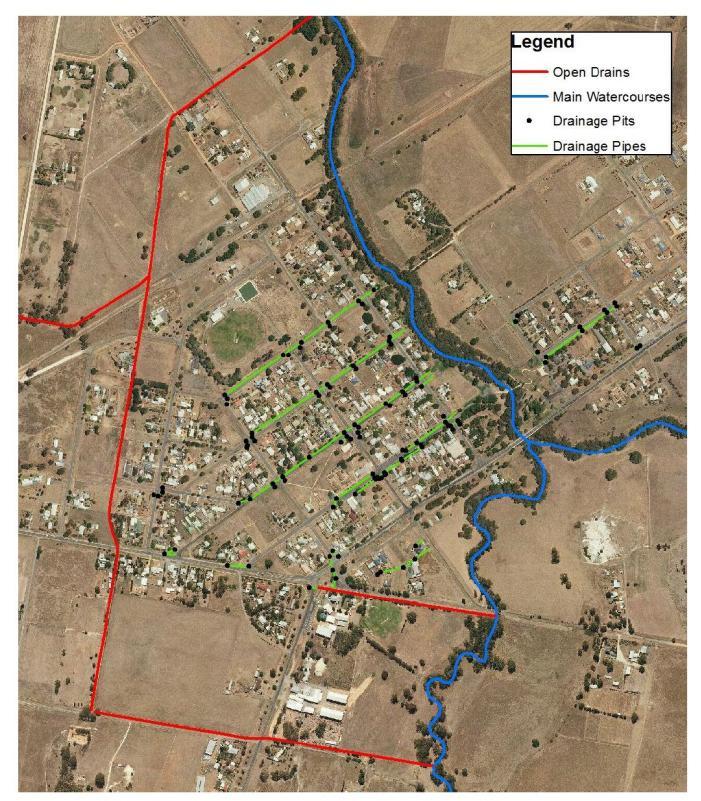
Figure 4-37 Stormwater Pipe Network

It is expected that there may be more pipes and culverts under Bucknall Street and Pyrenees Highway than are shown in Council's Asset Register.

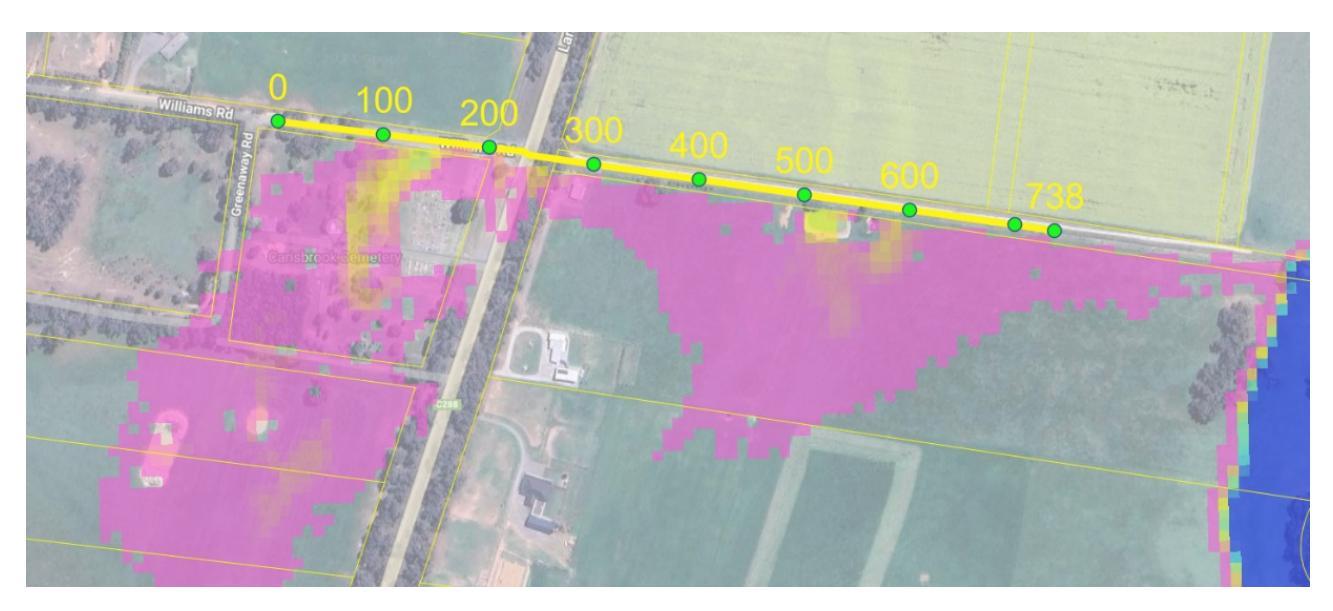
Figure 4-40 Modelled depth of flood water around Cemetery (mostly less than 25cm)

As the modelled depth of water is less that 25cm, the below shows how small differences in the terrain in many locations in and around the cemetery would have on flow directions. For example, a blockage in a drain, the model not picking up ALL subtle drainage lines and details around the cemetery etc. All would make a BIG difference to how the water behaves and where it flows.

From a visual inspection of the culvert under Landrigan Road and the start of the Bluestone Drain heading east, it appears that invert level of the culvert is much lower than the invert level of the drain. If this is found to be the case, this would mean that the culvert is *"effectively 80% blocked"* and would cause water to back up into and sit in the Cemetery for a longer period of time and to a greater extent.
