INVESTIGATION AND DESIGN OF CARISBROOK FLOOD AND DRAINAGE MITIGATION TREATMENTS

Detailed Design Report

ENTURA-A31FA
6 June 2016

Prepared by Hydro-Electric Corporation
ABN48 072 377 158

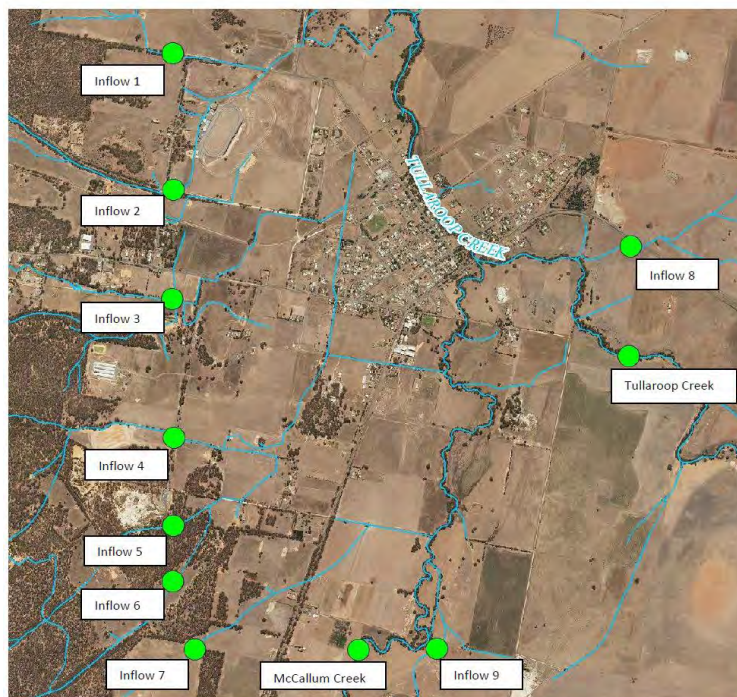
Figure 5.1: Extracted from Water Technology Report (2011); location of RORB extracted hydrographs around Carisbrook

Based on Figure 4-3 of the Water Technology Report (2011) which is shown in Figure 5.1, the MIKE Flood model has 11 inflow locations the hydrographs of which were extracted from a RORB model.

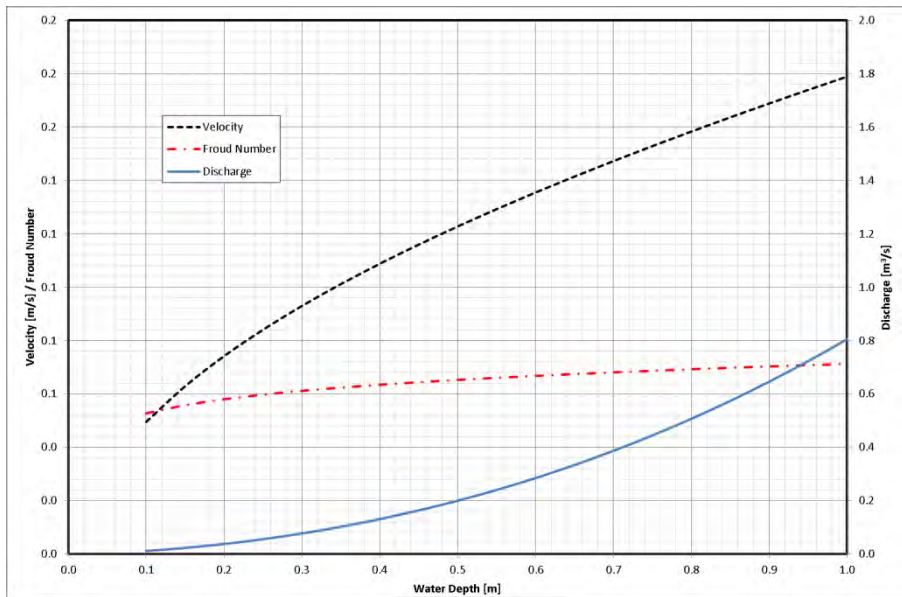
Figure 5.2: Hydraulic characteristics of the trapezoidal channel with a longitudinal slope of 0.00003

Summary of the levels and longitudinal slopes of the channel is provided in Table 5.8. The hydraulic calculations associated with different slopes are provided in Figure 5.2 to Figure 5.8. A manning’s coefficient of 0.022 has been considered for the calculations. It should be noted that all the channel segments are categorised hydraulically as Mild (M) and the water profiles at the intersections between them would be M1 and M2 curves.

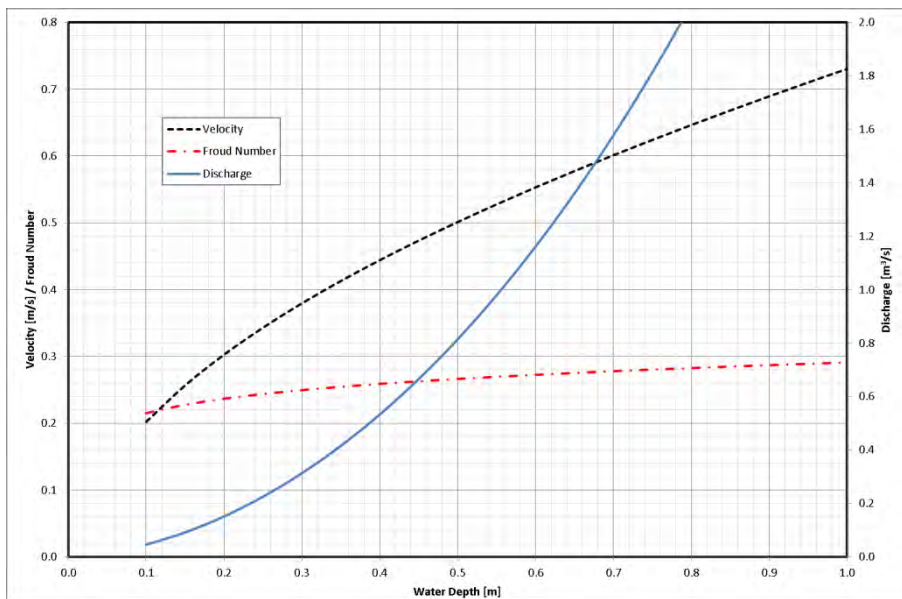
Figure 5.3: Hydraulic characteristics of the trapezoidal channel with a longitudinal slope of 0.0005

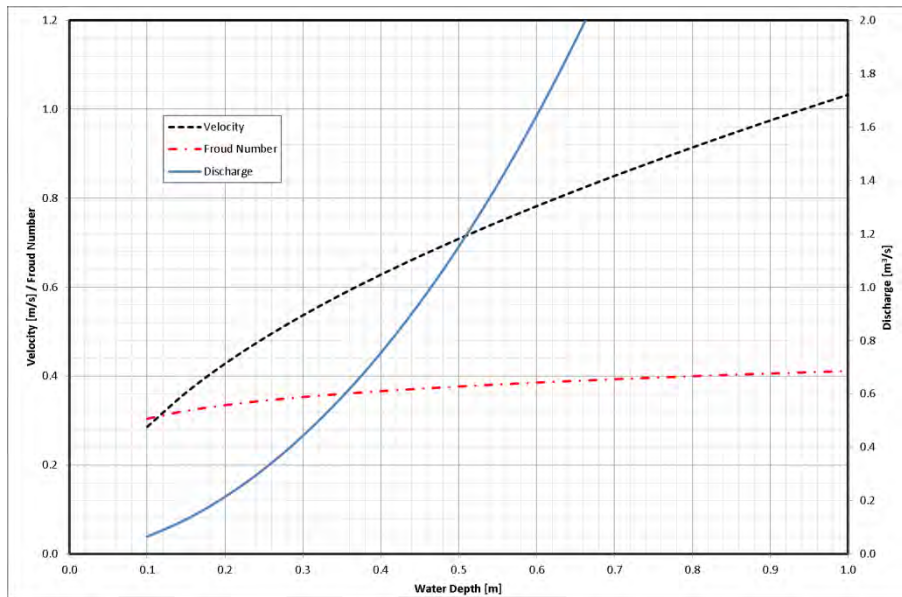
Figure 5.4: Hydraulic characteristics of the trapezoidal channel with a longitudinal slope of 0.001

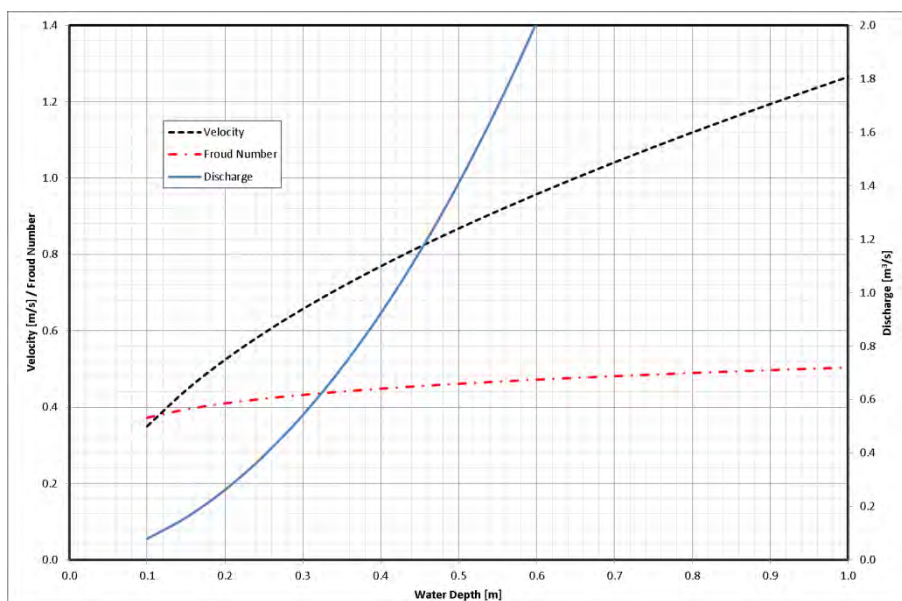
Figure 5.5: Hydraulic characteristics of the trapezoidal channel with a longitudinal slope of 0.0015

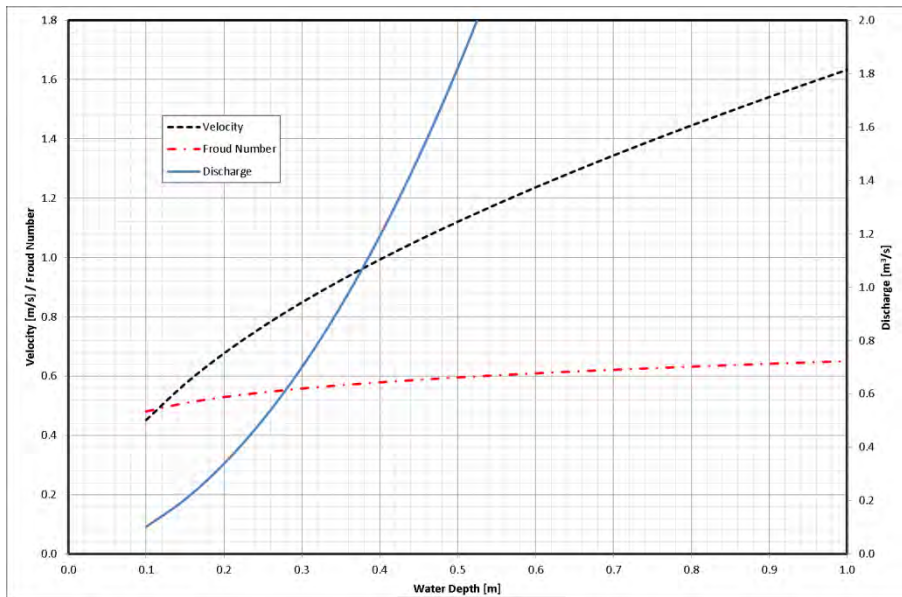
Figure 5.6: Hydraulic characteristics of the trapezoidal channel with a longitudinal slope of 0.0025

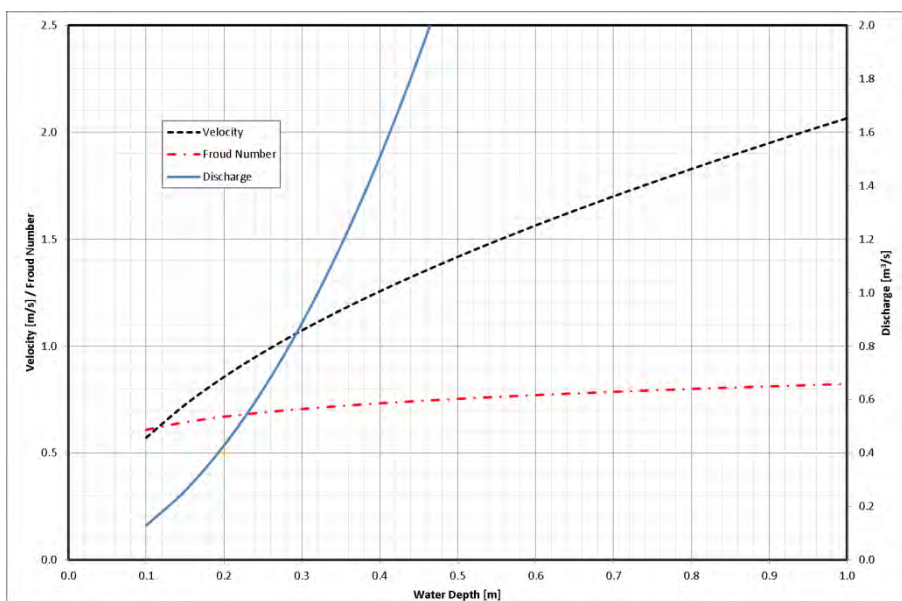
Figure 5.7: Hydraulic characteristics of the trapezoidal channel with a longitudinal slope of 0.004

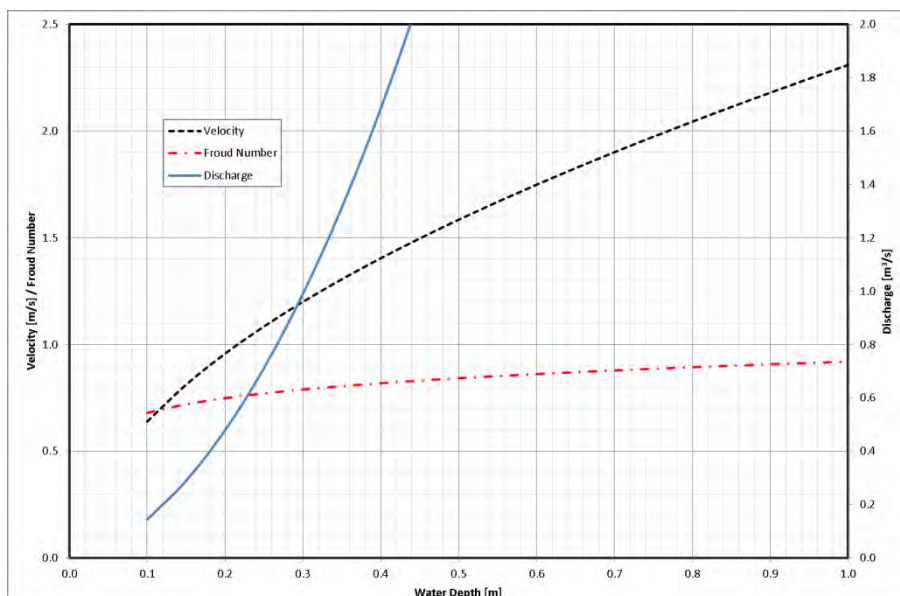
Figure 5.8: Hydraulic characteristics of the trapezoidal channel with a longitudinal slope of 0.005

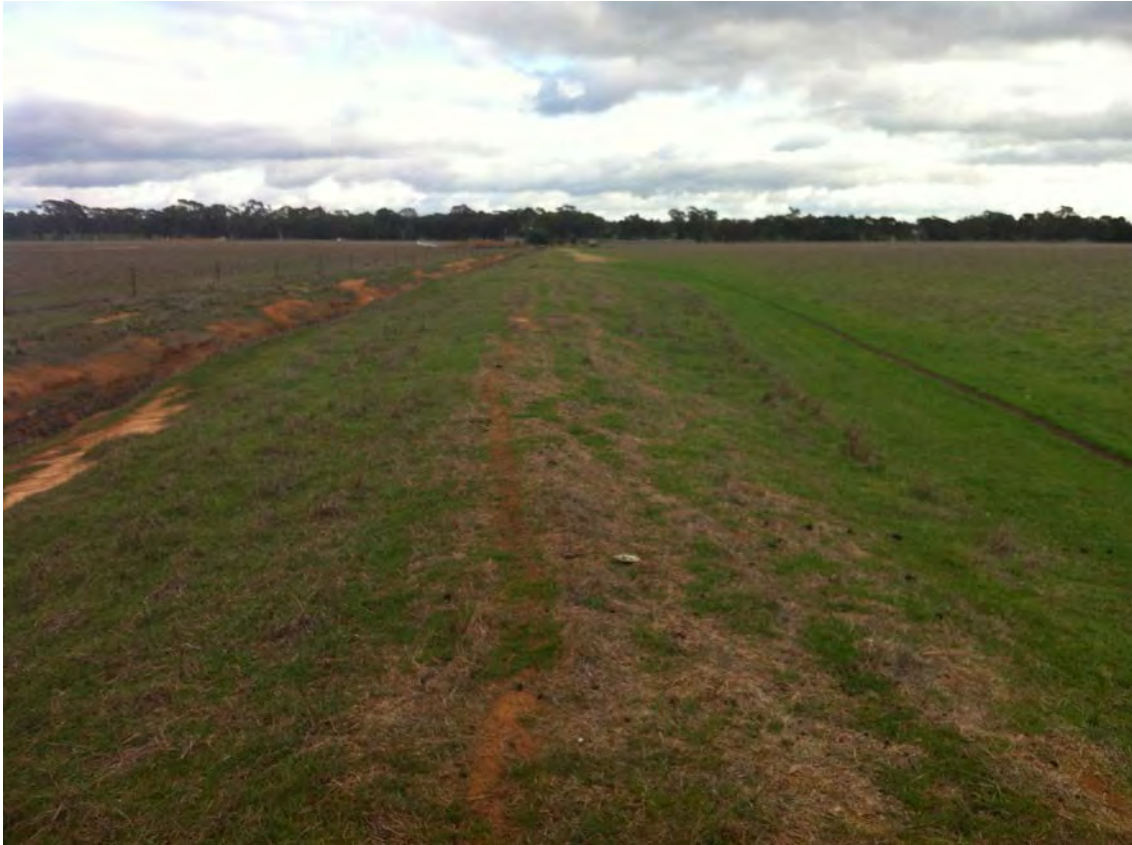
Figure 3. Existing drain, proposed for levee construction.

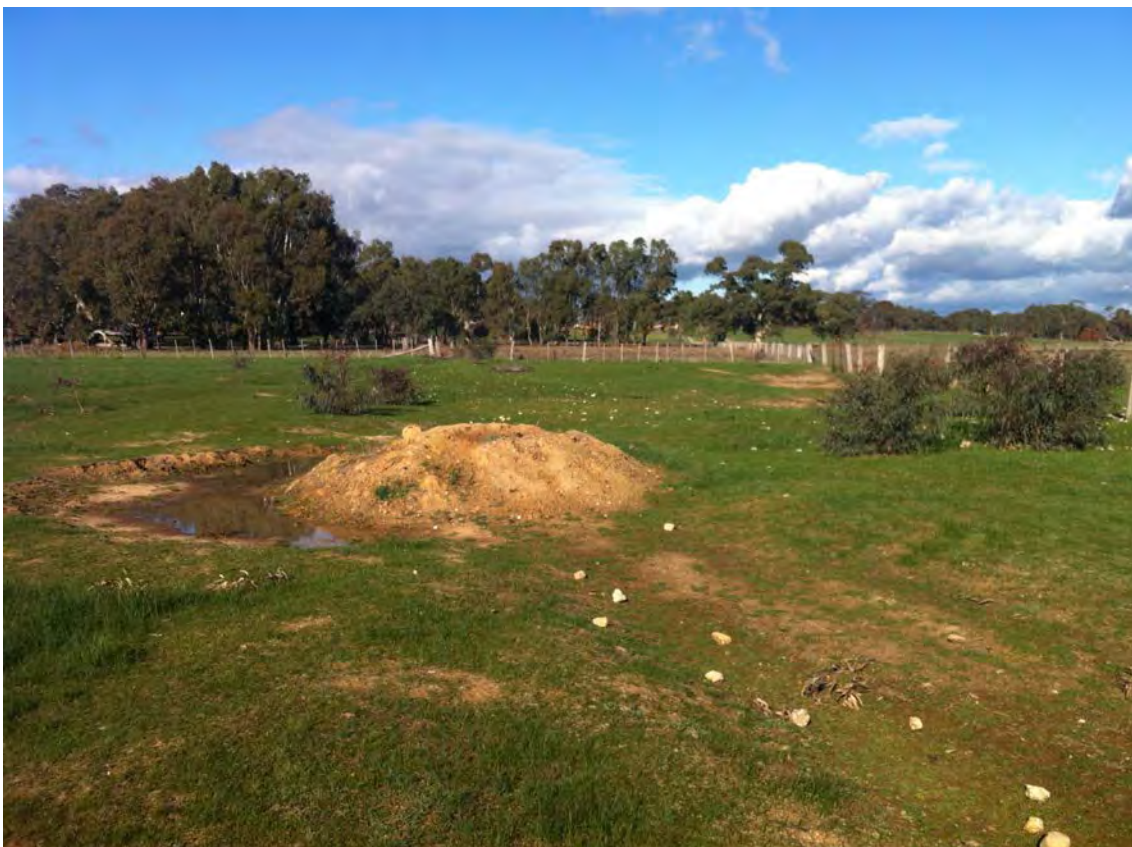
Figure 4. Existing drain, proposed for levee construction.

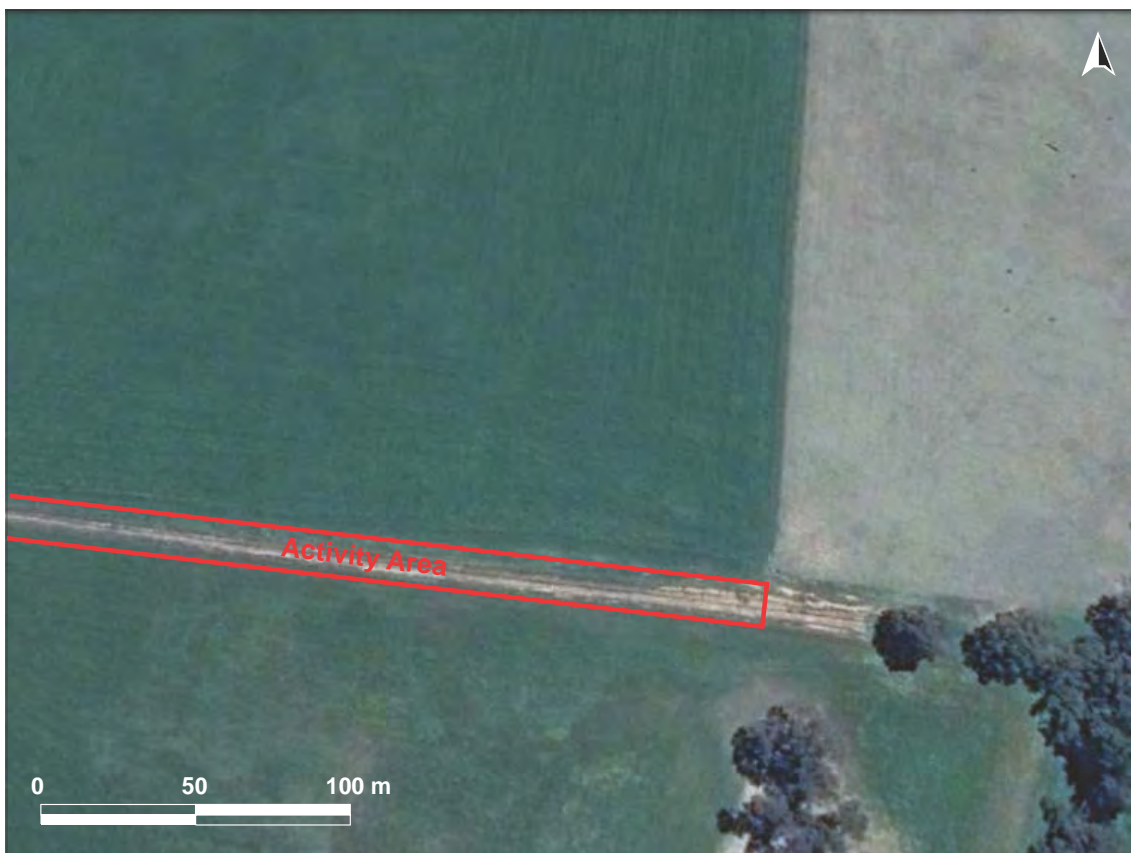
Figure 5. Aerial photograph of the section of the proposed infrastructure corridor within 200 m of McCallum Creek demonstrating the significant ground disturbance.

Common knowledge (Level 1) is not applicable in this case. Publicly available records (Level 2) in the form of an aerial photograph and expert advice (Level 4) based on the field investigation described in Section 4 (above) are instead used to establish that the section of the proposed infrastructure corridor within 200 m of McCallum Creek has been subject to significant ground disturbance. The aerial photograph in Figure 5 clearly shows the location of earthworks associated with past drain construction. These surface features clearly visible on a publicly available aerial photograph show that some corridor has been previous directly impacted by significant ground disturbance.

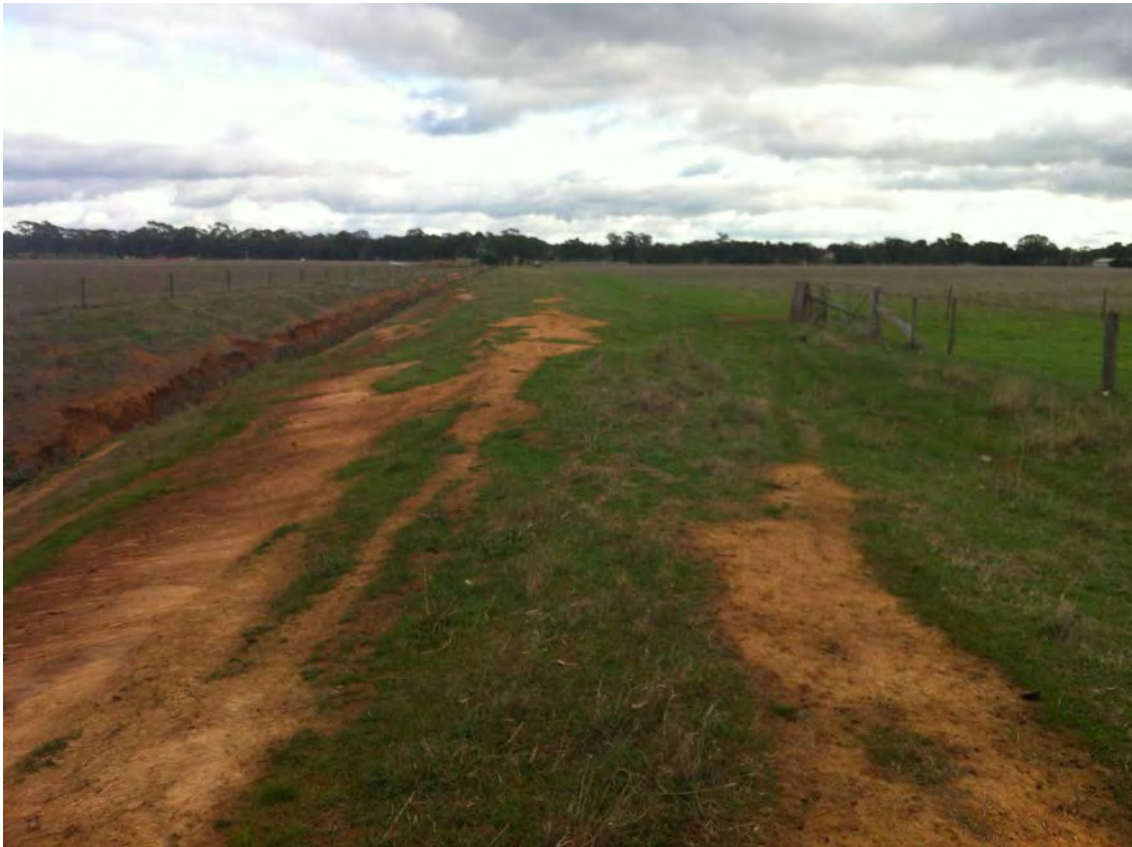
Figure 6. Section of the proposed infrastructure corridor within 200 m of McCallum Creek demonstrating the significant ground disturbance caused by drain construction.

The results of geomorphologist Dr Cupper's level 4 inquiry show that the corridor has been impacted by the use of light and heavy earthmoving machinery (Figures 6 and 7). This includes extensive excavations for a drain.

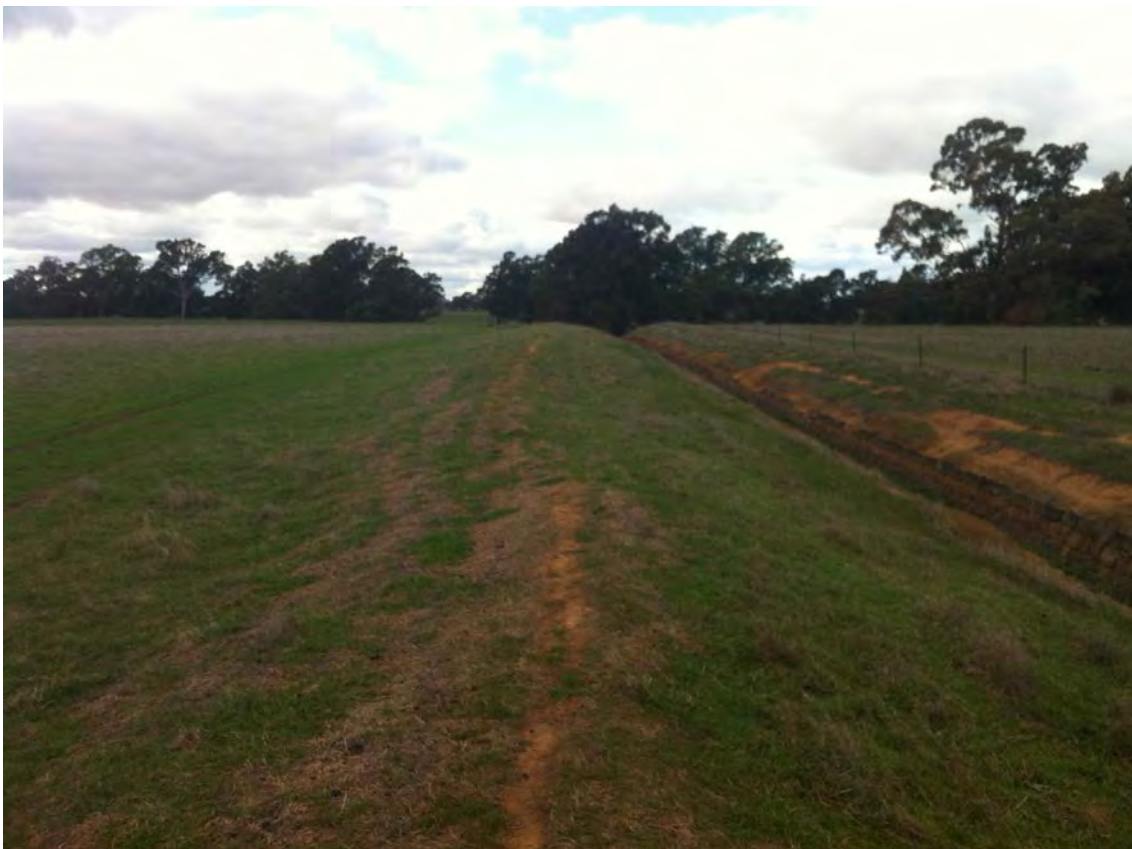
Figure 7. Section of the proposed infrastructure corridor within 200 m of McCallum Creek demonstrating the significant ground disturbance caused by drain construction.

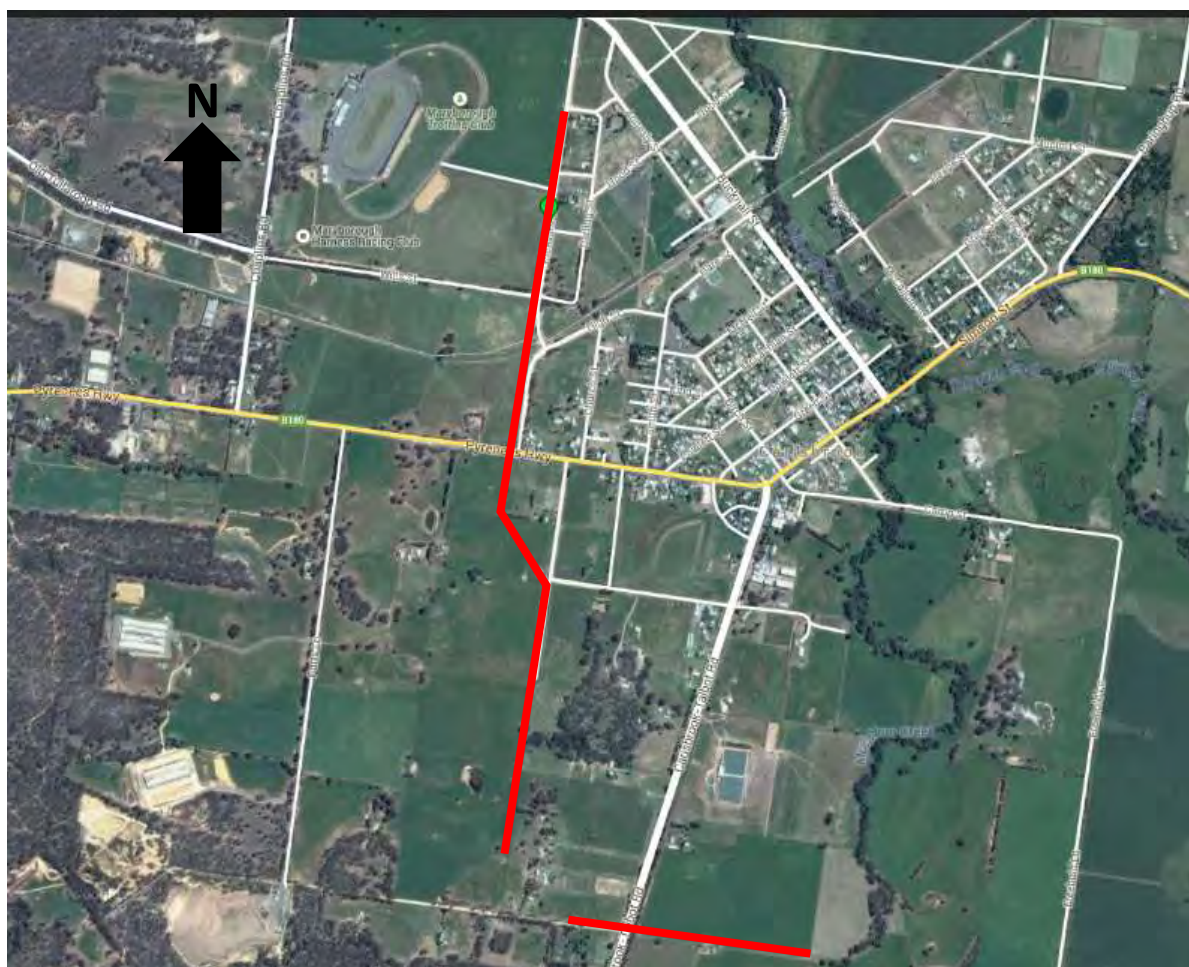
Figure 1 Aerial Photograph of Carisbrook (not to scale)

An aerial photograph of the township of Carisbrook has been sourced from the “Nearmap Online Aerial Photograph Site”, see figure 1. The proposed levee alignments are shown in red.

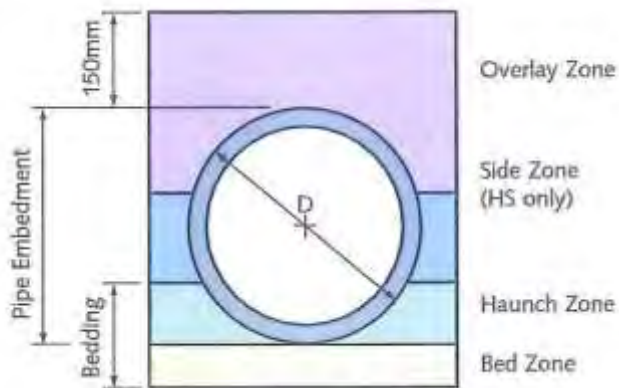
Pipe embedment is the general name given to the zone in the trench between the invert and crown of the pipe and includes the haunch zone, the side zone and overlay zone (Figure 8-1). Pipe bedding refers to the bed and haunch zones which provide the underlying support to the pipe

Figure 8-1 Pipe Trench Zones

The overlay zone shall be backfilled with compacted ordinary fill. Overlay material shall be compacted to a standard dry density ratio of 90% or a density index of 60%.

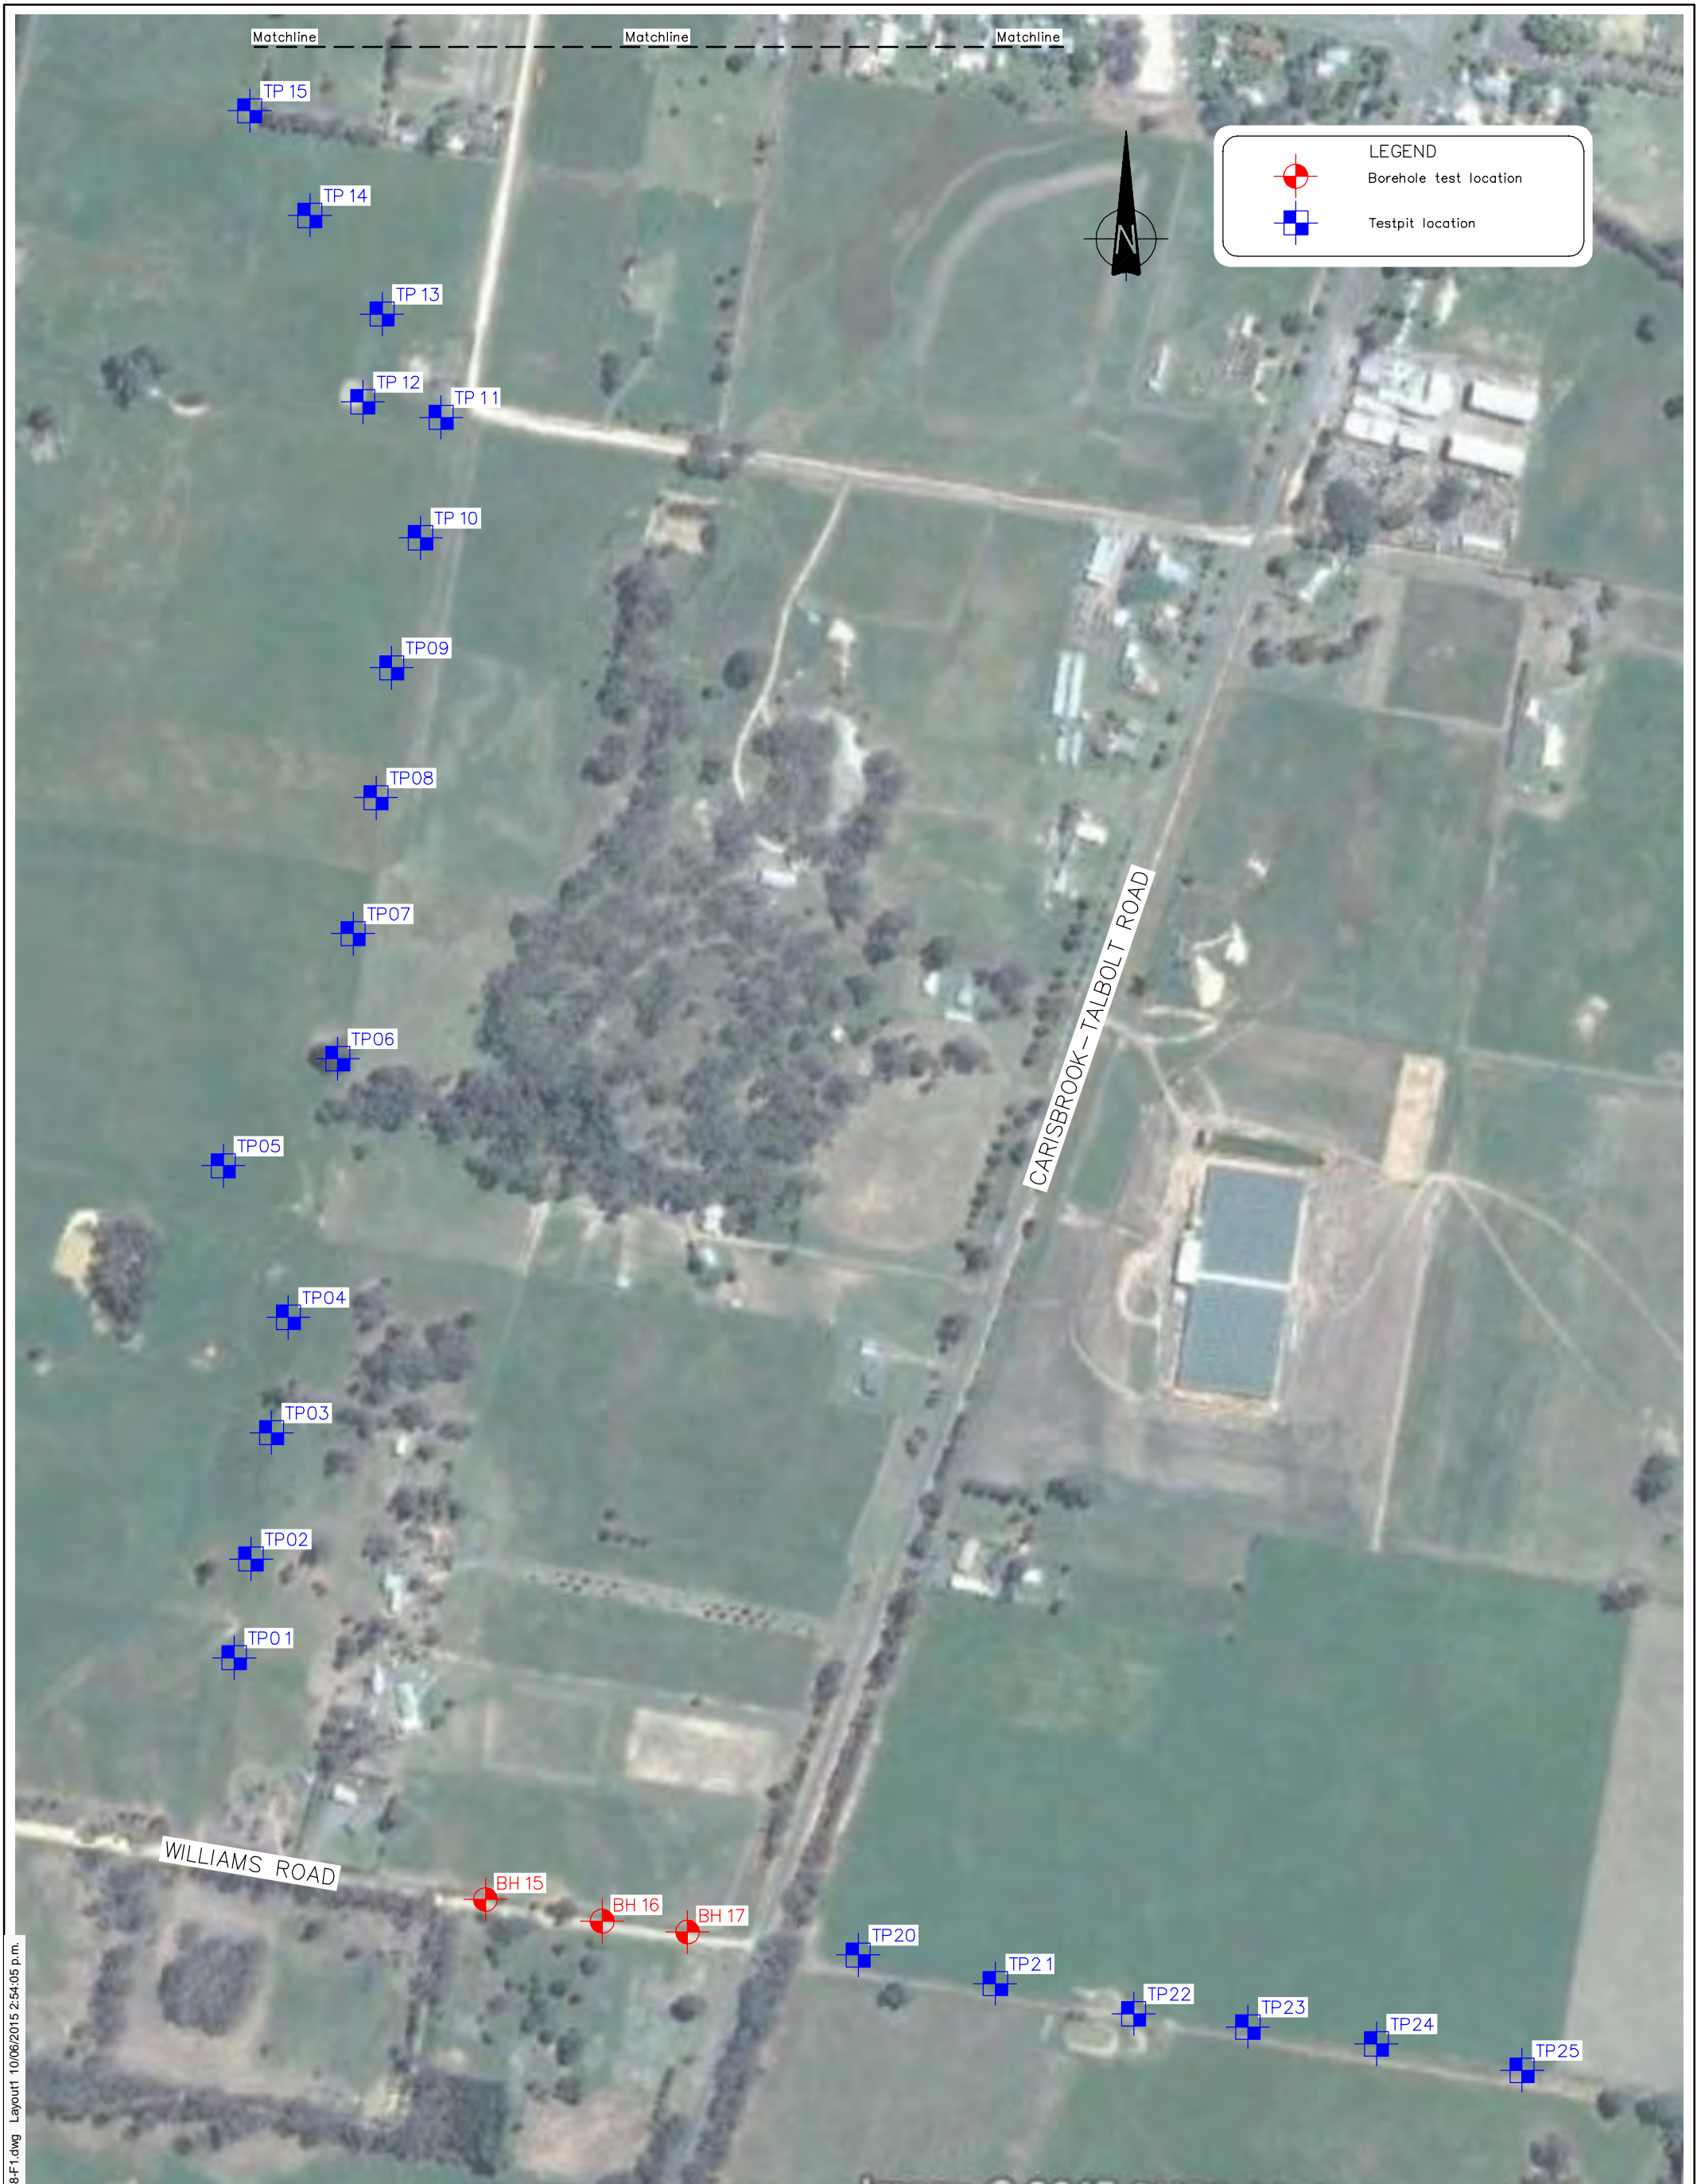
ENTURA
 GEOTECHNICAL INVESTIGATION
 CARISBROOK FLOOD & DRAINAGE MITIGATION
 Borehole & Testpit Location Plan

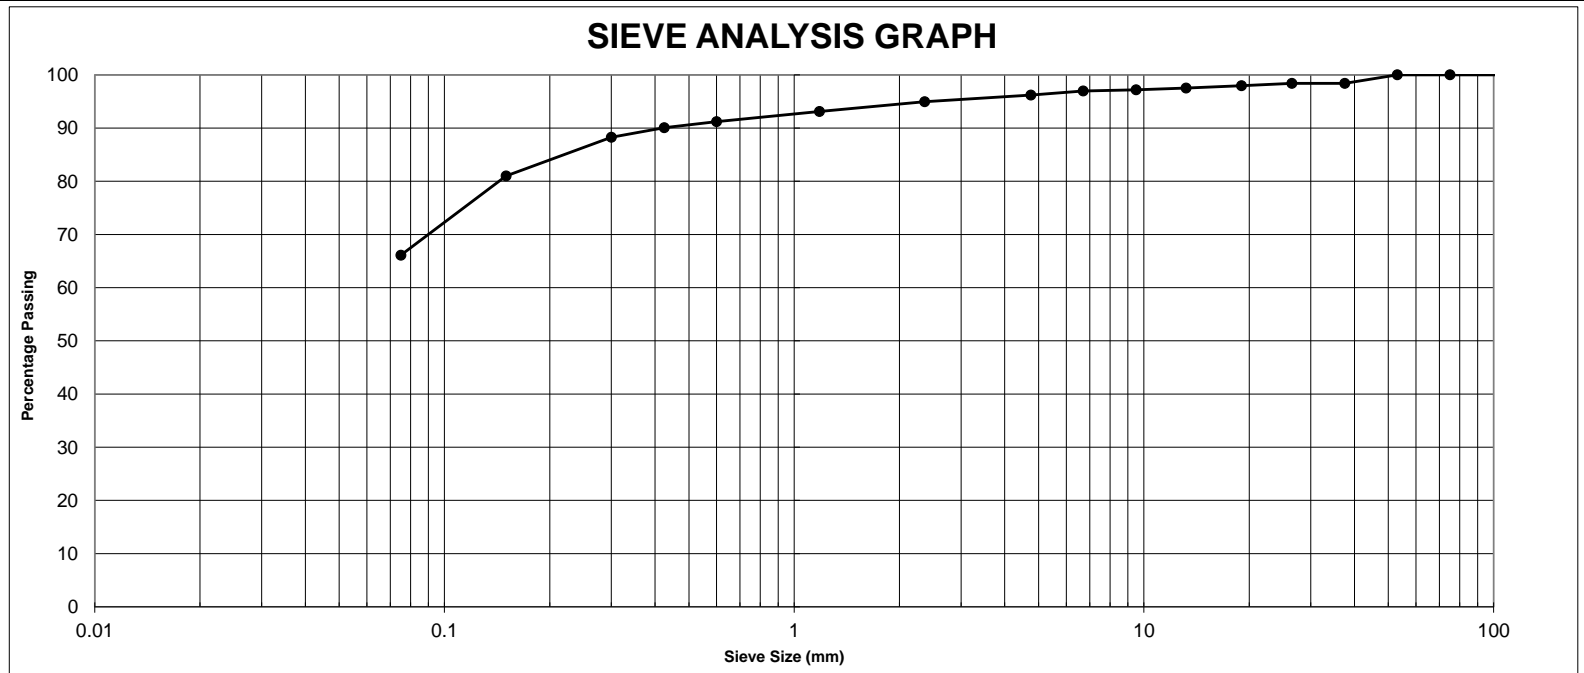
Sample No.:	1505754
ID No.:	1
Lot No.:	-
Date Sampled:	27/05/2015
Time Sampled:	am/pm
Date Tested:	11/06/2015
Material Source:	Insitu
Material Type:	Clay
To Be Used As	Material Analysis
Sample Location :	BH01 1.2-2.0m
Layer Depth (mm)	-
Test Depth (mm)	-
Sampling Method	AS1289.1.2.1.6.5.3
Moisture Content (%) AS 1289 2.1.1	12.0
Liquid Limit (%) AS 1289.3.1.2	22
Plastic Limit (%) AS 1289.3.2.1	14
Plasticity Index AS 1289.3.3.1	8
Linear Shrinkage (%) AS 1289.3.4.1	4.0
Cracking, Curling, Crumbling (1,2,3)	1
P.I. x % Passing 0.425mm	720
L.S. x % Passing 0.425mm	360
Ratio of % Passing (0.075/0.425)	0.73

300mm	150mm	75.00mm	53.00mm	37.50mm	26.50mm	19.00mm	13.2mm	9.50mm	6.70mm	4.75mm	2.36mm	1.18mm	0.600mm	0.425mm	0.300mm	0.150mm	0.075mm
			100	98	98	98	98	97	97	96	95	93	91	90	88	81	66

Soil Classification in accordance with Unified Soil Classification Laboratory Identification Procedure AS1726 Table A1 (1993) - Appendix A, Section A

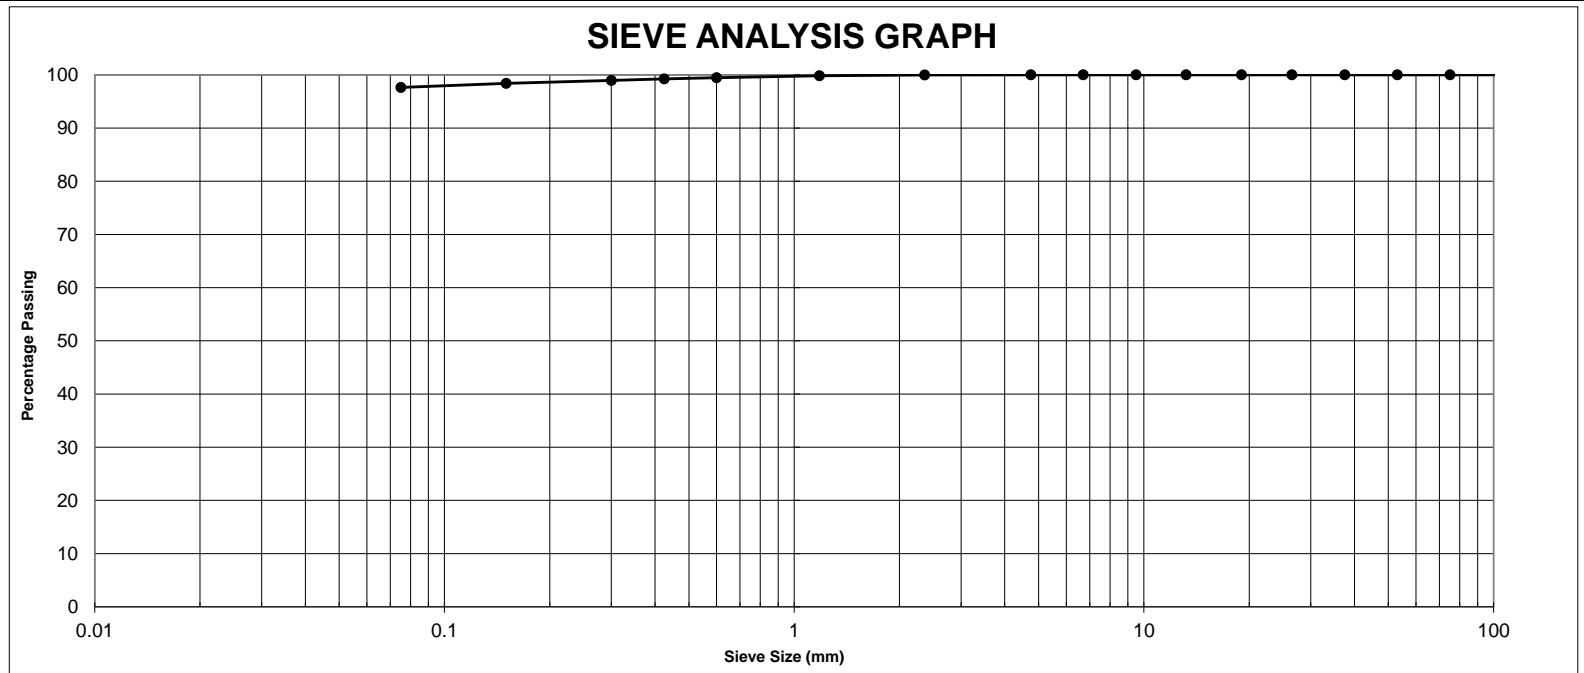
Sample No.:	1505757
ID No.:	4
Lot No.:	-
Date Sampled:	27/05/2015
Time Sampled:	am/pm
Date Tested:	11/06/2015
Material Source:	Insitu
Material Type:	Clay
To Be Used As	Material Analysis
Sample Location :	BH01 4.7-6.0m
Layer Depth (mm)	-
Test Depth (mm)	-
Sampling Method	AS1289.1.2.1.6.5.3
Moisture Content (%) AS 1289 2.1.1	28.7
Liquid Limit (%) AS 1289.3.1.2	54
Plastic Limit (%) AS 1289.3.2.1	28
Plasticity Index AS 1289.3.3.1	26
Linear Shrinkage (%) AS 1289.3.4.1	7.0
Cracking, Curling, Crumbling (1,2,3)	2
P.I. x % Passing 0.425mm	2580
L.S. x % Passing 0.425mm	695
Ratio of % Passing (0.075/0.425)	0.98

300mm	150mm	75.00mm	53.00mm	37.50mm	26.50mm	19.00mm	13.2mm	9.50mm	6.70mm	4.75mm	2.36mm	1.18mm	0.600mm	0.425mm	0.300mm	0.150mm	0.075mm
										100	100	100	99	99	99	98	98

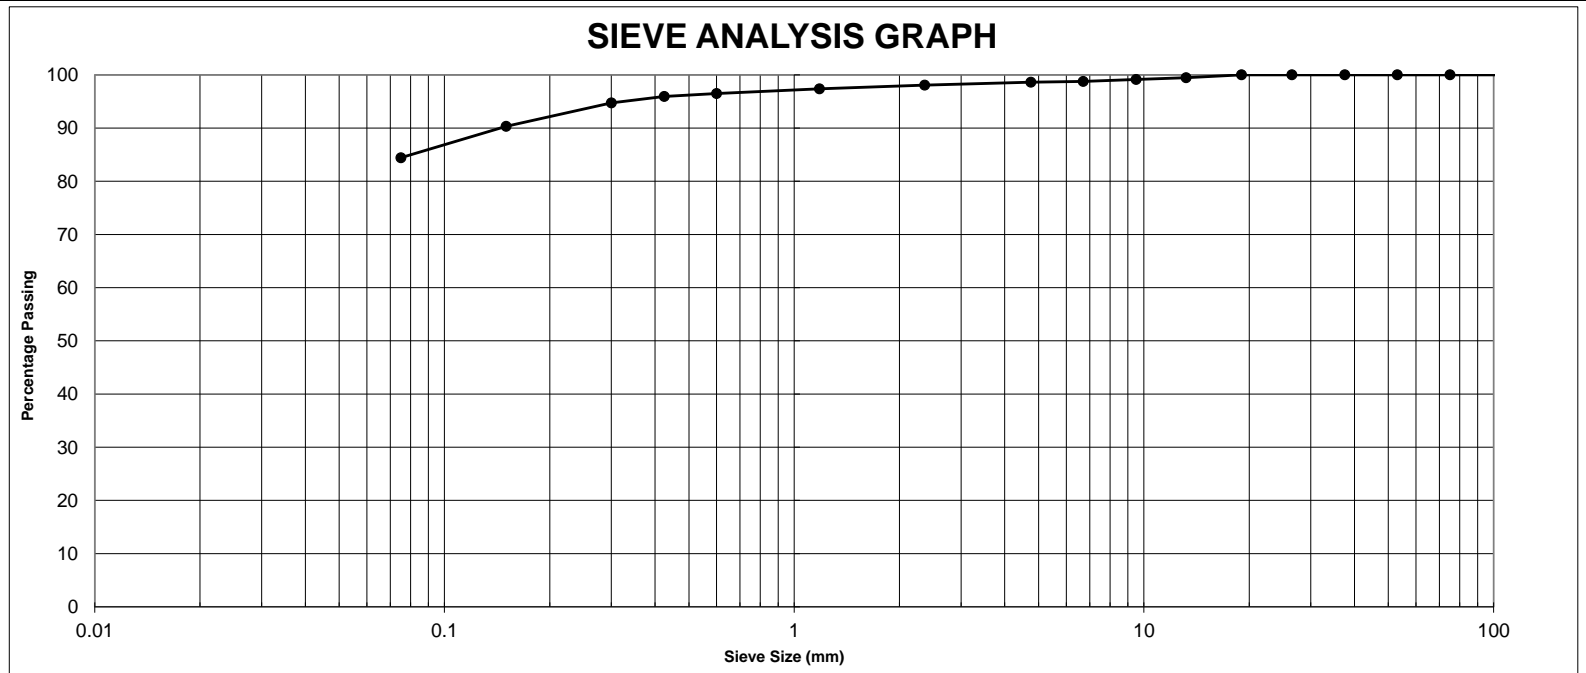
Sample No.:	1505761
ID No.:	8
Lot No.:	-
Date Sampled:	27/05/2015
Time Sampled:	am/pm
Date Tested:	11/06/2015
Material Source:	Insitu
Material Type:	Clay
To Be Used As	Material Analysis
Sample Location :	BH05 0.3-1.5m
Layer Depth (mm)	-
Test Depth (mm)	-
Sampling Method	AS1289.1.2.1.6.5.3
Moisture Content (%) AS 1289 2.1.1	17.4
Liquid Limit (%) AS 1289.3.1.2	30
Plastic Limit (%) AS 1289.3.2.1	16
Plasticity Index AS 1289.3.3.1	14
Linear Shrinkage (%) AS 1289.3.4.1	6.0
Cracking, Curling, Crumbling (1,2,3)	
P.I. x % Passing 0.425mm	1343
L.S. x % Passing 0.425mm	576
Ratio of % Passing (0.075/0.425)	0.88

300mm	150mm	75.00mm	53.00mm	37.50mm	26.50mm	19.00mm	13.2mm	9.50mm	6.70mm	4.75mm	2.36mm	1.18mm	0.600mm	0.425mm	0.300mm	0.150mm	0.075mm
						100	99	99	99	99	98	97	96	96	95	90	84

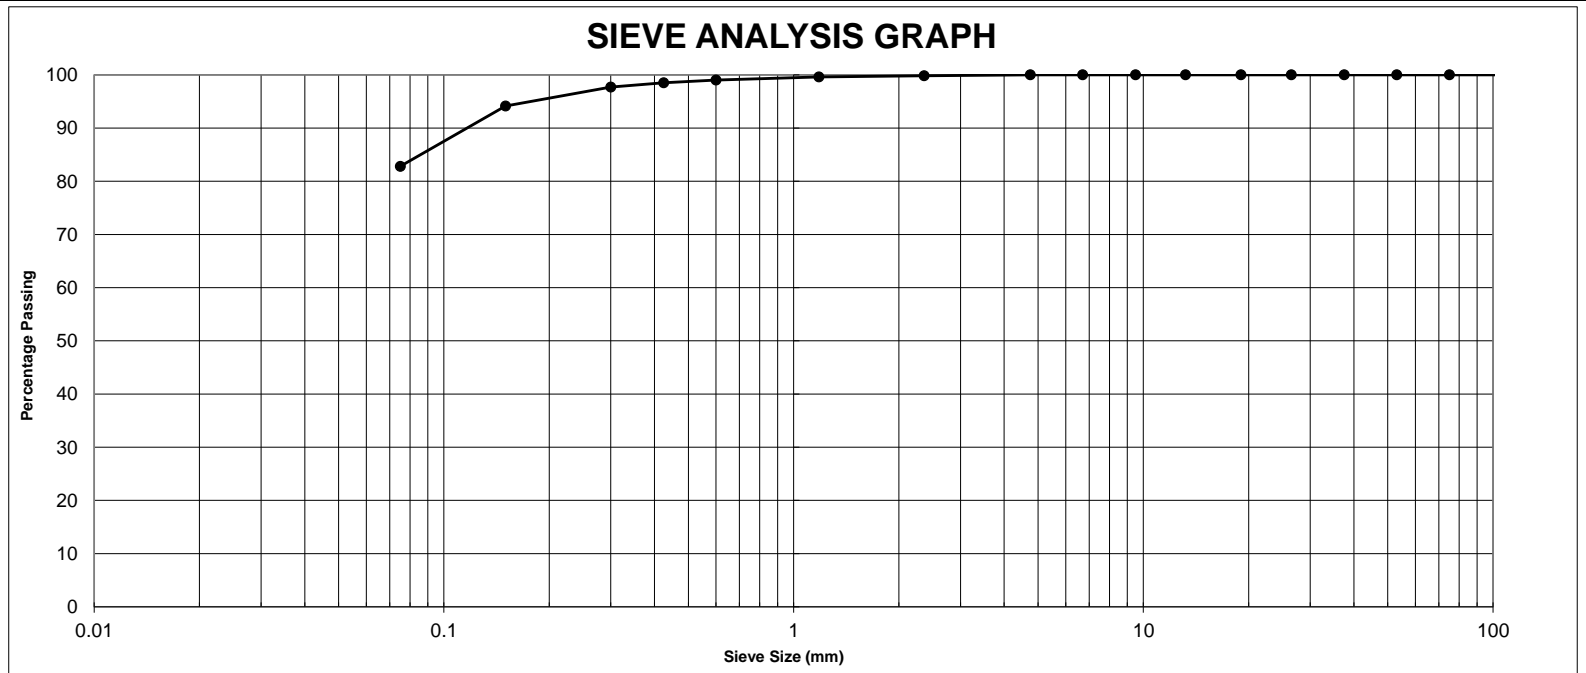
Sample No.:	1505763
ID No.:	10
Lot No.:	-
Date Sampled:	27/05/2015
Time Sampled:	am/pm
Date Tested:	11/06/2015
Material Source:	Insitu
Material Type:	Clay
To Be Used As	Material Analysis
Sample Location :	BH05 3.6-4.5m
Layer Depth (mm)	-
Test Depth (mm)	-
Sampling Method	AS1289.1.2.1.6.5.3
Moisture Content (%) AS 1289 2.1.1	24.3
Liquid Limit (%) AS 1289.3.1.2	26
Plastic Limit (%) AS 1289.3.2.1	17
Plasticity Index AS 1289.3.3.1	9
Linear Shrinkage (%) AS 1289.3.4.1	5.0
Cracking, Curling, Crumbling (1,2,3)	
P.I. x % Passing 0.425mm	887
L.S. x % Passing 0.425mm	493
Ratio of % Passing (0.075/0.425)	0.84

300mm	150mm	75.00mm	53.00mm	37.50mm	26.50mm	19.00mm	13.2mm	9.50mm	6.70mm	4.75mm	2.36mm	1.18mm	0.600mm	0.425mm	0.300mm	0.150mm	0.075mm
										100	100	100	99	99	98	94	83

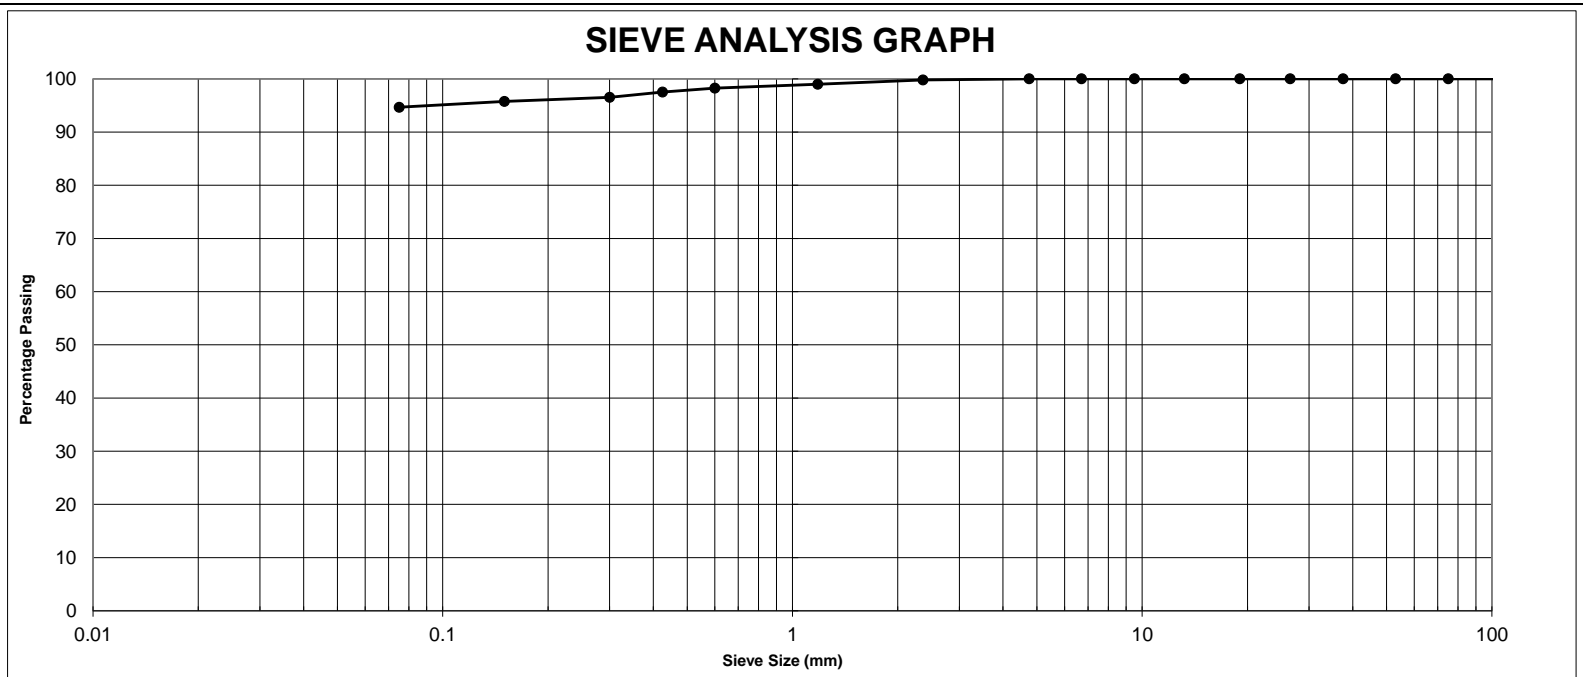
Sample No.:	1505771
ID No.:	18
Lot No.:	-
Date Sampled:	27/05/2015
Time Sampled:	am/pm
Date Tested:	11/06/2015
Material Source:	Insitu
Material Type:	Clay
To Be Used As	Material Analysis
Sample Location :	BH11 0.5-2.0m
Layer Depth (mm)	-
Test Depth (mm)	-
Sampling Method	AS1289.1.2.1.6.5.3
Moisture Content (%) AS 1289 2.1.1	23.3
Liquid Limit (%) AS 1289.3.1.2	43
Plastic Limit (%) AS 1289.3.2.1	19
Plasticity Index AS 1289.3.3.1	24
Linear Shrinkage (%) AS 1289.3.4.1	9.0
Cracking, Curling, Crumbling (1,2,3)	2
P.I. x % Passing 0.425mm	2341
L.S. x % Passing 0.425mm	878
Ratio of % Passing (0.075/0.425)	0.97

300mm	150mm	75.00mm	53.00mm	37.50mm	26.50mm	19.00mm	13.2mm	9.50mm	6.70mm	4.75mm	2.36mm	1.18mm	0.600mm	0.425mm	0.300mm	0.150mm	0.075mm
										100	100	99	98	98	97	96	95

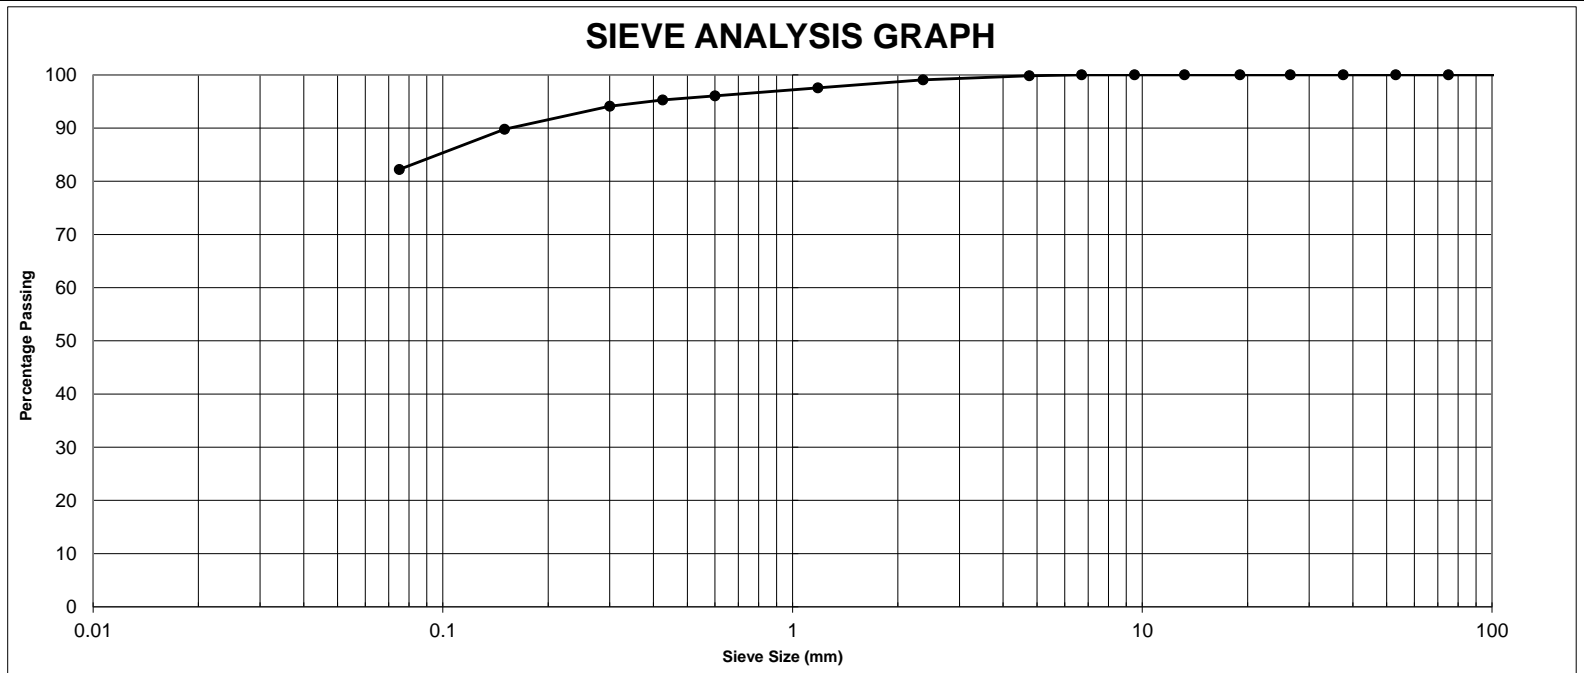
Sample No.:	1505773
ID No.:	20
Lot No.:	-
Date Sampled:	27/05/2015
Time Sampled:	am/pm
Date Tested:	11/06/2015
Material Source:	Insitu
Material Type:	Clay
To Be Used As	Material Analysis
Sample Location :	BH16 0.5-1.5m
Layer Depth (mm)	-
Test Depth (mm)	-
Sampling Method	AS1289.1.2.1.6.5.3
Moisture Content (%) AS 1289 2.1.1	14.2
Liquid Limit (%) AS 1289.3.1.2	23
Plastic Limit (%) AS 1289.3.2.1	13
Plasticity Index AS 1289.3.3.1	10
Linear Shrinkage (%) AS 1289.3.4.1	5.0
Cracking, Curling, Crumbling (1,2,3)	
P.I. x % Passing 0.425mm	953
L.S. x % Passing 0.425mm	476
Ratio of % Passing (0.075/0.425)	0.86

300mm	150mm	75.00mm	53.00mm	37.50mm	26.50mm	19.00mm	13.2mm	9.50mm	6.70mm	4.75mm	2.36mm	1.18mm	0.600mm	0.425mm	0.300mm	0.150mm	0.075mm
								100	100	99	98	96	95	94	90	82
