INVESTIGATION AND DESIGN OF CARISBROOK FLOOD AND DRAINAGE MITIGATION TREATMENTS

Detailed Design Report

ENTURA-A31FA
6 June 2016

Prepared by Hydro-Electric Corporation
ABN48 072 377 158

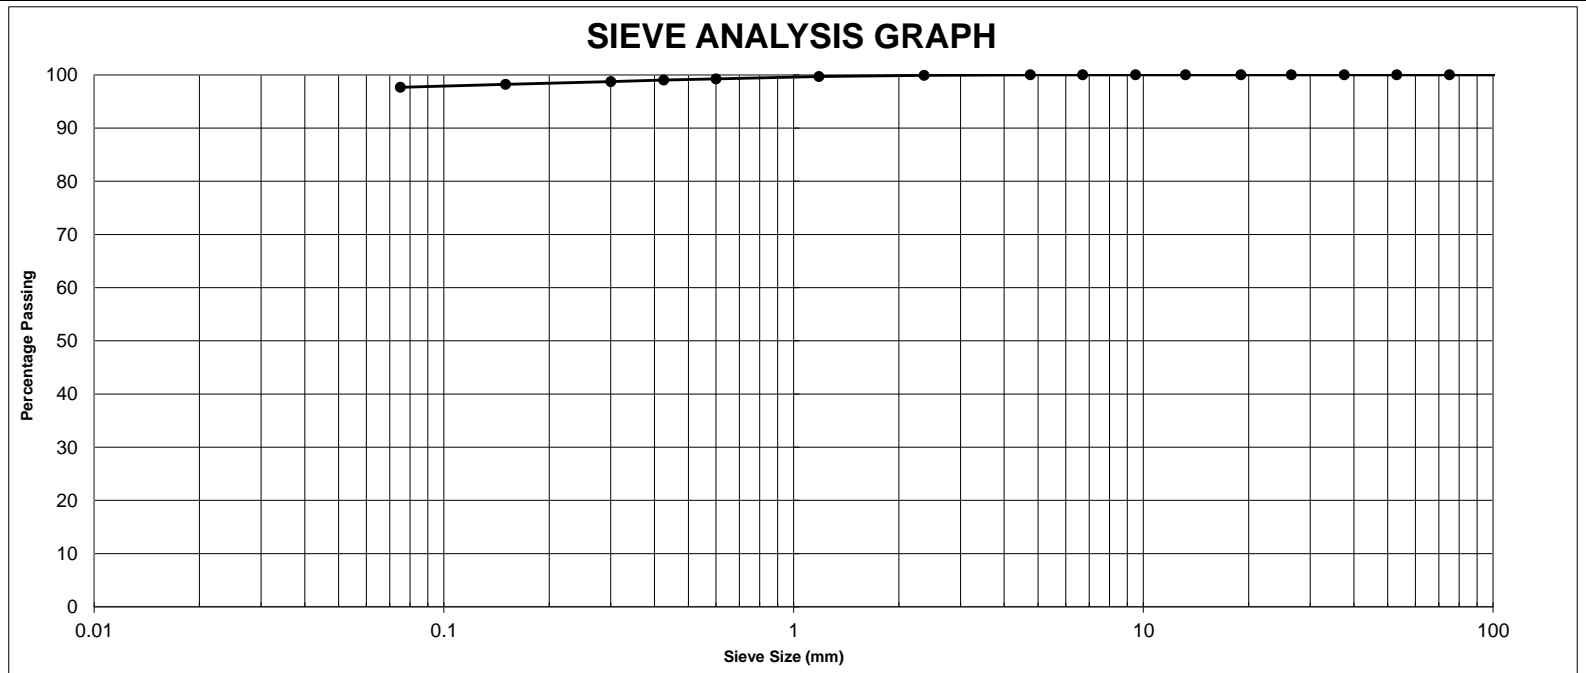
Sample No.:	1505776
ID No.:	23
Lot No.:	-
Date Sampled:	27/05/2015
Time Sampled:	am/pm
Date Tested:	12/06/2015
Material Source:	Insitu
Material Type:	Clay
To Be Used As	Material Analysis
Sample Location :	TP05 0.3-1.1m
Layer Depth (mm)	-
Test Depth (mm)	-
Sampling Method	AS1289.1.2.1.6.5.3
Moisture Content (%) AS 1289 2.1.1	22.2
Liquid Limit (%) AS 1289.3.1.2	51
Plastic Limit (%) AS 1289.3.2.1	21
Plasticity Index AS 1289.3.3.1	30
Linear Shrinkage (%) AS 1289.3.4.1	9.5
Cracking, Curling, Crumbling (1,2,3)	2
P.I. x % Passing 0.425mm	2970
L.S. x % Passing 0.425mm	941
Ratio of % Passing (0.075/0.425)	0.99

300mm	150mm	75.00mm	53.00mm	37.50mm	26.50mm	19.00mm	13.2mm	9.50mm	6.70mm	4.75mm	2.36mm	1.18mm	0.600mm	0.425mm	0.300mm	0.150mm	0.075mm
										100	100	100	99	99	99	98	98

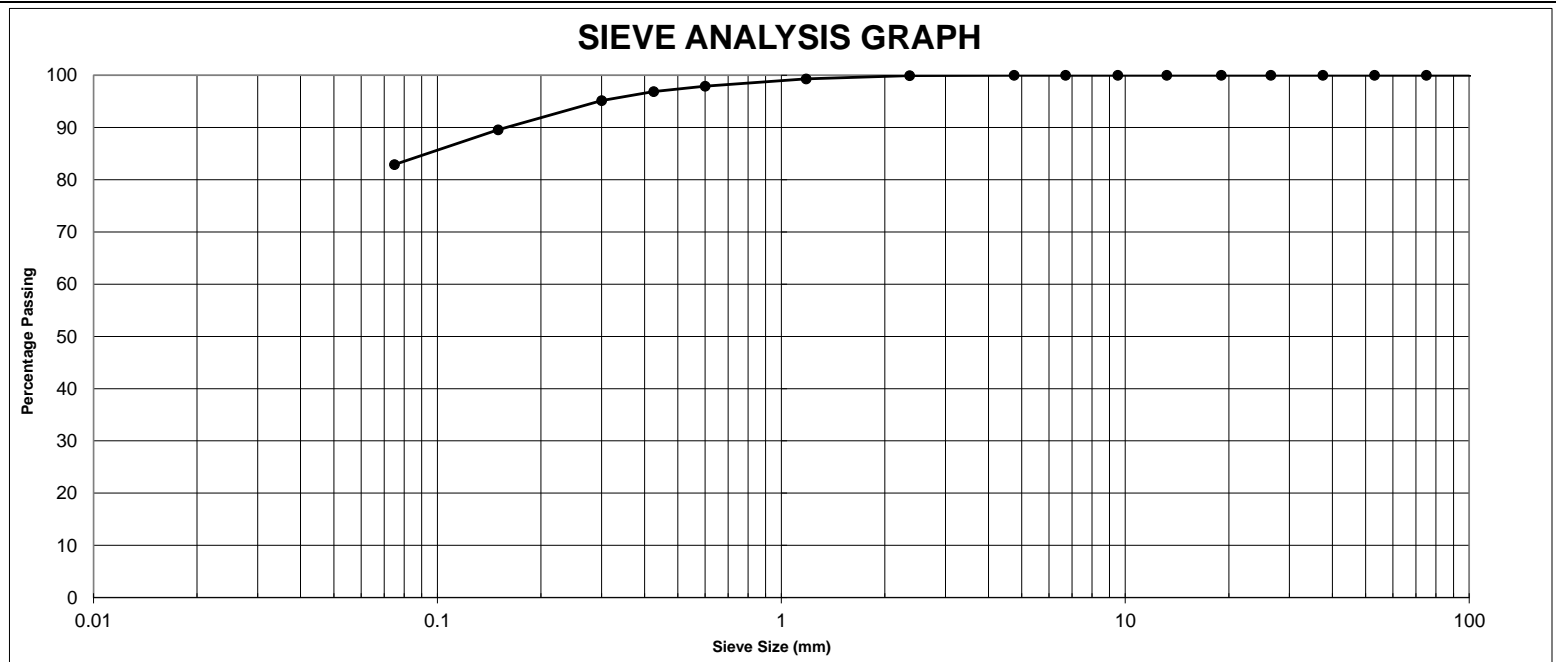
Sample No.:	1505777
ID No.:	24
Lot No.:	-
Date Sampled:	27/05/2015
Time Sampled:	am/pm
Date Tested:	12/06/2015
Material Source:	Insitu
Material Type:	Clay
To Be Used As	Material Analysis
Sample Location :	TP05 2.2-3.0m
Layer Depth (mm)	-
Test Depth (mm)	-
Sampling Method	AS1289.1.2.1.6.5.3
Moisture Content (%) AS 1289 2.1.1	25.8
Liquid Limit (%) AS 1289.3.1.2	27
Plastic Limit (%) AS 1289.3.2.1	16
Plasticity Index AS 1289.3.3.1	11
Linear Shrinkage (%) AS 1289.3.4.1	4.5
Cracking, Curling, Crumbling (1,2,3)	1
P.I. x % Passing 0.425mm	1066
L.S. x % Passing 0.425mm	436
Ratio of % Passing (0.075/0.425)	0.86

300mm	150mm	75.00mm	53.00mm	37.50mm	26.50mm	19.00mm	13.2mm	9.50mm	6.70mm	4.75mm	2.36mm	1.18mm	0.600mm	0.425mm	0.300mm	0.150mm	0.075mm
										100	100	99	98	97	95	90	83

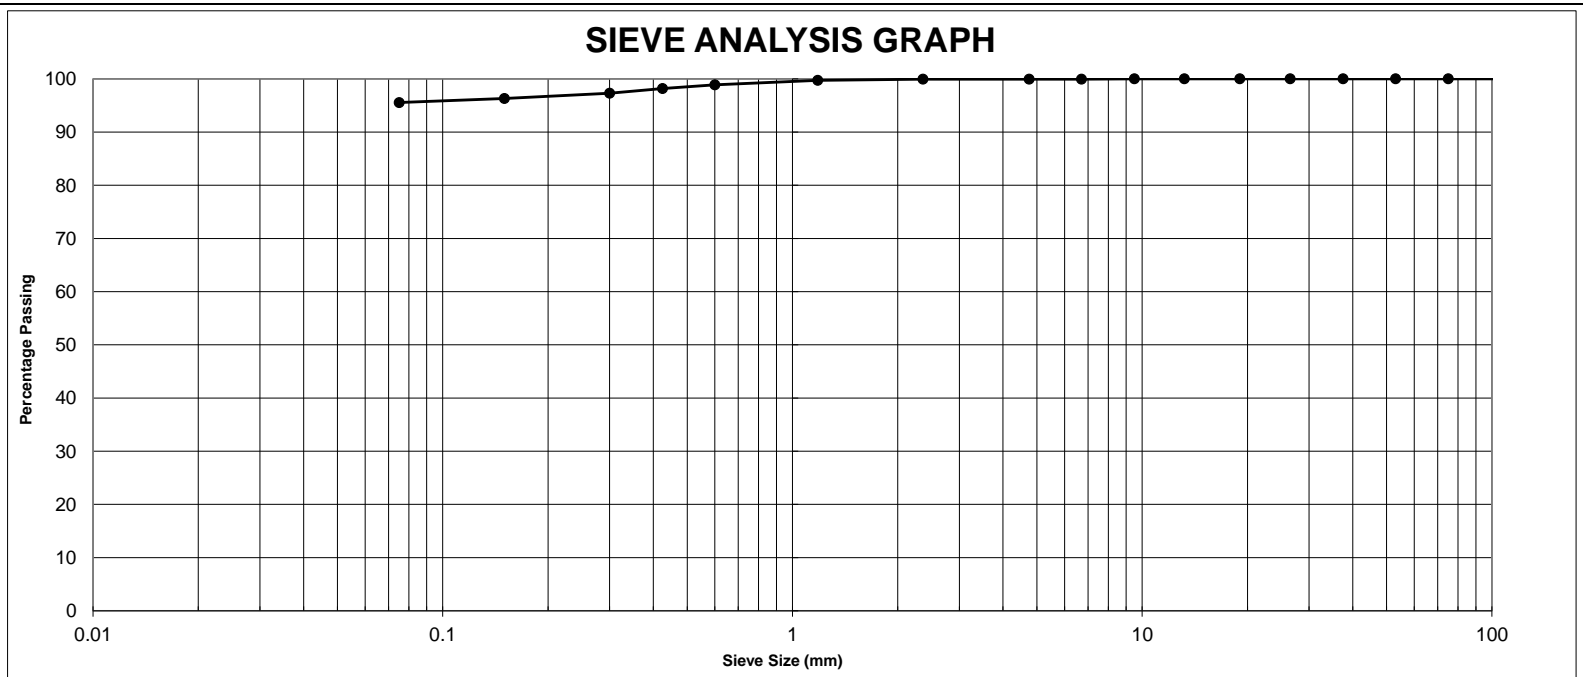
Sample No.:	1505780
ID No.:	27
Lot No.:	-
Date Sampled:	27/05/2015
Time Sampled:	am/pm
Date Tested:	12/06/2015
Material Source:	Insitu
Material Type:	Clay
To Be Used As	Material Analysis
Sample Location :	TP12 0.6-1.4m
Layer Depth (mm)	-
Test Depth (mm)	-
Sampling Method	AS1289.1.2.1.6.5.3
Moisture Content (%) AS 1289 2.1.1	21.1
Liquid Limit (%) AS 1289.3.1.2	45
Plastic Limit (%) AS 1289.3.2.1	20
Plasticity Index AS 1289.3.3.1	25
Linear Shrinkage (%) AS 1289.3.4.1	9.0
Cracking, Curling, Crumbling (1,2,3)	2
P.I. x % Passing 0.425mm	2454
L.S. x % Passing 0.425mm	883
Ratio of % Passing (0.075/0.425)	0.97

300mm	150mm	75.00mm	53.00mm	37.50mm	26.50mm	19.00mm	13.2mm	9.50mm	6.70mm	4.75mm	2.36mm	1.18mm	0.600mm	0.425mm	0.300mm	0.150mm	0.075mm
							100	100	100	100	100	100	99	98	97	96	96

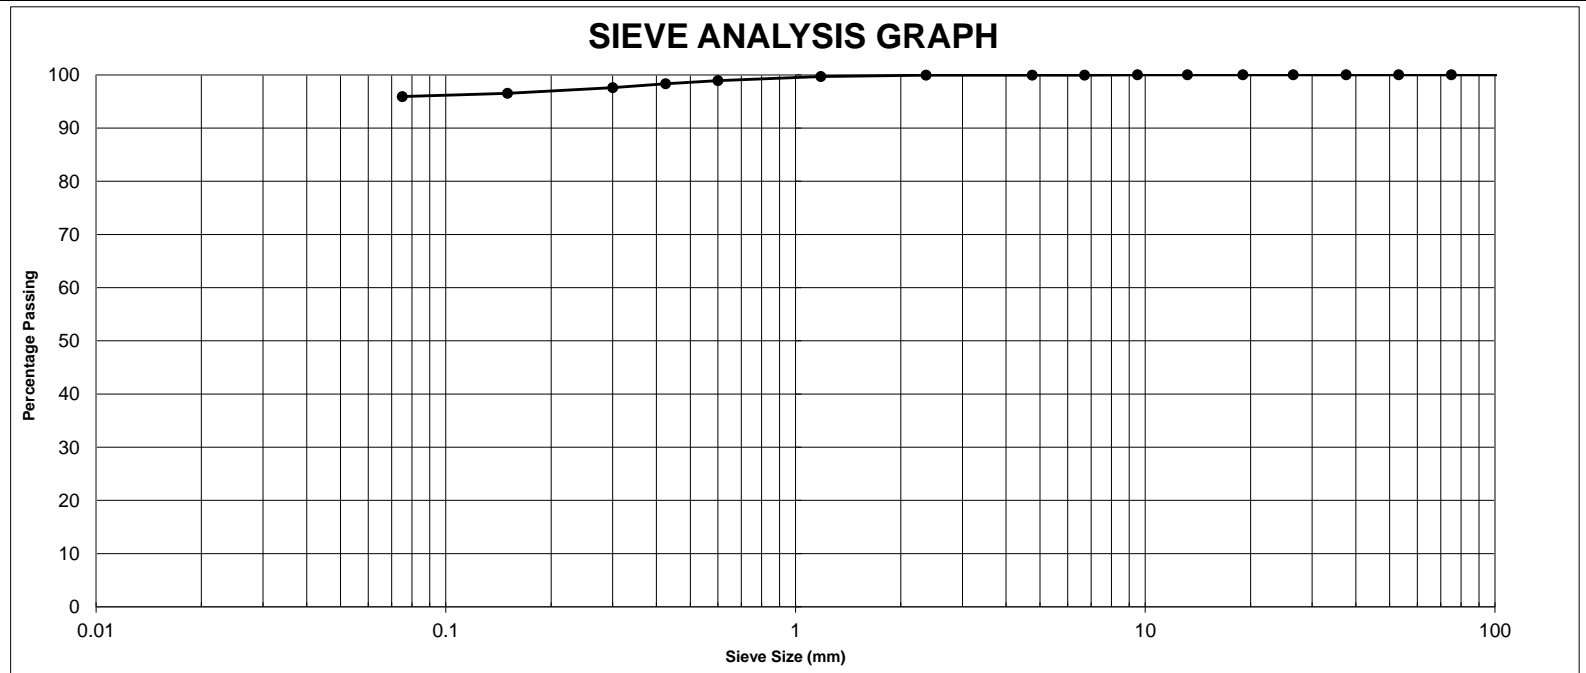
Sample No.:	1505781
ID No.:	28
Lot No.:	-
Date Sampled:	27/05/2015
Time Sampled:	am/pm
Date Tested:	13/06/2015
Material Source:	Insitu
Material Type:	Clay
To Be Used As	Material Analysis
Sample Location :	TP12 2-3.0m
Layer Depth (mm)	-
Test Depth (mm)	-
Sampling Method	AS1289.1.2.1.6.5.3
Moisture Content (%) AS 1289 2.1.1	26.0
Liquid Limit (%) AS 1289.3.1.2	41
Plastic Limit (%) AS 1289.3.2.1	21
Plasticity Index AS 1289.3.3.1	20
Linear Shrinkage (%) AS 1289.3.4.1	7.0
Cracking, Curling, Crumbling (1,2,3)	2
P.I. x % Passing 0.425mm	1967
L.S. x % Passing 0.425mm	688
Ratio of % Passing (0.075/0.425)	0.98

300mm	150mm	75.00mm	53.00mm	37.50mm	26.50mm	19.00mm	13.2mm	9.50mm	6.70mm	4.75mm	2.36mm	1.18mm	0.600mm	0.425mm	0.300mm	0.150mm	0.075mm
								100	100	100	100	100	99	98	98	97	96

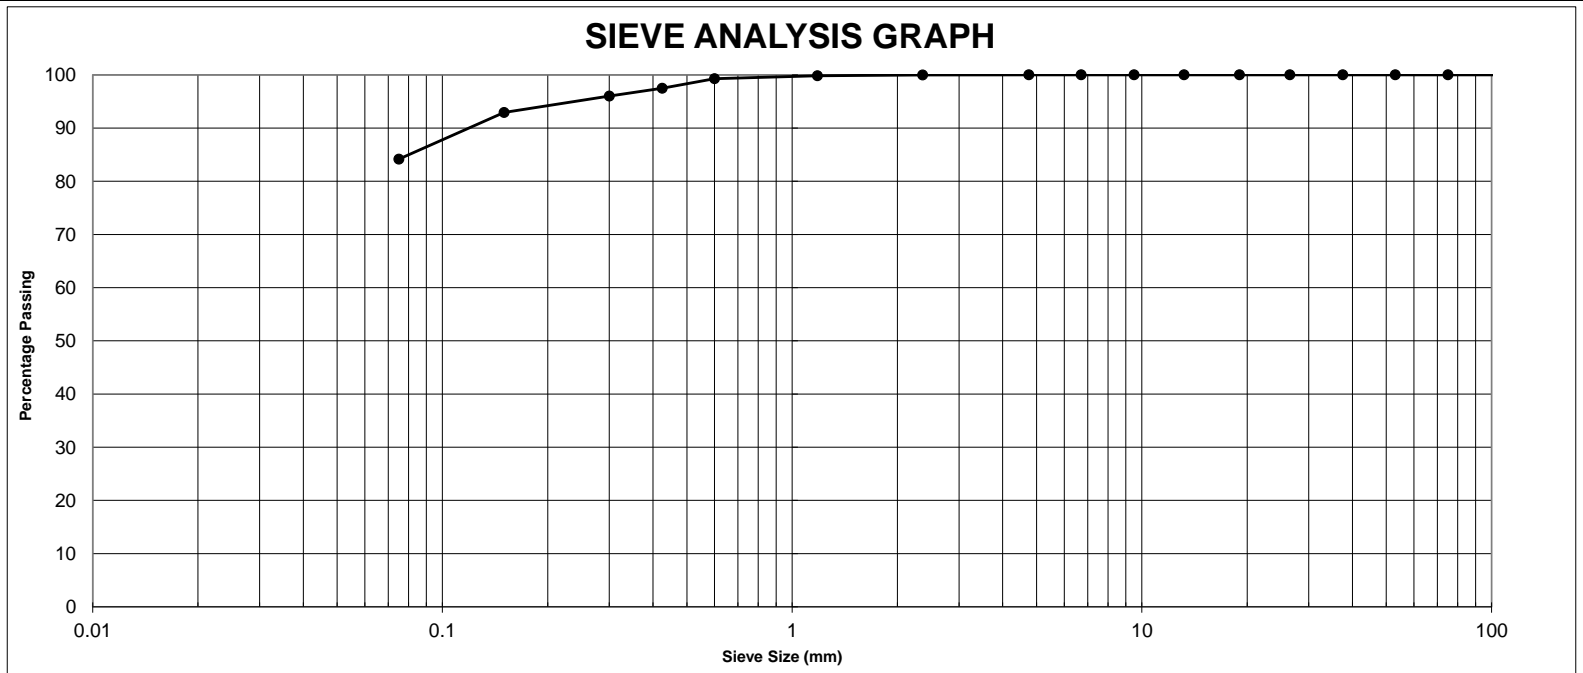
Sample No.:	1505782
ID No.:	29
Lot No.:	-
Date Sampled:	27/05/2015
Time Sampled:	am/pm
Date Tested:	12/06/2015
Material Source:	Insitu
Material Type:	Clay
To Be Used As	Material Analysis
Sample Location :	TP16 0.4-1.1m
Layer Depth (mm)	-
Test Depth (mm)	-
Sampling Method	AS1289.1.2.1.6.5.3
Moisture Content (%) AS 1289 2.1.1	10.7
Liquid Limit (%) AS 1289.3.1.2	36
Plastic Limit (%) AS 1289.3.2.1	15
Plasticity Index AS 1289.3.3.1	21
Linear Shrinkage (%) AS 1289.3.4.1	9.0
Cracking, Curling, Crumbling (1,2,3)	1
P.I. x % Passing 0.425mm	2047
L.S. x % Passing 0.425mm	877
Ratio of % Passing (0.075/0.425)	0.86

300mm	150mm	75.00mm	53.00mm	37.50mm	26.50mm	19.00mm	13.2mm	9.50mm	6.70mm	4.75mm	2.36mm	1.18mm	0.600mm	0.425mm	0.300mm	0.150mm	0.075mm
										100	100	100	99	97	96	93	84

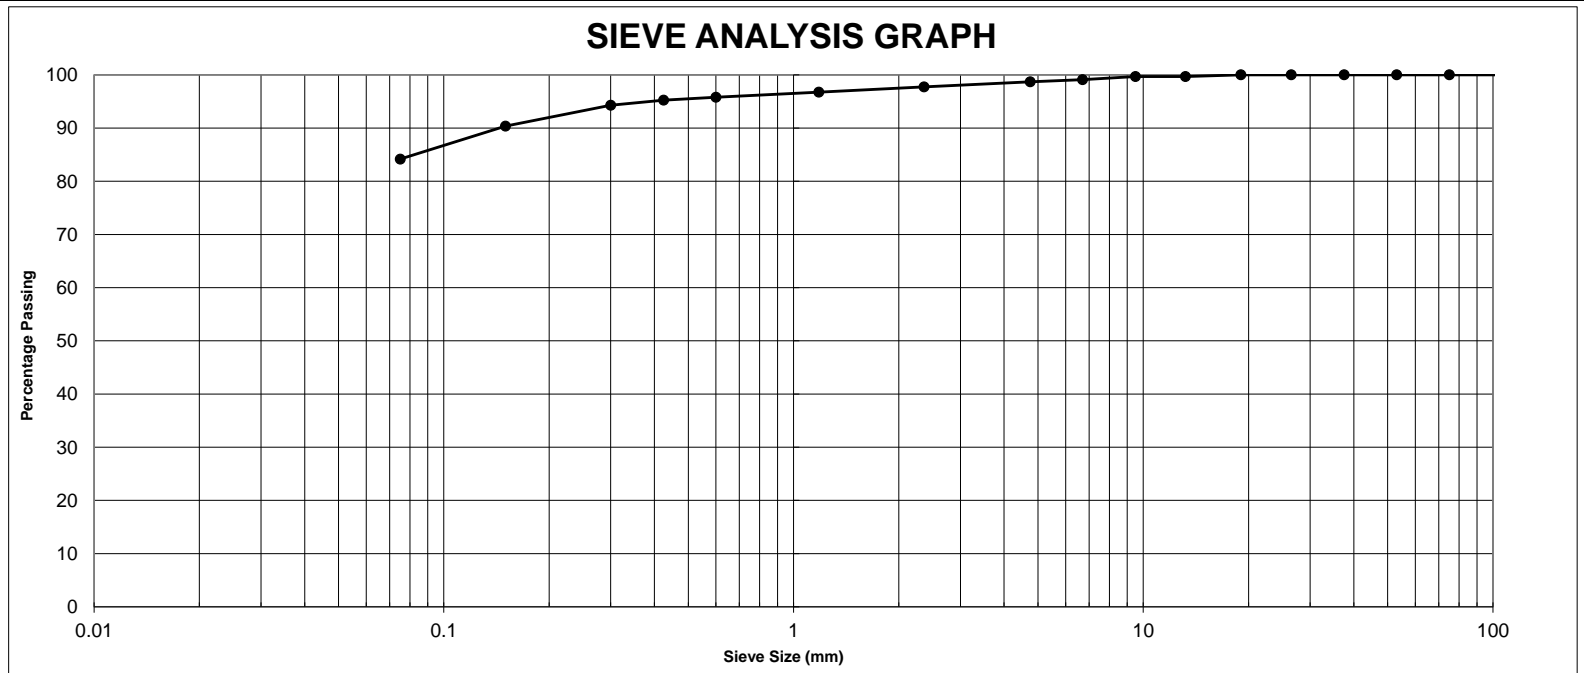
Sample No.:	1505783
ID No.:	30
Lot No.:	-
Date Sampled:	27/05/2015
Time Sampled:	am/pm
Date Tested:	12/06/2015
Material Source:	Insitu
Material Type:	Clay
To Be Used As	Material Analysis
Sample Location :	TP18 0-1.5m
Layer Depth (mm)	-
Test Depth (mm)	-
Sampling Method	AS1289.1.2.1.6.5.3
Moisture Content (%) AS 1289 2.1.1	19.1
Liquid Limit (%) AS 1289.3.1.2	44
Plastic Limit (%) AS 1289.3.2.1	18
Plasticity Index AS 1289.3.3.1	26
Linear Shrinkage (%) AS 1289.3.4.1	8.5
Cracking, Curling, Crumbling (1,2,3)	1, 2
P.I. x % Passing 0.425mm	2476
L.S. x % Passing 0.425mm	810
Ratio of % Passing (0.075/0.425)	0.88

300mm	150mm	75.00mm	53.00mm	37.50mm	26.50mm	19.00mm	13.2mm	9.50mm	6.70mm	4.75mm	2.36mm	1.18mm	0.600mm	0.425mm	0.300mm	0.150mm	0.075mm
						100	100	100	99	99	98	97	96	95	94	90	84

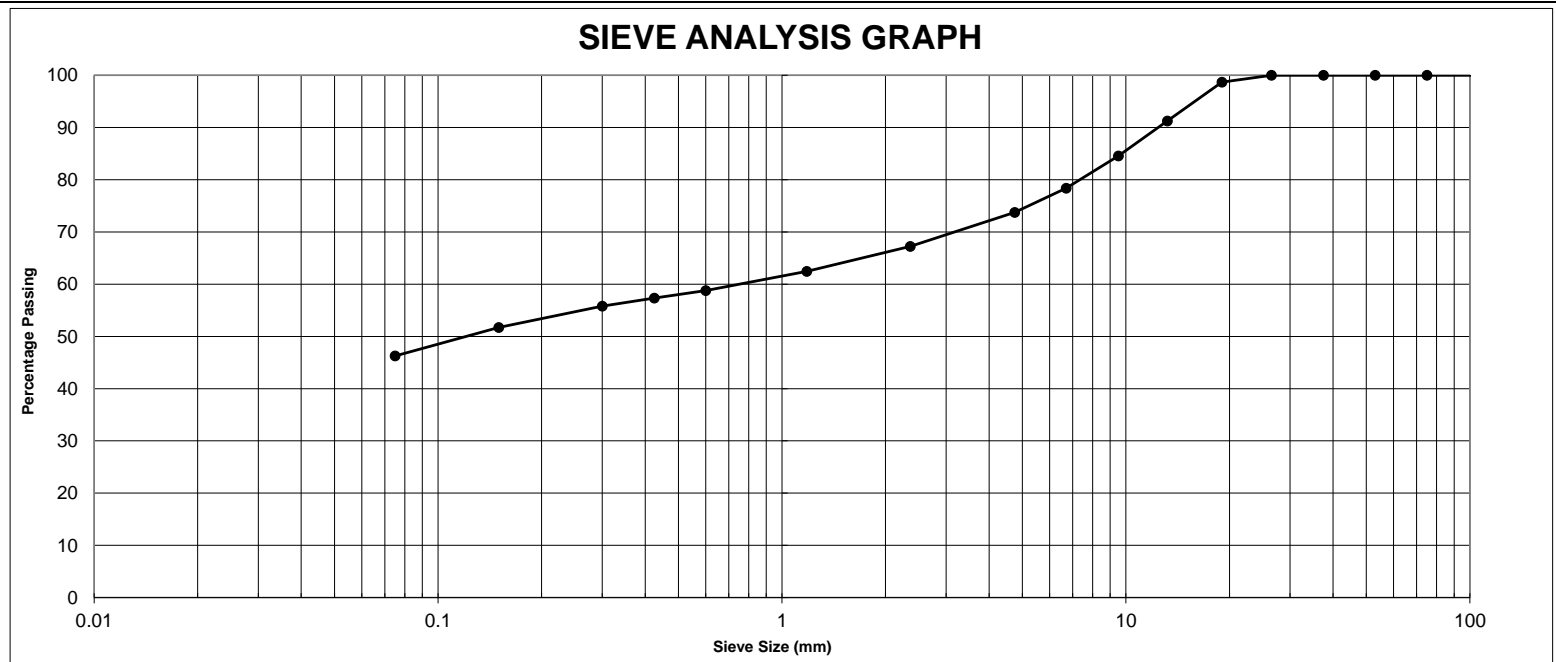
Sample No.:	1505784
ID No.:	31
Lot No.:	-
Date Sampled:	27/05/2015
Time Sampled:	am/pm
Date Tested:	12/06/2015
Material Source:	Insitu
Material Type:	Clay
To Be Used As	Material Analysis
Sample Location :	TP18 1.5-2.2m
Layer Depth (mm)	-
Test Depth (mm)	-
Sampling Method	AS1289.1.2.1.6.5.3
Moisture Content (%) AS 1289.2.1.1	12.8
Liquid Limit (%) AS 1289.3.1.2	28
Plastic Limit (%) AS 1289.3.2.1	22
Plasticity Index AS 1289.3.3.1	6
Linear Shrinkage (%) AS 1289.3.4.1	3.5
Cracking, Curling, Crumbling (1,2,3)	1
P.I. x % Passing 0.425mm	344
L.S. x % Passing 0.425mm	201
Ratio of % Passing (0.075/0.425)	0.81

300mm	150mm	75.00mm	53.00mm	37.50mm	26.50mm	19.00mm	13.2mm	9.50mm	6.70mm	4.75mm	2.36mm	1.18mm	0.600mm	0.425mm	0.300mm	0.150mm	0.075mm
					100	99	91	85	78	74	67	62	59	57	56	52	46

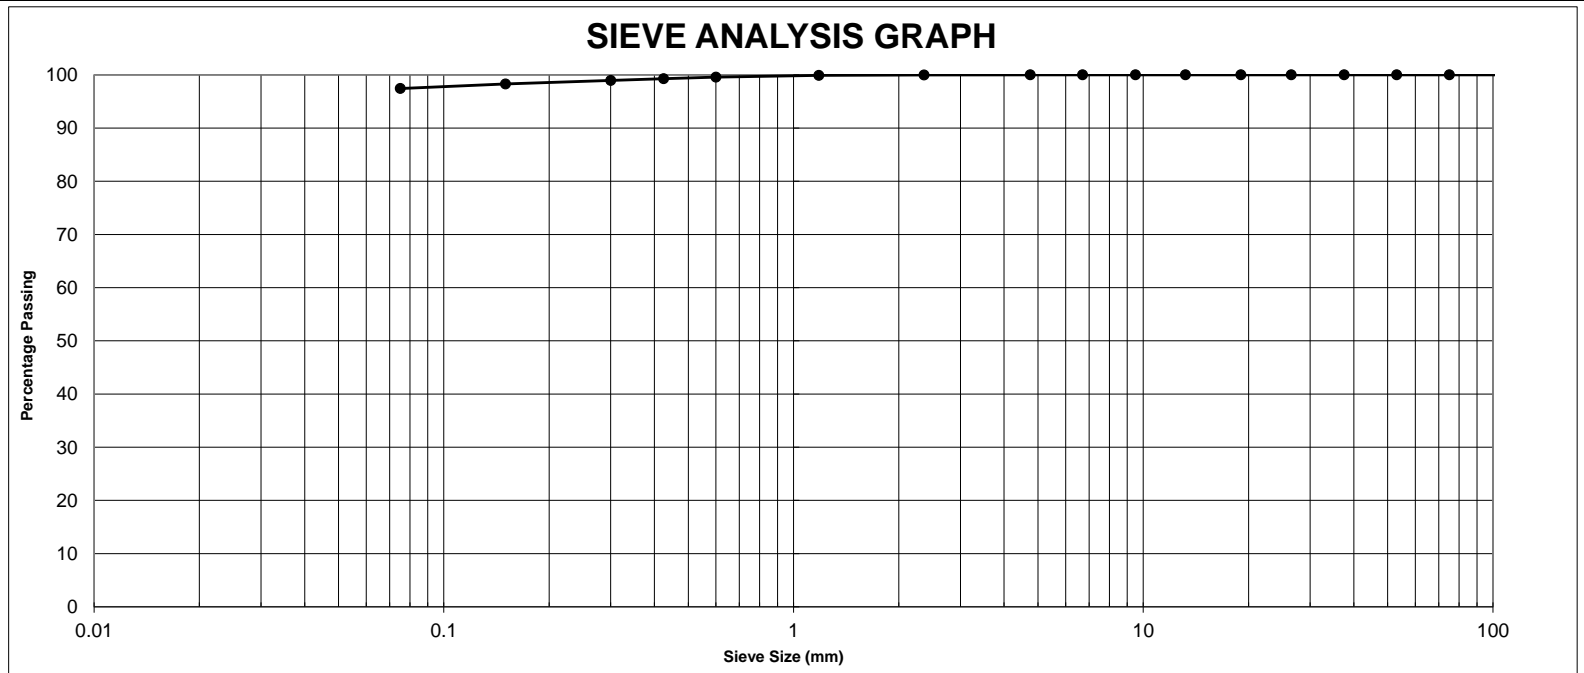
Sample No.:	1505785
ID No.:	32
Lot No.:	-
Date Sampled:	27/05/2015
Time Sampled:	am/pm
Date Tested:	12/06/2015
Material Source:	Insitu
Material Type:	Clay
To Be Used As	Material Analysis
Sample Location :	TP19 0-0.9m
Layer Depth (mm)	-
Test Depth (mm)	-
Sampling Method	AS1289.1.2.1.6.5.3
Moisture Content (%) AS 1289 2.1.1	20.4
Liquid Limit (%) AS 1289.3.1.2	42
Plastic Limit (%) AS 1289.3.2.1	19
Plasticity Index AS 1289.3.3.1	23
Linear Shrinkage (%) AS 1289.3.4.1	12.0
Cracking, Curling, Crumbling (1,2,3)	1, 2
P.I. x % Passing 0.425mm	2283
L.S. x % Passing 0.425mm	1191
Ratio of % Passing (0.075/0.425)	0.98

300mm	150mm	75.00mm	53.00mm	37.50mm	26.50mm	19.00mm	13.2mm	9.50mm	6.70mm	4.75mm	2.36mm	1.18mm	0.600mm	0.425mm	0.300mm	0.150mm	0.075mm
										100	100	100	100	99	99	98	97

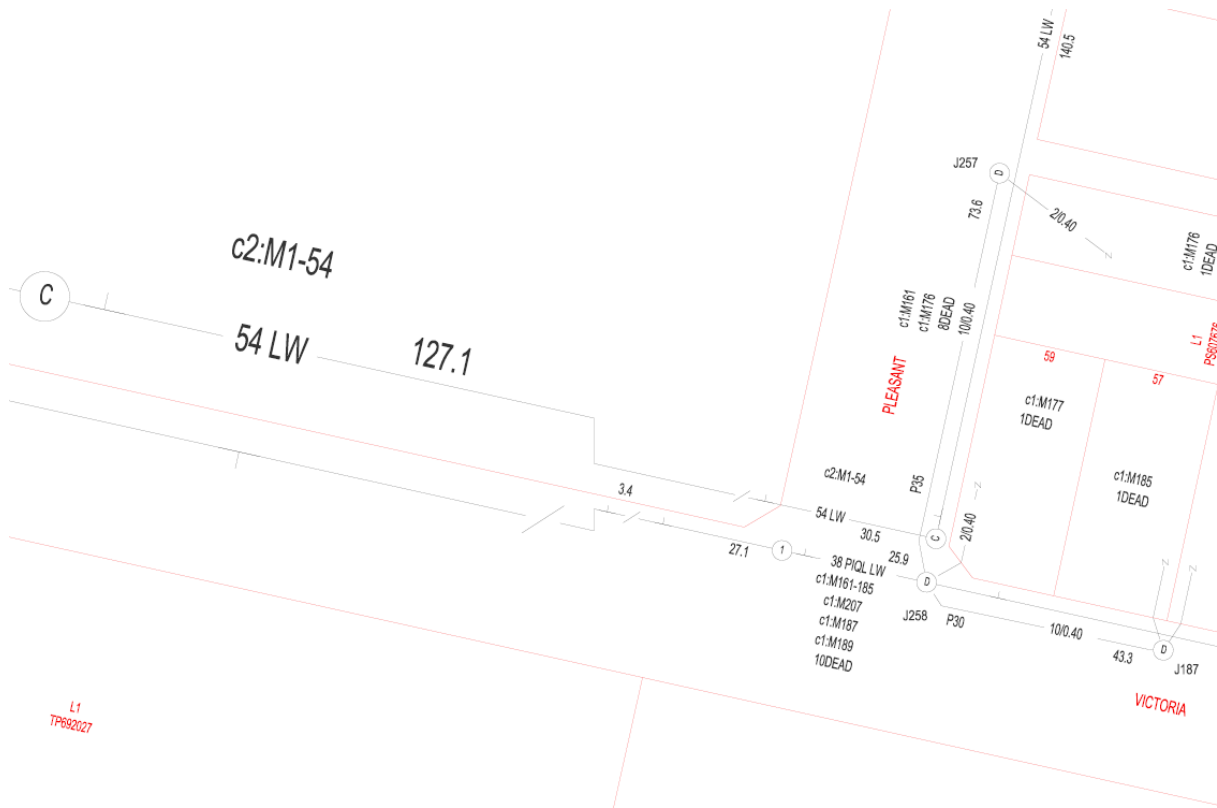
At Pyrenees Highway:

D.3 Telstra cables

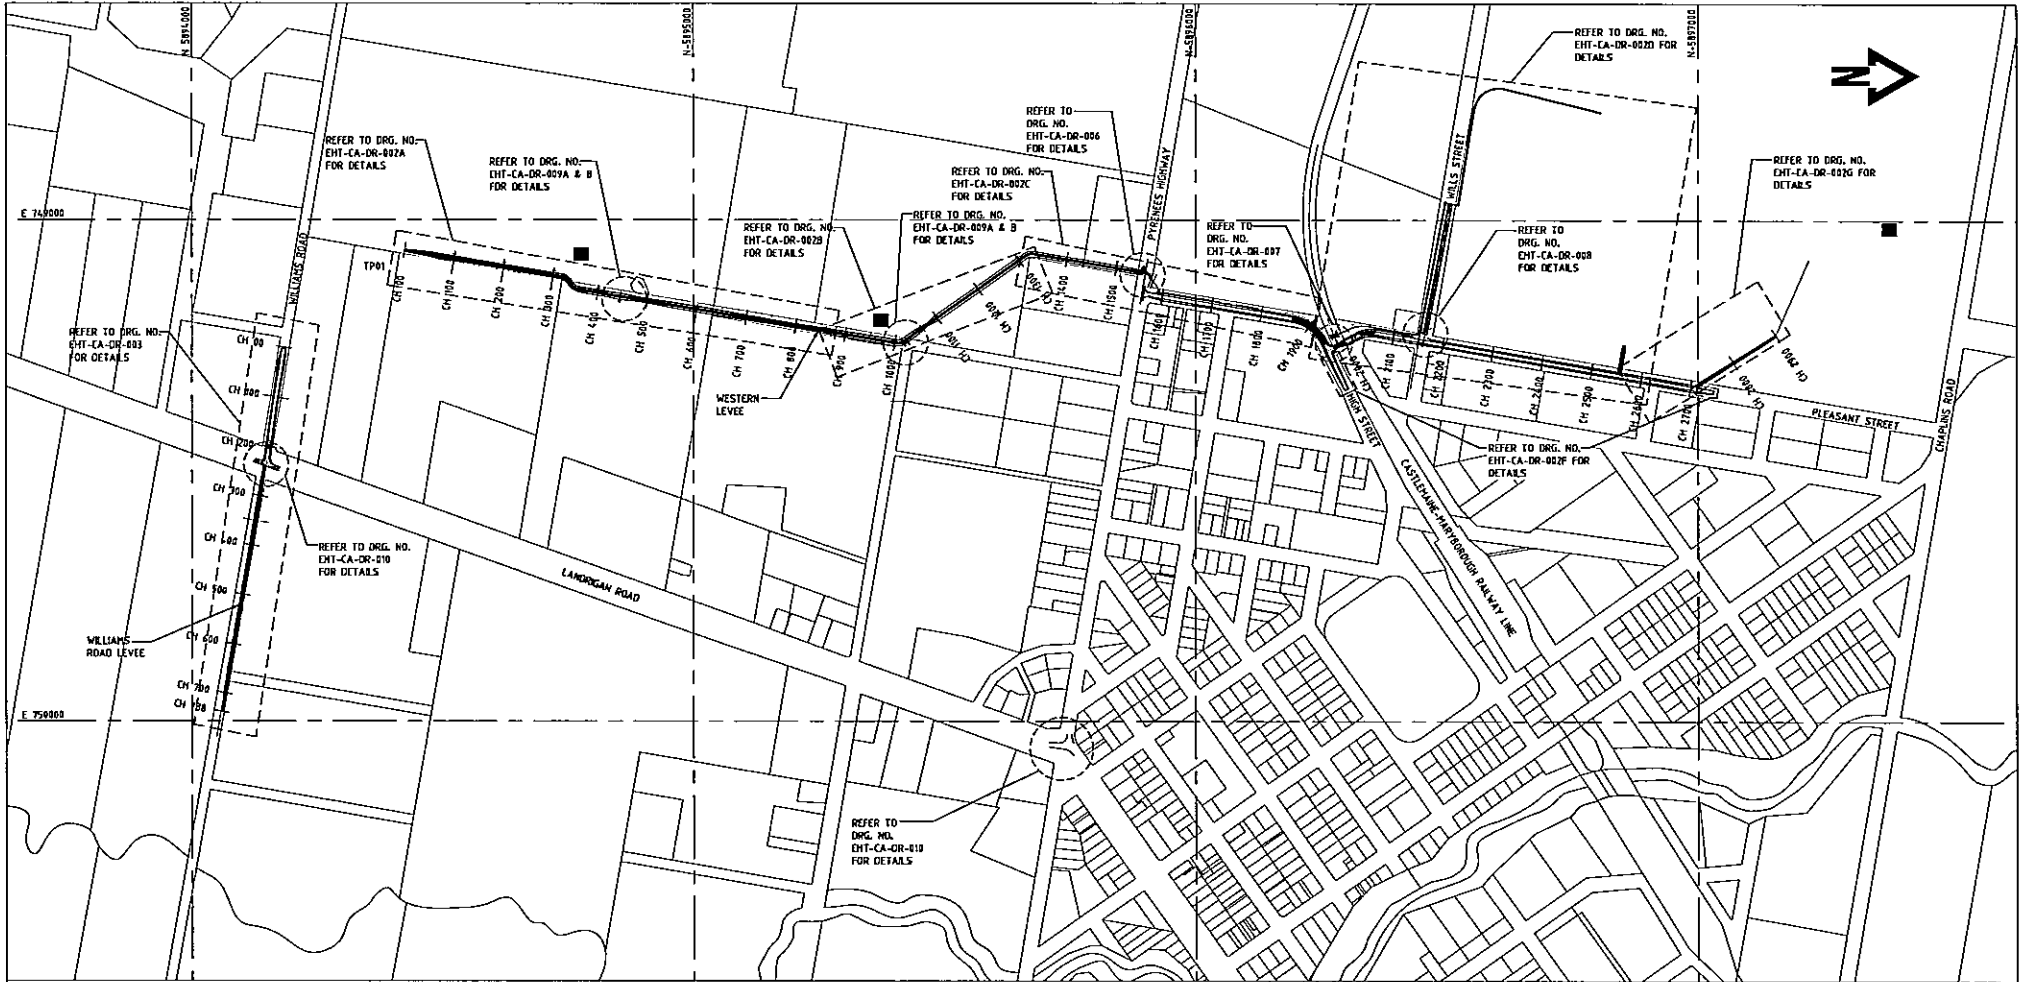
PLAN
SCALE 1:10000

CLIENT	CENTRAL GOLDFIELDS SHIRE COUNCIL	PROJECT NO.	E304639
PROJECT	CARISBROOK FLOOD AND DRAINAGE MITIGATION PROJECT	SCALE	1:10000
GENERAL ARRANGEMENT PLAN			
PROJECT NO.	EHT-CA-DR-001A	DATE	15/03/2016

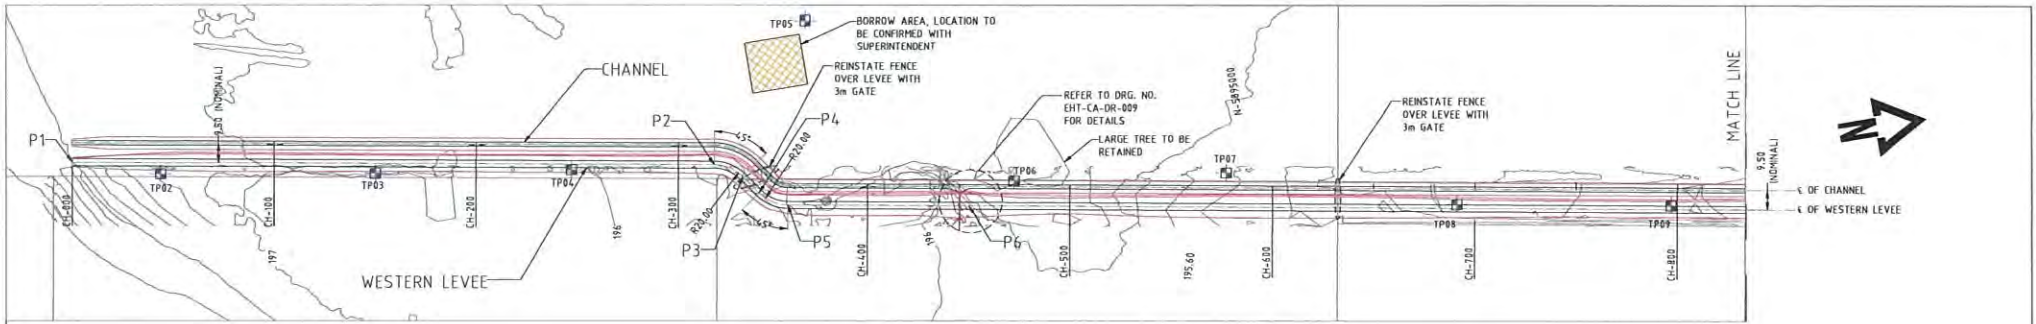
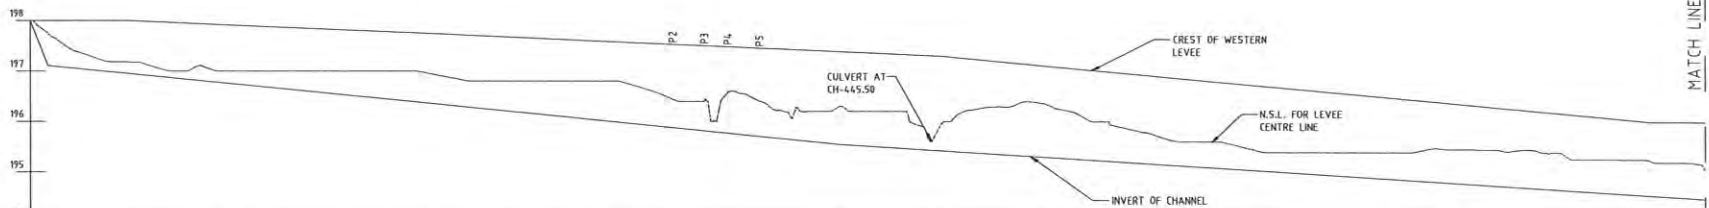
TOP OF THE LEVEE	198.00	198.00	197.74	197.54	197.39	197.20	197.11	196.74	196.37	196.00
LEVEE GRADING	HORIZONTAL		0.00175			0.00371				
INVERT LEVEL OF CHANNEL	198.00	197.11	196.35	196.35	195.95	195.55	195.30	195.05	194.80	194.55
CHANNEL GRADING	0.1		0.004			0.0025				
LEVEE SURFACE	GRAVEL

CLIENT	CENTRAL GOLDFIELDS SHIRE COUNCIL	PROJECT NO.	E304639
TITLE	CARISBROOK FLOOD AND DRAINAGE MITIGATION PROJECT	SCALE	AS SHOWN
	WESTERN LEVEE	SHEET	A3
	PLAN AND PROFILE	DWG. NO.	EHT-CA-DR-002A
		REV.	1

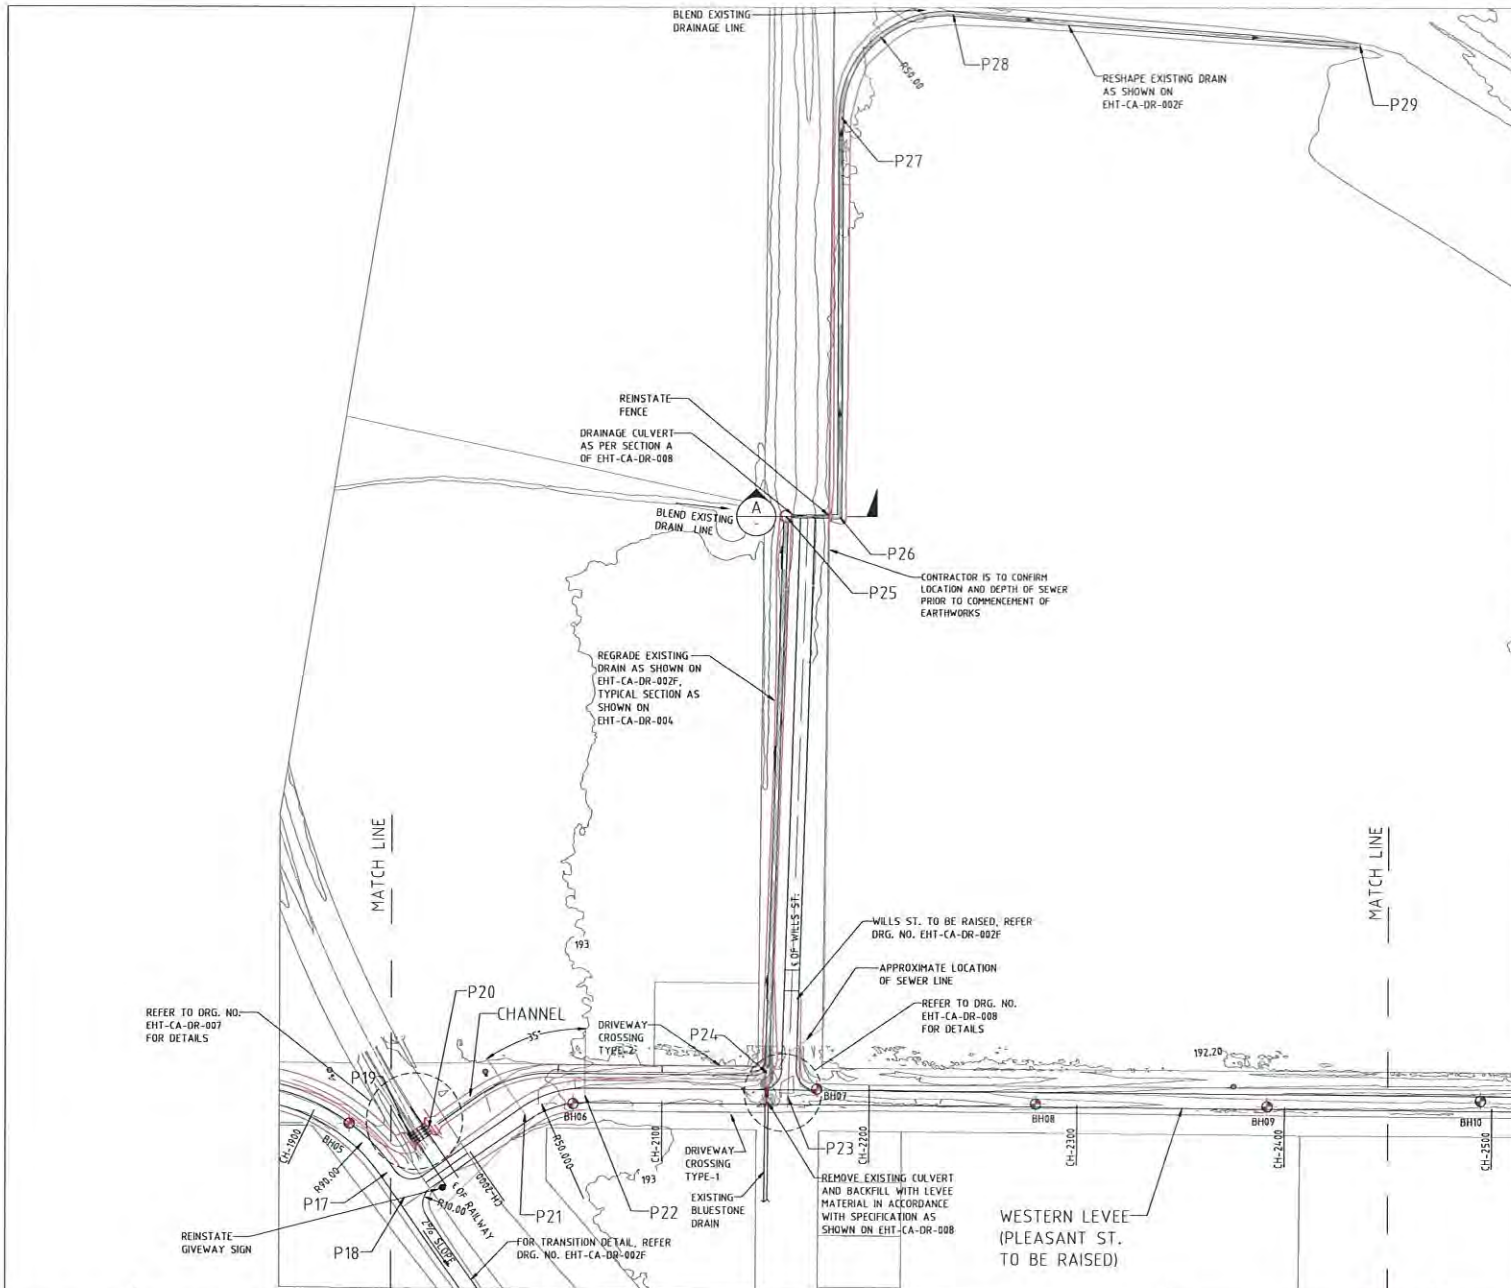
- LEVEE FOOTPRINT
- LEVEE CREST
- CULVERTS
- BOREHOLES
- POWER POLES

CLIENT	CENTRAL GOLDFIELDS SHIRE COUNCIL	ENGAGEMENT No.	E304639
PROJECT	CARISBROOK FLOOD AND DRAINAGE MITIGATION PROJECT	SCALE	AS SHOWN
	WESTERN LEVEE	REV	A3
	PLAN AND PROFILE	REV.	1
DWG No.	EHT-CA-DR-002D	DR.	4/7

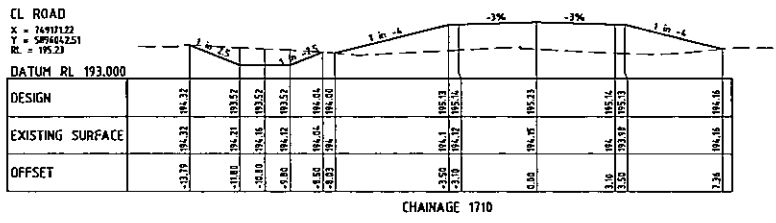
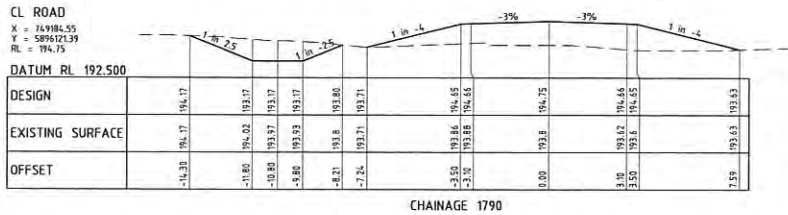
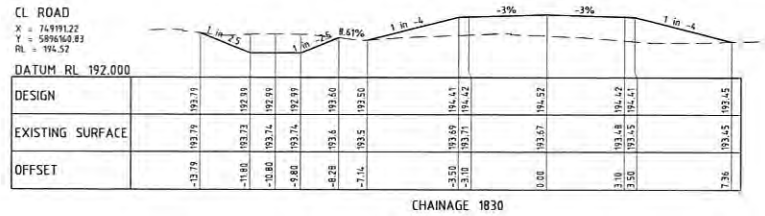
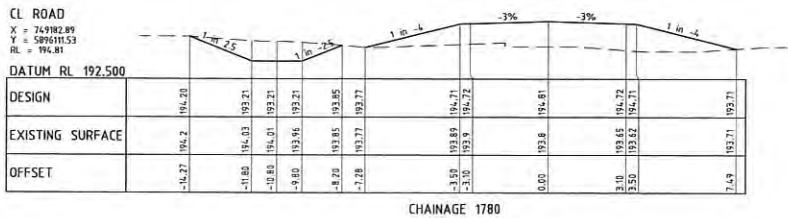
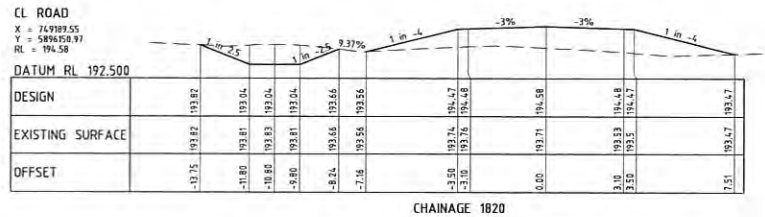
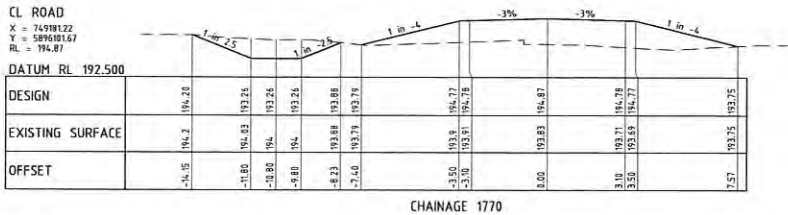
DRAWN	BOSS	CHECKED		DESIGNED		ENGINEER	PS	APPROVED	TG	DATE	11-05-16	CLIENT APPROV		DATE
DRAWN	BOSS																							
CHECKED																								
DESIGNED																								
ENGINEER	PS																							
APPROVED	TG																							
DATE	11-05-16																							
CLIENT APPROV																								
DATE																								
<p>entura The power of natural thinking</p> <p>Hydro Tasmania</p> <p>Level 25, 500 Collins St, Melbourne Victoria, 3000, AUSTRALIA Ph: 03 8628 9700 Fax: 03 8628 9764 www.entura.com.au</p>								<p>CLIENT: CENTRAL GOLDFIELDS SHIRE COUNCIL DRAWING NO: E304639</p> <p>CARISBROOK FLOOD AND DRAINAGE MITIGATION PROJECT</p> <p>WESTERN ROAD LEVEE CROSS SECTIONS</p> <p>SCALE 1:100</p> <p>NO. A1</p> <p>REV 0</p>

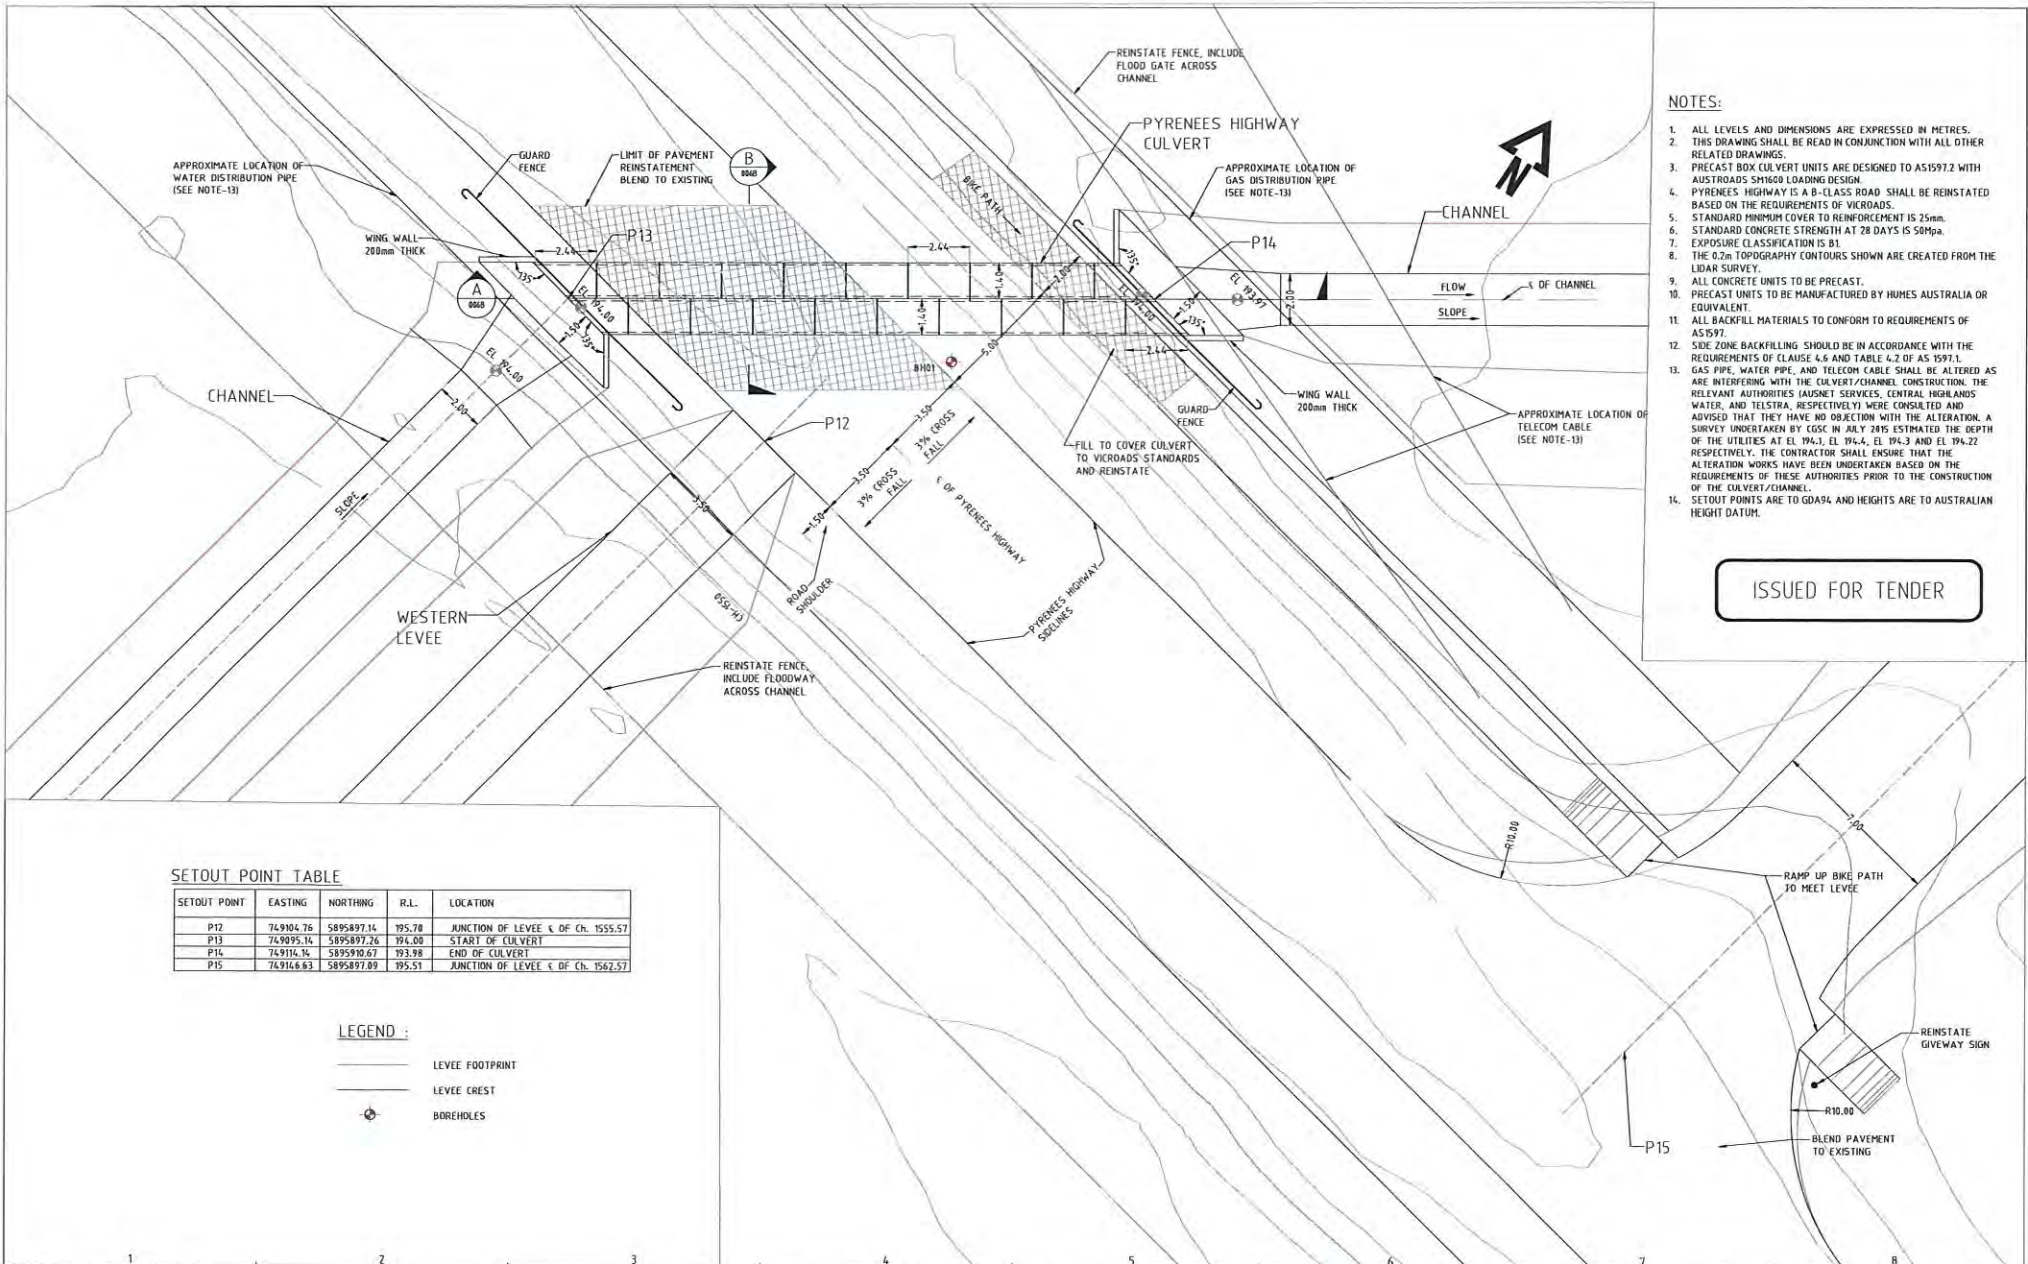
CLIENT: CENTRAL GOLDFIELDS SHIRE COUNCIL	DRAWING NO: E304639
PROJECT: CARISBROOK FLOOD AND DRAINAGE MITIGATION PROJECT	SCALE: AS SHOWN
PLAN AND SECTIONS	SHEET: A3
DWG NO: EHT-CA-DR-006A	REV: 1

- NOTES:**
1. ALL LEVELS AND DIMENSIONS ARE EXPRESSED IN METRES.
 2. THIS DRAWING SHALL BE READ IN CONJUNCTION WITH ALL OTHER RELATED DRAWINGS.
 3. PRECAST BOX CULVERT UNITS ARE DESIGNED TO AS15197.2 WITH AUSTRROADS SH1600 LOADING DESIGN.

4. PYRENEES HIGHWAY IS A B-CLASS ROAD SHALL BE REINSTATED BASED ON THE REQUIREMENTS OF VIKROADS.
 5. STANDARD MINIMUM COVER TO REINFORCEMENT IS 25mm.
 6. STANDARD CONCRETE STRENGTH AT 28 DAYS IS 50MPa.

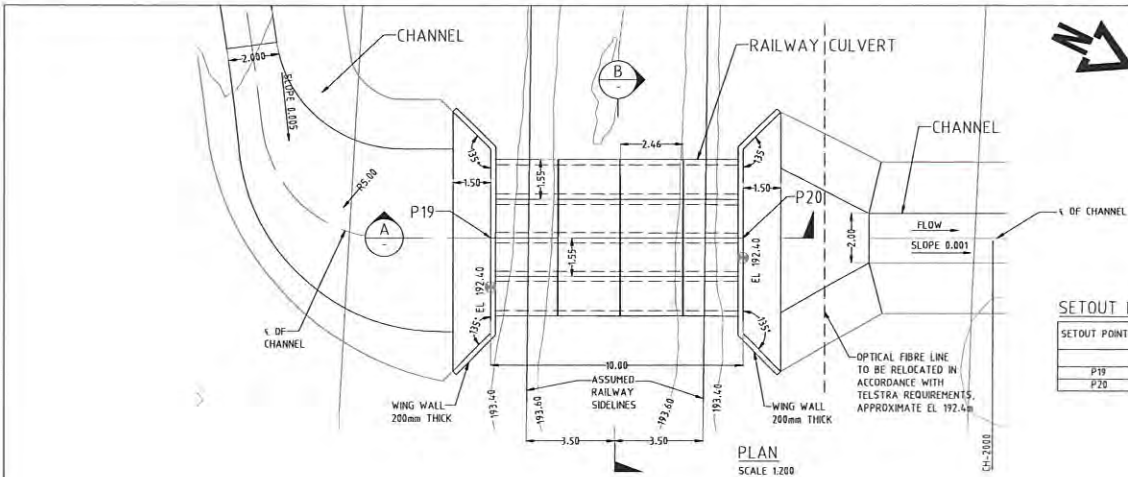
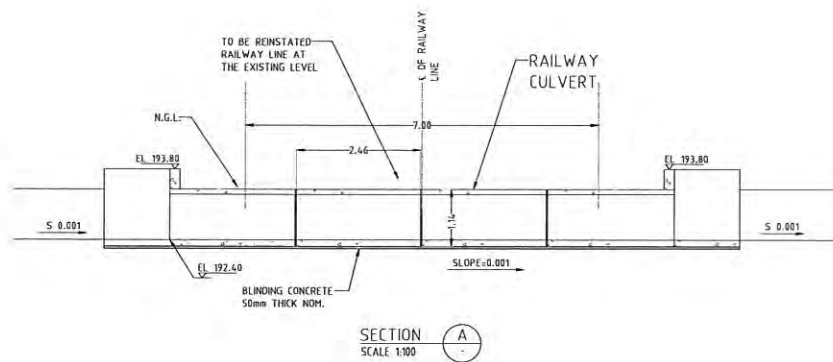
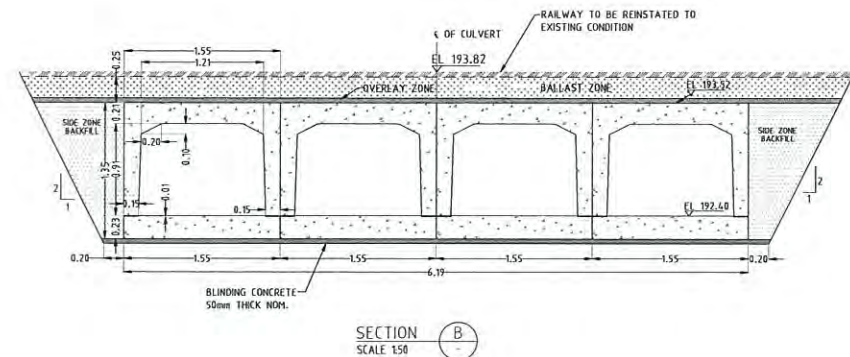
CLIENT: CENTRAL GOLDFIELDS SHIRE COUNCIL	PROJECT NO: E304639
PROJECT: CARISBROOK FLOOD AND DRAINAGE MITIGATION PROJECT	SCALE AS SHOWN
PROJECT: RAILWAY CULVERT	SHEET A3
PROJECT: PLAN AND SECTIONS	REV. 1
DWG. NO. EHT-CA-DR-007	DATE: --

- ALL LEVELS AND DIMENSIONS ARE EXPRESSED IN METRES.
- THIS DRAWINGS SHALL BE READ IN CONJUNCTION WITH ALL OTHER RELATED DRAWINGS.
- THE RAILWAY LINE SHALL BE REINSTATED TO EXISTING CONDITIONS.
- THESE UNITS ARE DESIGNED TO AS1597.2 WITH R300LA LOADING DESIGN.
- STANDARD MINIMUM COVER TO REINFORCEMENT IS 25mm
- STANDARD CONCRETE STRENGTH AT 28 DAYS IS 50mpa
- EXPOSURE CLASSIFICATION IS B1
- MASS IS CALCULATED ON NOMINAL BULK DENSITY BEING 2600kg/m³
- THE 0.2m TOPOGRAPHY CONTOURS SHOWN ARE CREATED FROM THE LIDAR SURVEY.
- ALL CONCRETE UNITS ARE TO BE PRECAST UNITS MANUFACTURED BY HUMES AUSTRALIA OR EQUIVALENT.
- SETOUT POINTS ARE TO GD94 AND HEIGHTS ARE TO AUSTRALIAN HEIGHT DATUM.

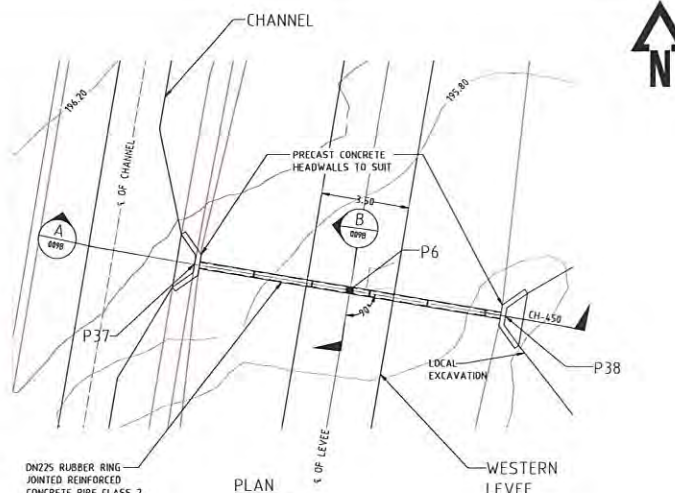
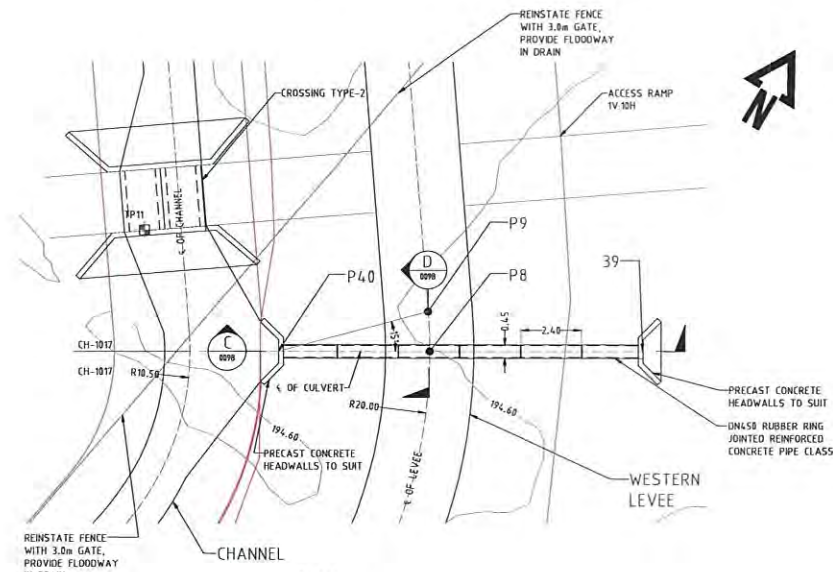
CLIENT	CENTRAL GOLDFIELDS SHIRE COUNCIL	PROJECT No.	E304639
PROJECT	CARISBROOK FLOOD AND DRAINAGE MITIGATION PROJECT	SCALE	AS SHOWN
OTHER CULVERT PLAN		SHEET	A3
PROJECT No.	EHT-CA-DR-009A	REV	1
		DATE	1/2

- ALL LEVELS AND DIMENSIONS ARE EXPRESSED IN METRES.
- THIS DRAWING SHALL BE READ IN CONJUNCTION WITH ALL OTHER RELATED DRAWINGS AND SPECIFICATION.
- THESE UNITS ARE DESIGNED TO AS1972 WITH AUSTRADRA'S SYMBOL LOADING DESIGN.
- FOR TOP OF THE LEVEE AND CHANNEL INVERT LEVELS REFER TO EHT-CA-DR-002A TO EHT-CA-DR-002G.
- FOR PROPERTIES OF HOMOGENOUS MATERIAL & BASE COURSE REFER TO THE SPECIFICATION.
- STANDARD MINIMUM COVER TO REINFORCEMENT IS 25mm.
- STANDARD CONCRETE STRENGTH AT 28 DAYS IS 50MPa.
- EXPOSURE CLASSIFICATION IS B1.
- MASS IS CALCULATED ON NOMINAL BULK DENSITY BEING 2600kg/m³.
- THE 0.2m TOPOGRAPHY CONTOURS SHOWN ARE CREATED FROM ENTURA FEATURE SURVEY.
- ALL CONCRETE UNITS ARE TO BE PRECAST UNITS MANUFACTURED BY HUMES AUSTRALIA OR EQUIVALENT.
- SETOUT POINTS ARE TO GD494 AND HEIGHTS ARE TO AUSTRALIAN HEIGHT DATUM.
