INVESTIGATION AND DESIGN OF CARISBROOK FLOOD AND DRAINAGE MITIGATION TREATMENTS

Detailed Design Report

ENTURA-A31FA
6 June 2016

Prepared by Hydro-Electric Corporation
ABN48 072 377 158

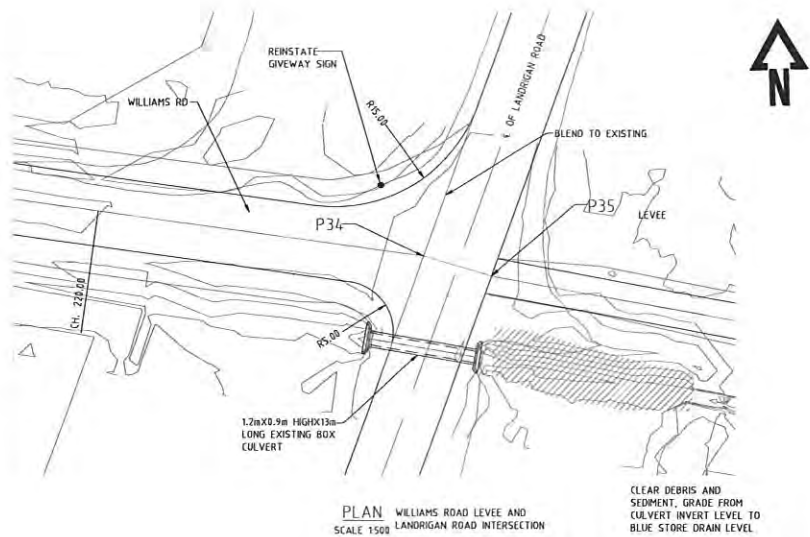
PLAN WILLIAMS ROAD LEVEE AND LANDRIGAN ROAD INTERSECTION
SCALE 1:500

- NOTES:**
1. ALL LEVELS AND DIMENSION ARE IN METRES.
 2. THIS DRAWINGS SHALL BE READ IN CONJUNCTION WITH ALL OTHER RELATED DRAWINGS AND SPECIFICATION.
 3. FOR TOP OF THE LEVEE LEVELS REFER TO EHT-CA-DR-003.
 4. FOR PROPERTIES OF HOMOGENOUS MATERIAL & BASE COURSE TYPE A & B REFER TO THE SPECIFICATION.
 5. WILLIAM ROAD IS TO BE RAISED & REINSTATED BASED ON SECTION 12 OF THE INFRASTRUCTURE DESIGN MANUAL, AUSTRROADS GUIDE TO ROAD DESIGN, VIADUCTS GUIDELINES & SPECIFICATION.
 11. SETOUT POINTS ARE TO 60A% AND HEIGHTS ARE TO AUSTRALIAN HEIGHT DATUM.

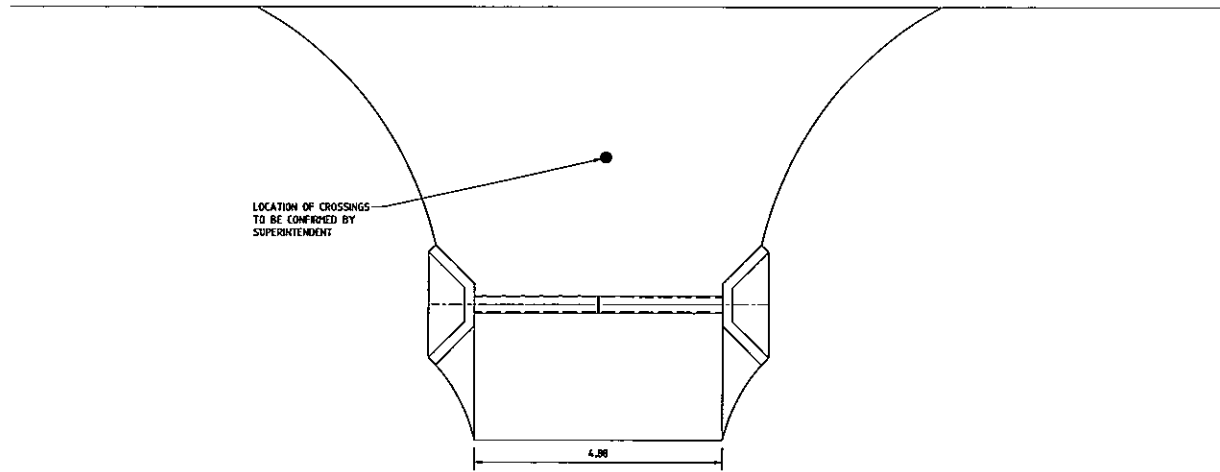
TYPICAL PLAN FOR DRIVEWAY CROSSINGS
SCALE 1:100

1. ALL LEVELS AND DIMENSIONS ARE IN METRES.
2. THIS DRAWINGS SHALL BE READ IN CONJUNCTION WITH ALL OTHER RELATED DRAWINGS AND SPECIFICATION.
3. FOR TOP OF THE LEVEE AND CHANNEL INVERT LEVELS REFER TO EHT-CA-DR-007A TO EHT-CA-DR-012C.
4. FOR PROPERTIES OF HOMOGENOUS MATERIAL & BASE COURSE REFER TO THE SPECIFICATION.
5. PLEASANT ST. IS TO BE RAISED & REINSTATED BASED ON SECTION 12 OF THE INFRASTRUCTURE DESIGN HANDBOOK, AUSTRROADS GADE TO ROAD DESIGN, VICTORIAS GUIDELINES & SPECIFICATION.

9	Engineering	Civil	Property owner has accident while accessing road from road levee	5. Possible	3. Moderate	15	Design: provide safe crossing with grade limited to 1V:10H and sufficient width. Construction: comply with design requirements.	2. Extremely Rare	2. Minor	4	✓	→	Ongoing
10	Engineering	Civil	Road user loses control and drives into floodwater.	4. Unlikely	5. Extreme	20	Design: provide flood protection up to 1:100AEP level plus freeboard, batters limited to 1V:4H to allow drivers to regain control. Operations: Maintain road in good condition, close road during flood conditions.	2. Extremely Rare	4. Major	8	✓	→	Ongoing
11	Engineering	Civil	Collision between train and vehicle at Pleasant St causes death or injury	2. Extremely Rare	5. Extreme	10	Design: railway currently disused. Crossing should be reviewed and possibly closed if railway reopened. Operations: Monitor use of railway and change crossing if required.	2. Extremely Rare	4. Major	8	✓	→	Ongoing
